iCYCLONE CHASE REPORT

storm	Hurricane ODILE		
location	Cabo San Lucas, Baja California Sur, Mexico		
date	14-15 September 2014		
chasers	Josh Morgerman, Steve Crighton	author	Josh Morgerman

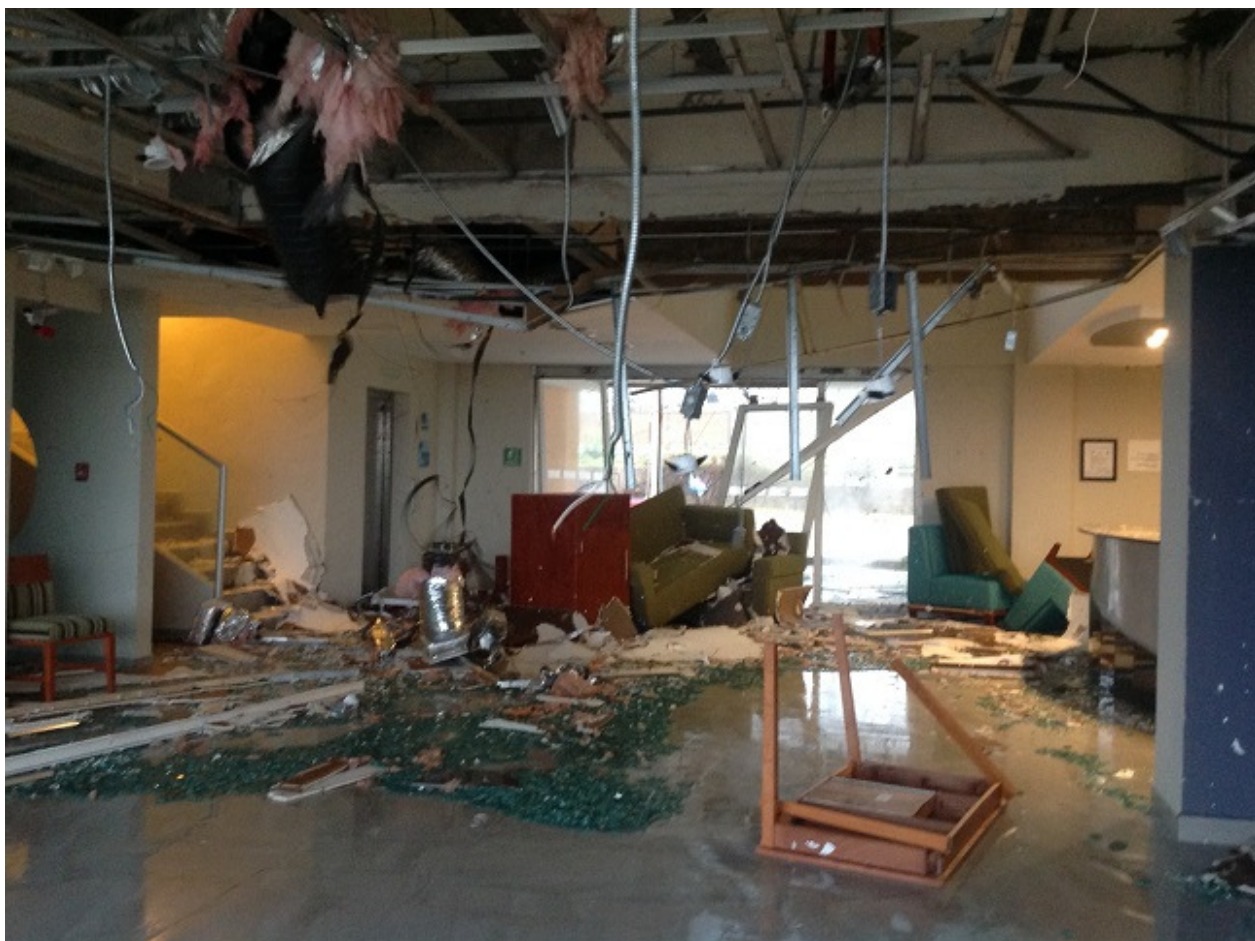
The interior of our hotel lobby the next morning. The front entrance (far end of this view) was blown out during the cyclone's front side. When the rear wall—made of glass—completely exploded during the backside, the lobby became a wind tunnel, resulting in heavy damage to the interior.

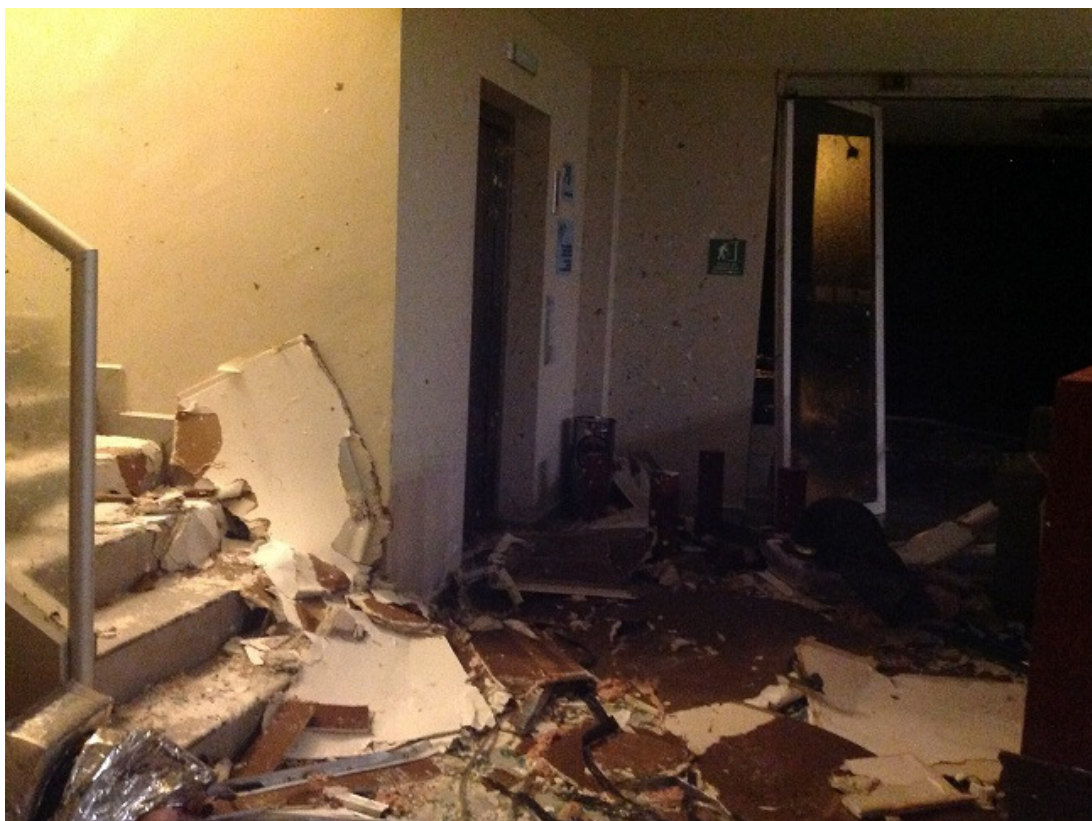
The interior of our hotel lobby—near the front entrance—just as the storm was moving away.

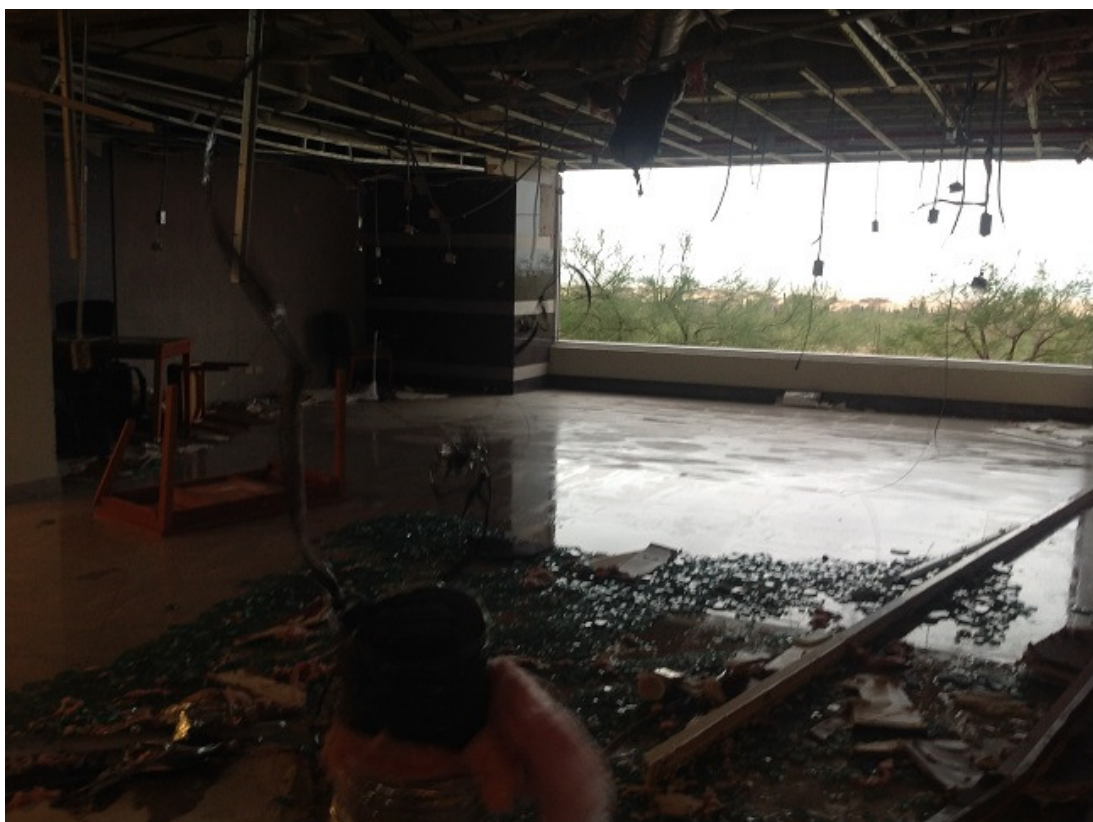
The rear glass wall of the lobby (facing S) completely blew out as the cyclone's backside swept in after the eye, turning the lobby into a wind tunnel. Powerful winds then gutted the interior.

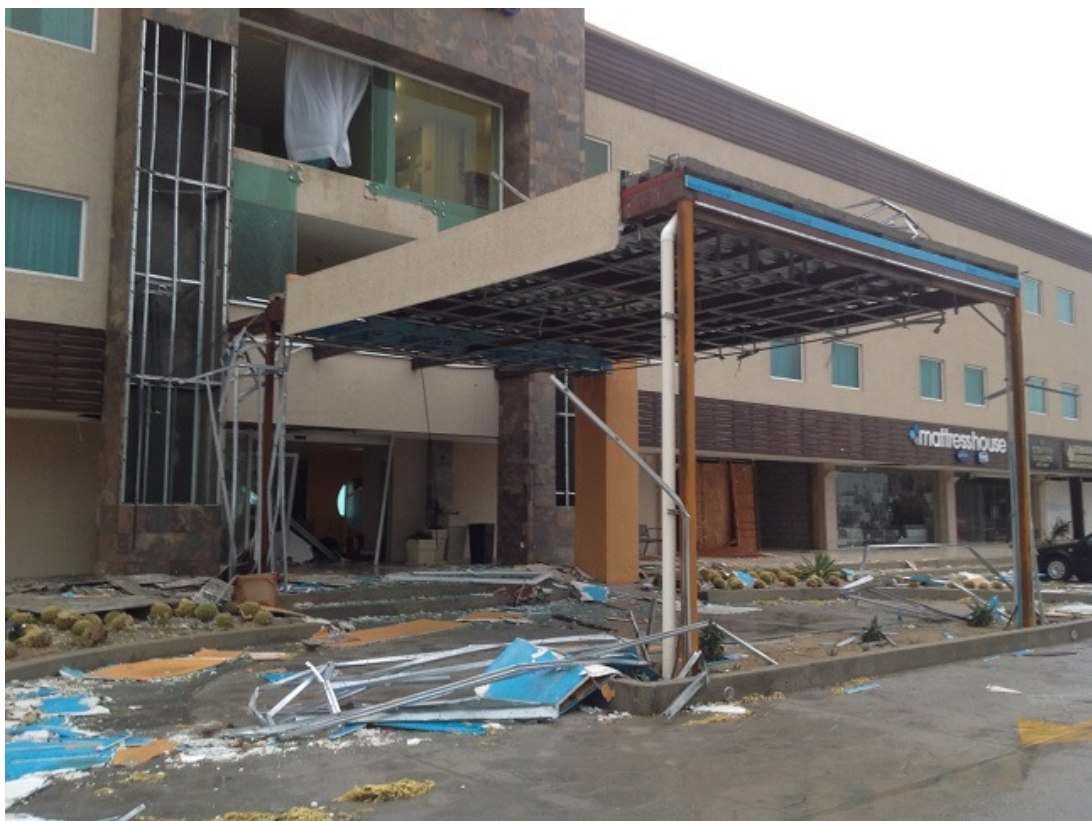
Exterior front entrance of our hotel the next morning. The hotel faces N, and most of the damage to the front of the building—smashed windows, destroyed entrance, collapsed facades, and shredded pillars and portico—happened during the cyclone’s front side.

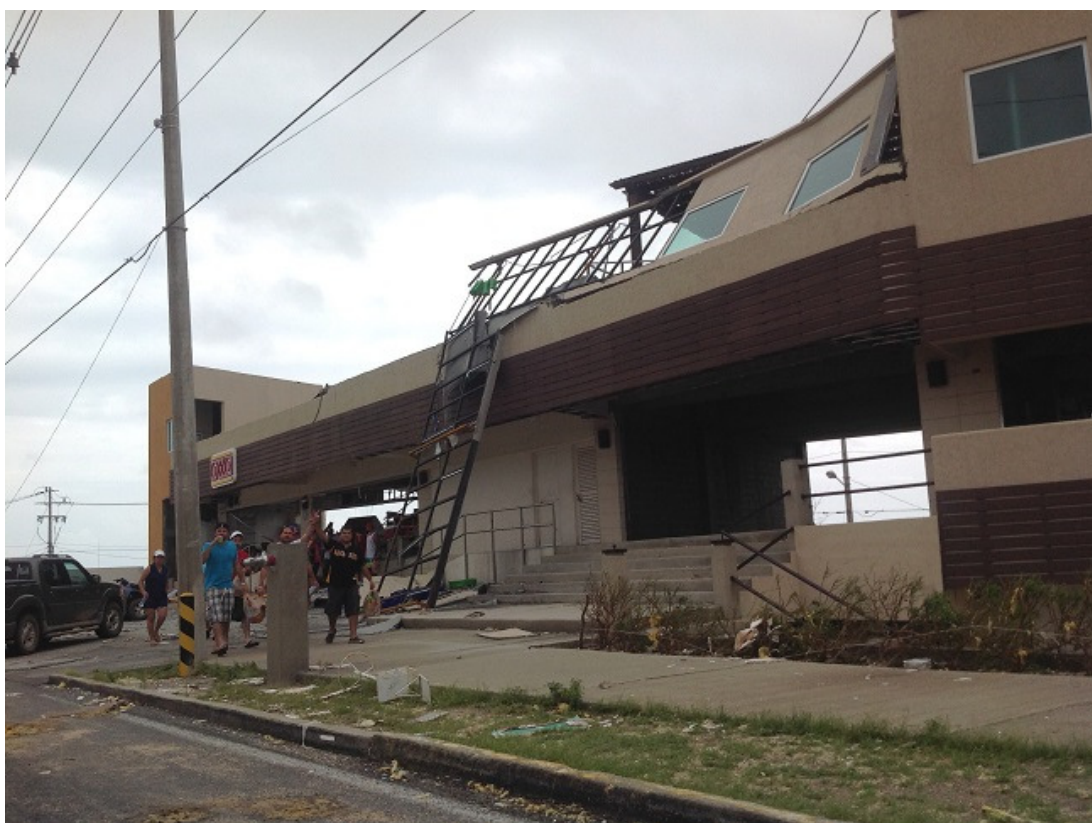
Exterior of our hotel. Front-side winds tore down a wall of the pool area on the top floor.

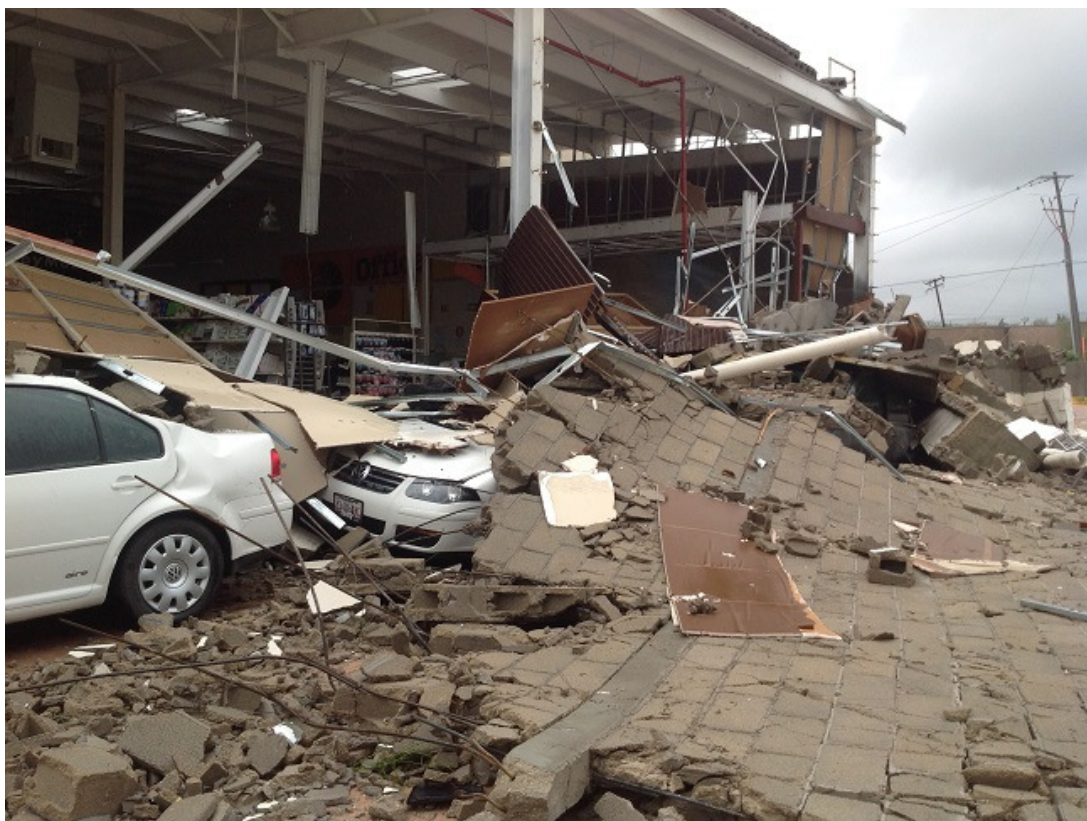
The Office Max next door to our hotel partially collapsed, burying nearby cars. The walls were made of cement blocks, with steel rods running through them.

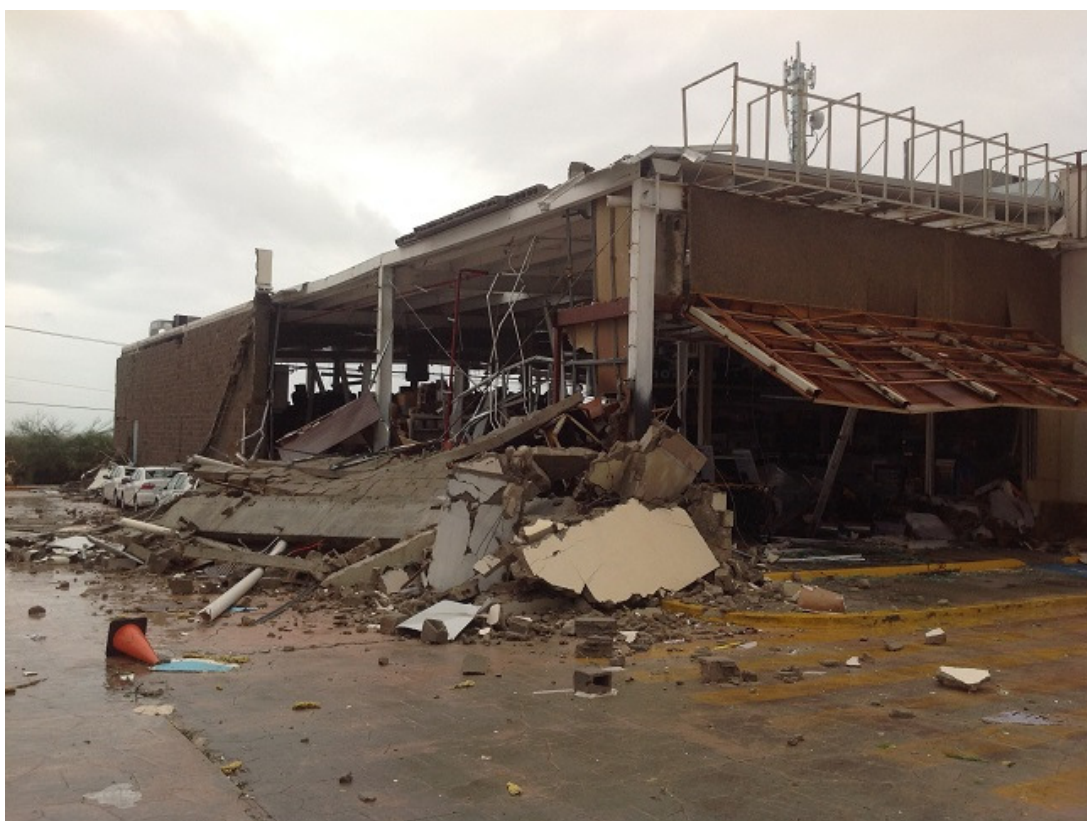
Another view of the collapsed Office Max.

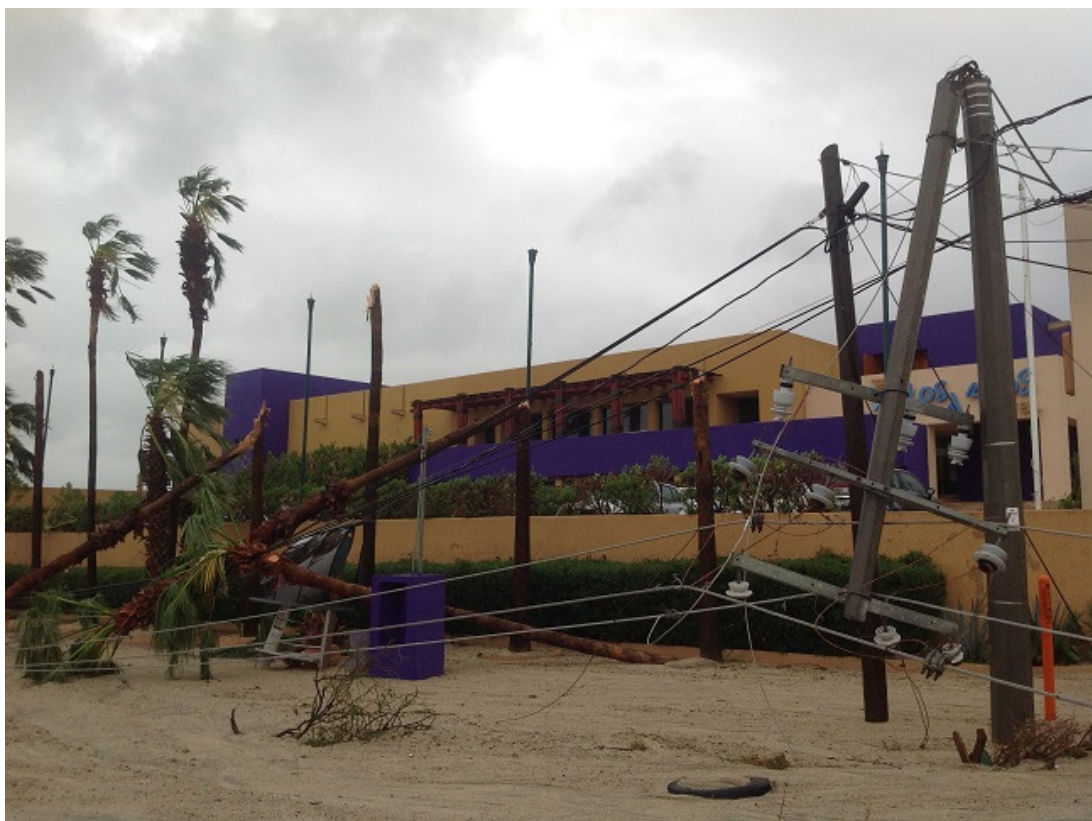
Near our hotel, palm trees and utility poles were snapped-off mid-trunk. The trees and poles broke roughly toward the S or SW, suggesting they fell before the eye. Fronds of surviving trees (in the background) are pointing roughly N, as backside winds were roughly from the S.

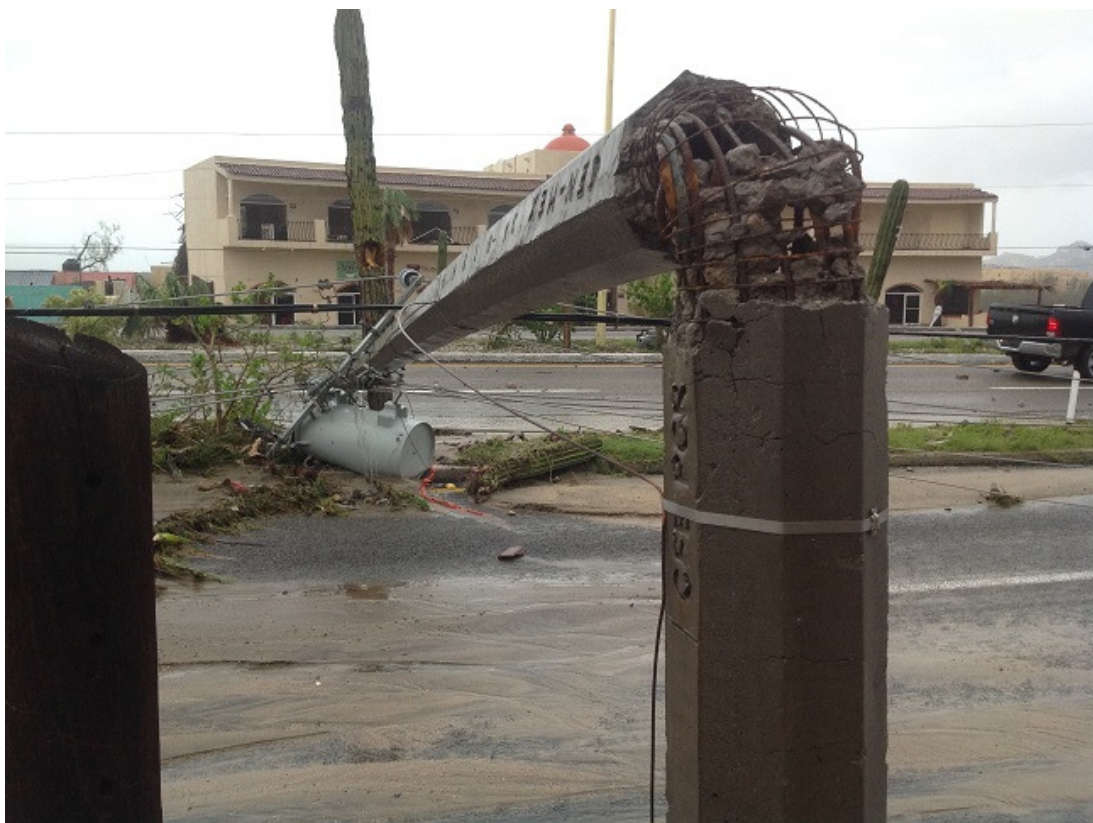
This snapped utility pole was made of steel-reinforced concrete.

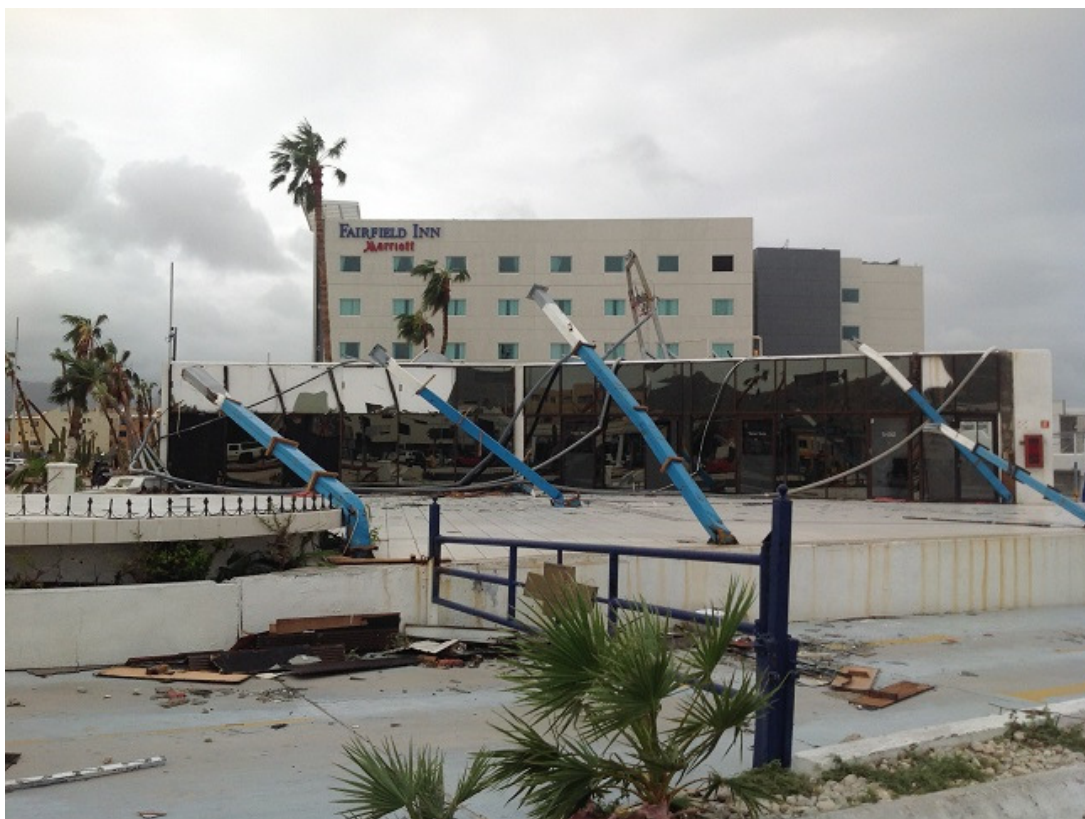
A large canopy structure was blown down, with the wreckage blowing into the street.

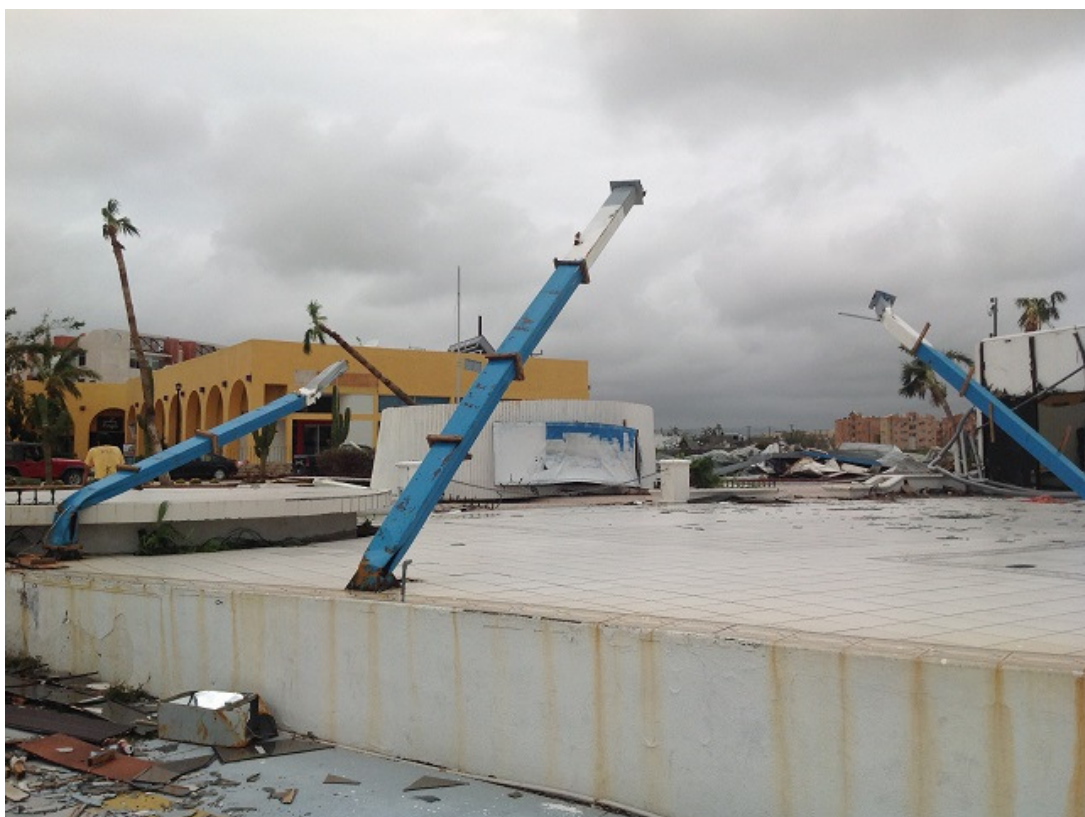
The wreckage was thrown quite far (see heap in far background).

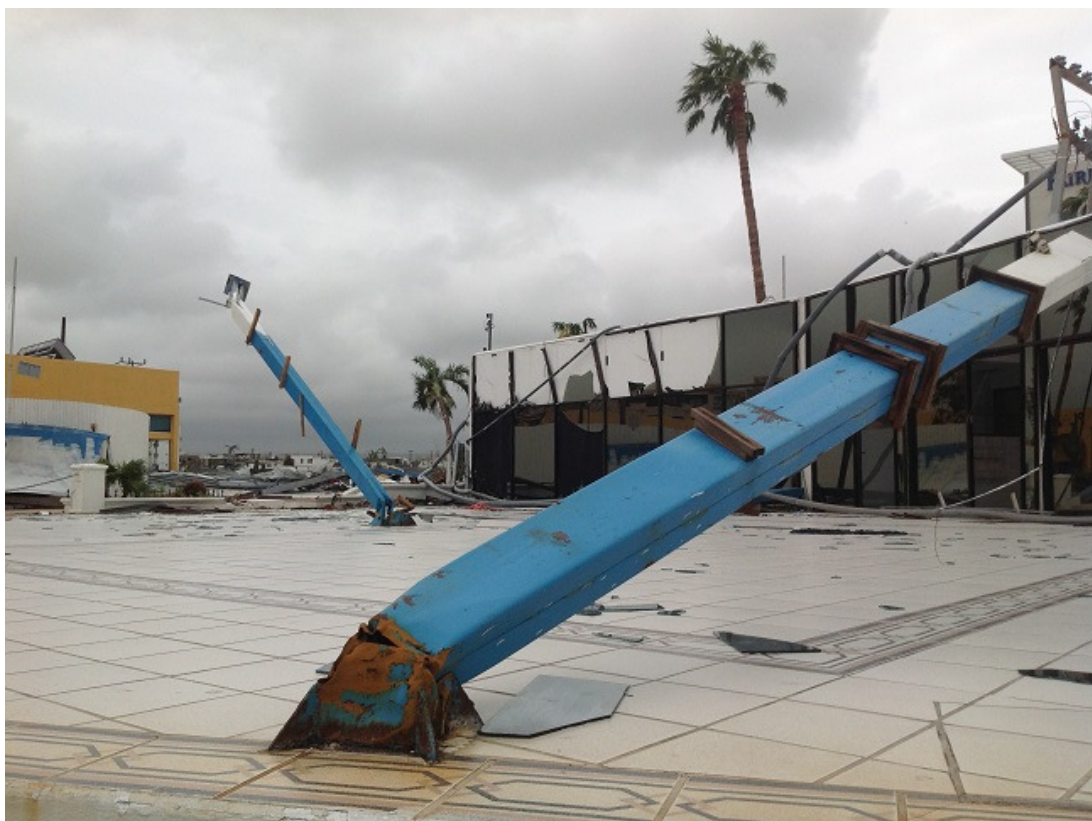
Some posts were bent in different directions, suggesting they fell at different times (during different phases of the storm) or the winds weren't totally straight-line.

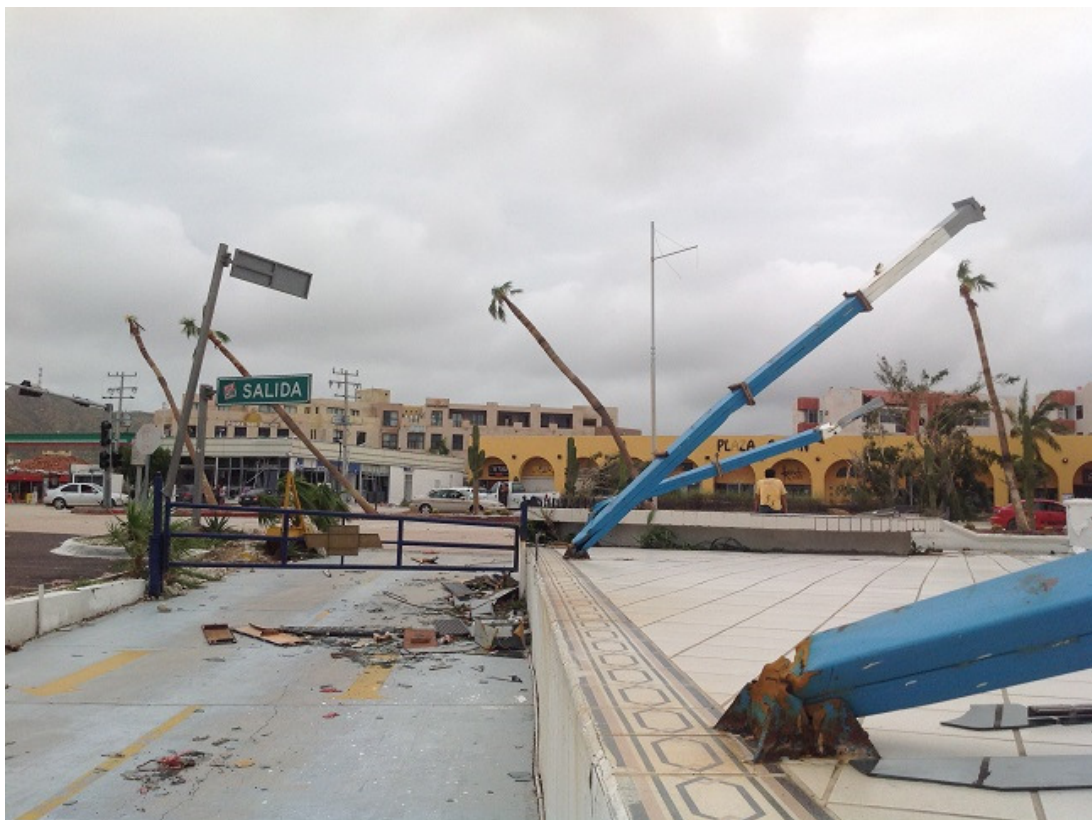
Another view shows the posts and trees bent in different directions as well.

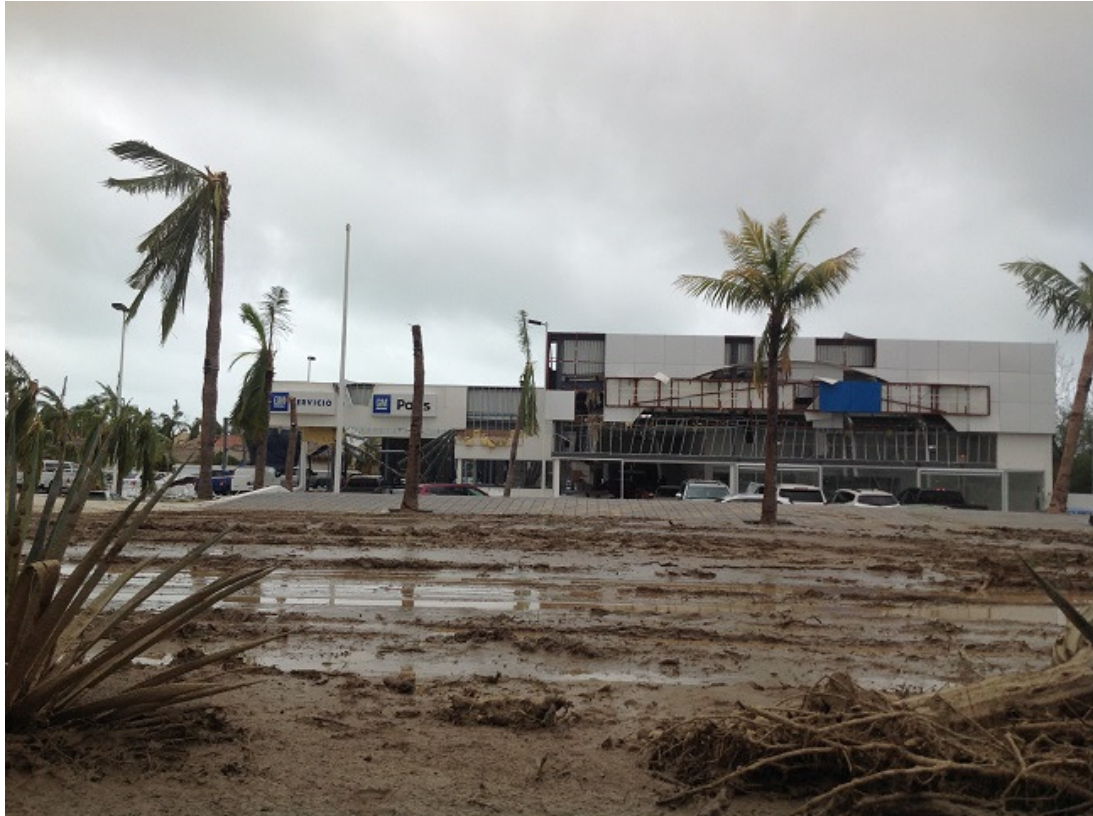
Smashed car dealership with damaged and snapped-off palm trees in foreground.

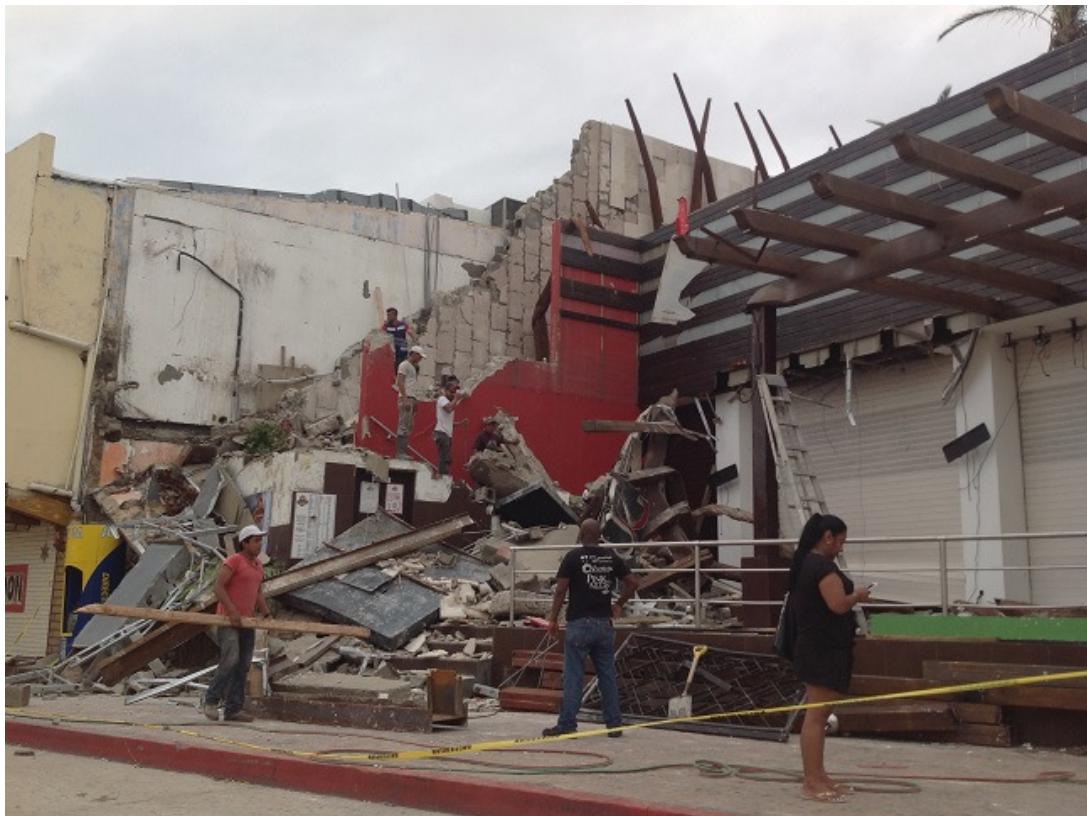
Major building failure in the heart of downtown.

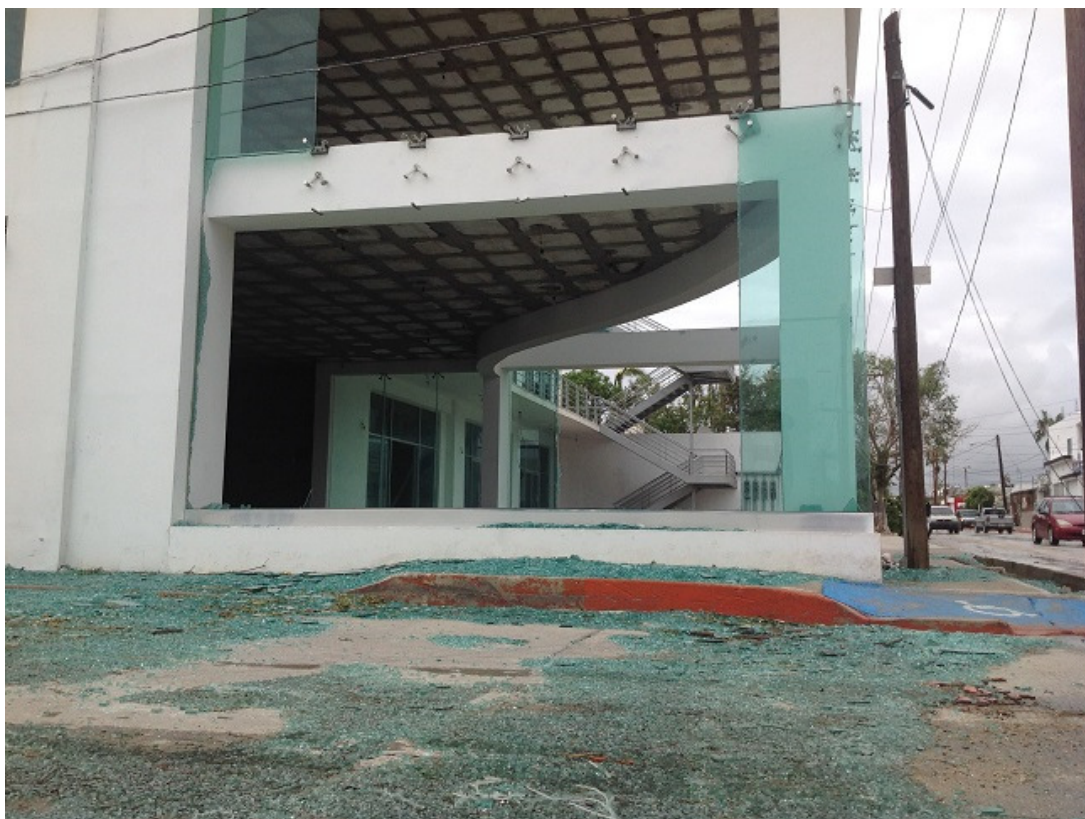
Smashed windows were extremely common. It seemed as if almost every building had lost windows, and many eyewitnesses reported broken windows in their dwellings or hotel rooms. It wasn't uncommon to find businesses (like this one) with all of the glass completely blown out.

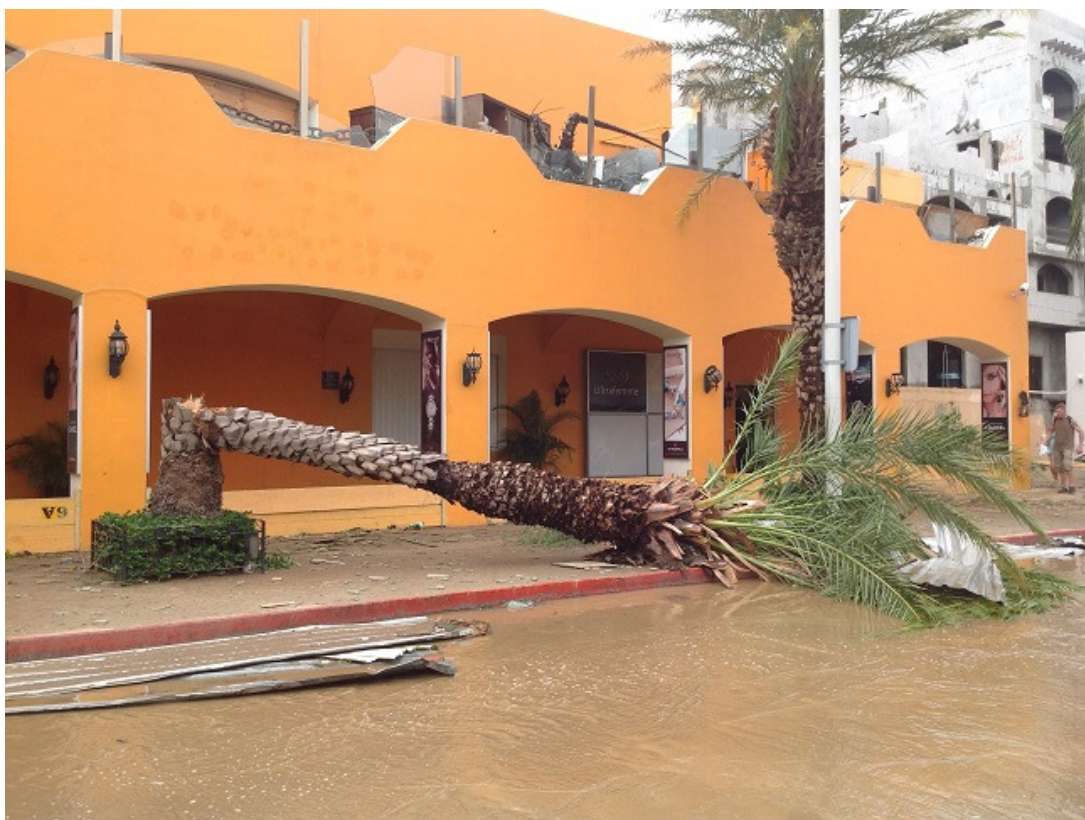
Even in the downtown area, some palm trees were snapped-off mid-trunk or near the base.
