# ICYCLONE CHASE REPORT

storm	Hurricane RICK		
location	Ixtapa, Guerrero, Mexico		
date	24-25 October 2021		
chasers	Josh Morgerman, Nicola Rustichelli	author	Josh Morgerman

**Hurricane RICK** was a Category-2 hurricane that struck the Pacific coast of Mexico, in the state of Guerrero, very early on 25 October 2021.

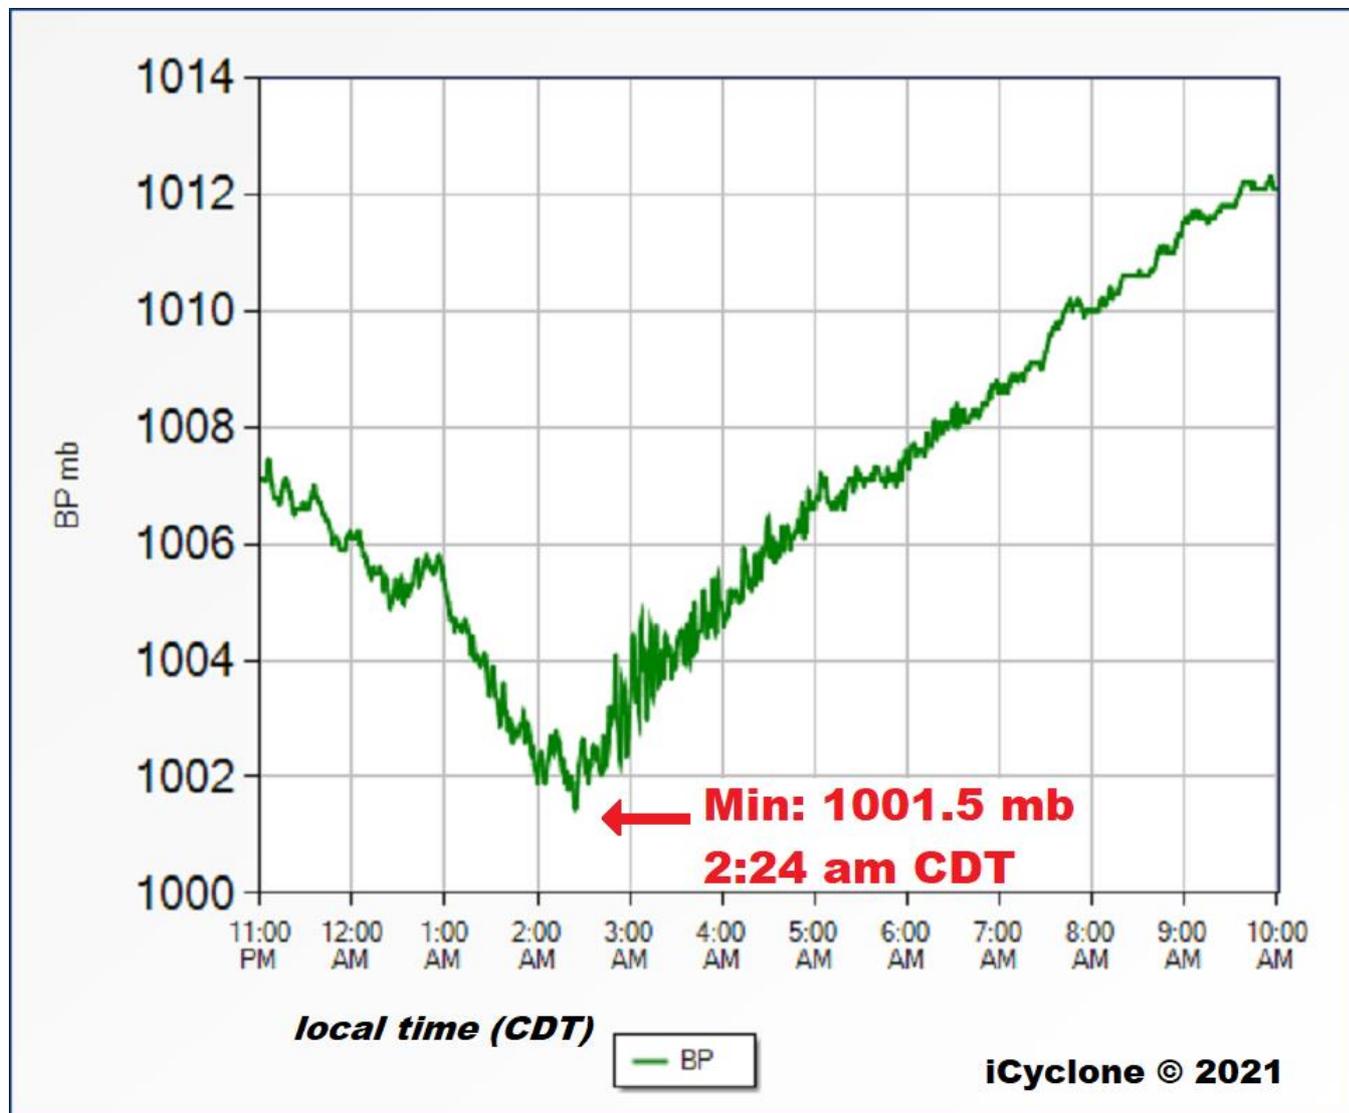
Figure 3: Barogram—Location A—Ixtapa, Guerrero

- **Location A (Ixtapa, Guerrero)**—which went through the right (E) eyewall, never penetrating the eye: **1001.5 mb at 2:24 am CDT (0724Z) 25 October.** (See **Figure 3**, below.)

The minimum value of 1001.5 mb occurred at 2:24 am CDT, as the center of the hurricane passed ~15 n mi W of this location.

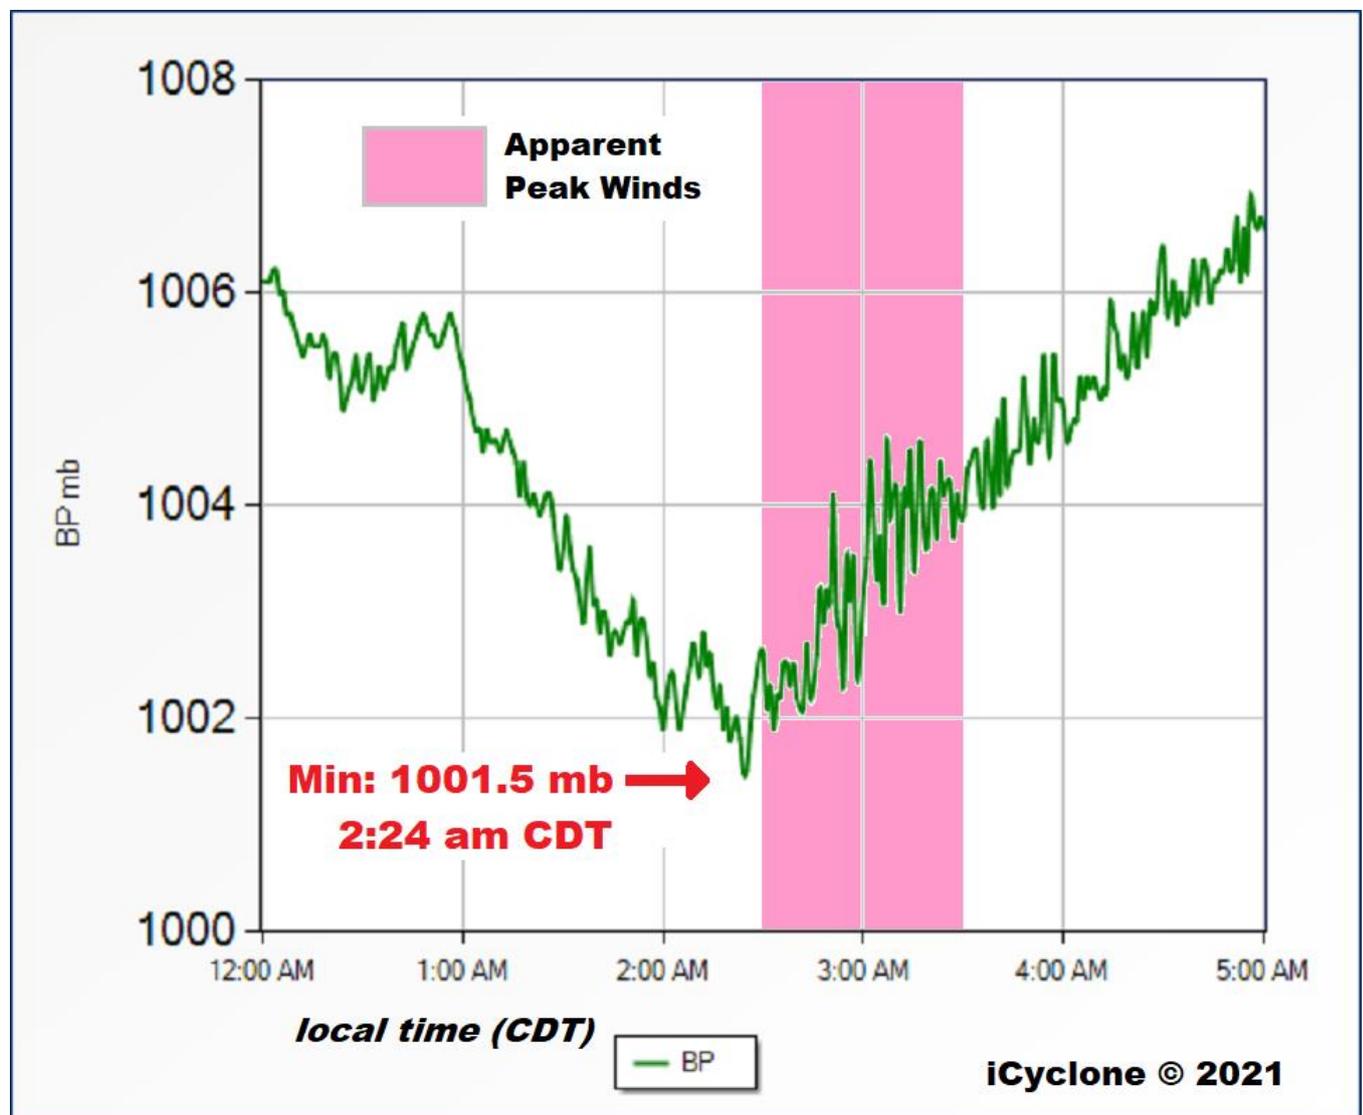
Figure 4: Barogram—Location A—Ixtapa, Guerrero (DETAILED)

- These apparent peak winds coincided with a period of especially volatile air-pressure fluctuations. (Refer to **Figure 4**, below, to see how these apparent peak winds coincided with the most “jagged” phase of the pressure trace.)

A more detailed view of the Ixtapa pressure data. The apparent peak winds—from around 2:30 to 3:30 am CDT—coincided with a period of especially volatile air-pressure fluctuations. At 3:13 am, the glass doors of the room next to the author's blew out of their frames violently.

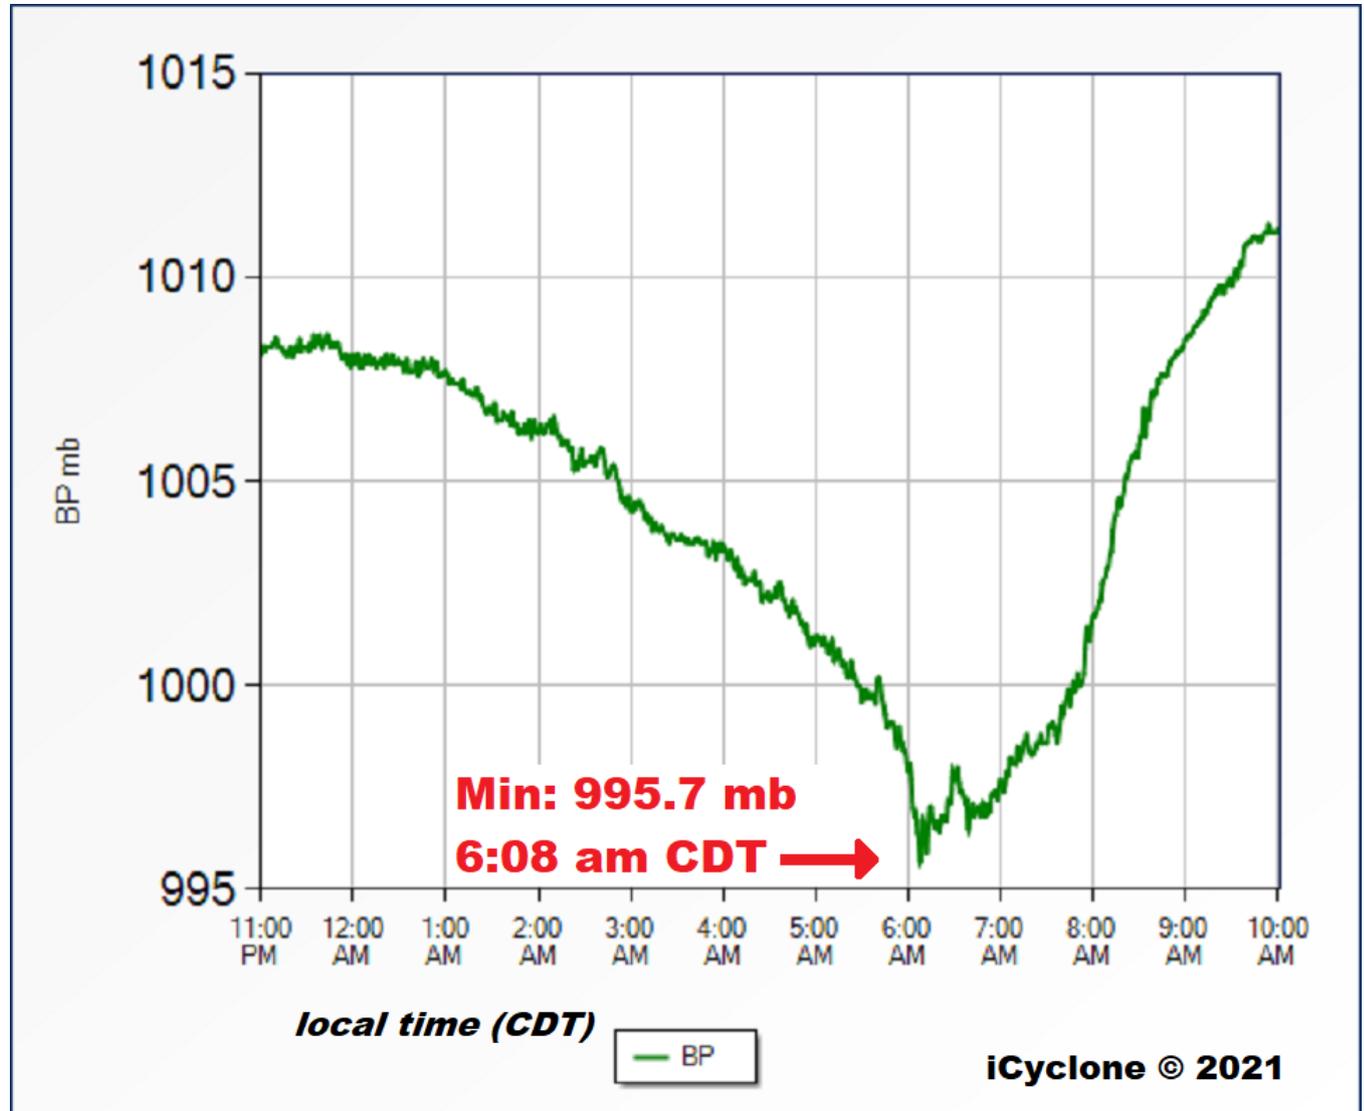
Figure 5: Barogram—Location B—Lazaro Cardenas, Michoacan

- **Location B (Lazaro Cardenas, Michoacan)**—which went through the left (W) eyewall, apparently never penetrating the eye: **995.7 mb at 6:08 am CDT (1108Z) 25 October.** (See **Figure 5**, below.)

- The timing of the minimum pressure seems somewhat late given the NHC's advisory positions (showing landfall E of Lazaro Cardenas at 5 am CDT)—suggesting perhaps the operational best track was a little fast.

This device registered a minimum value of 995.7 mb at 6:08 am CDT, apparently as the center of hurricane passed ~12 n mi E of this location.

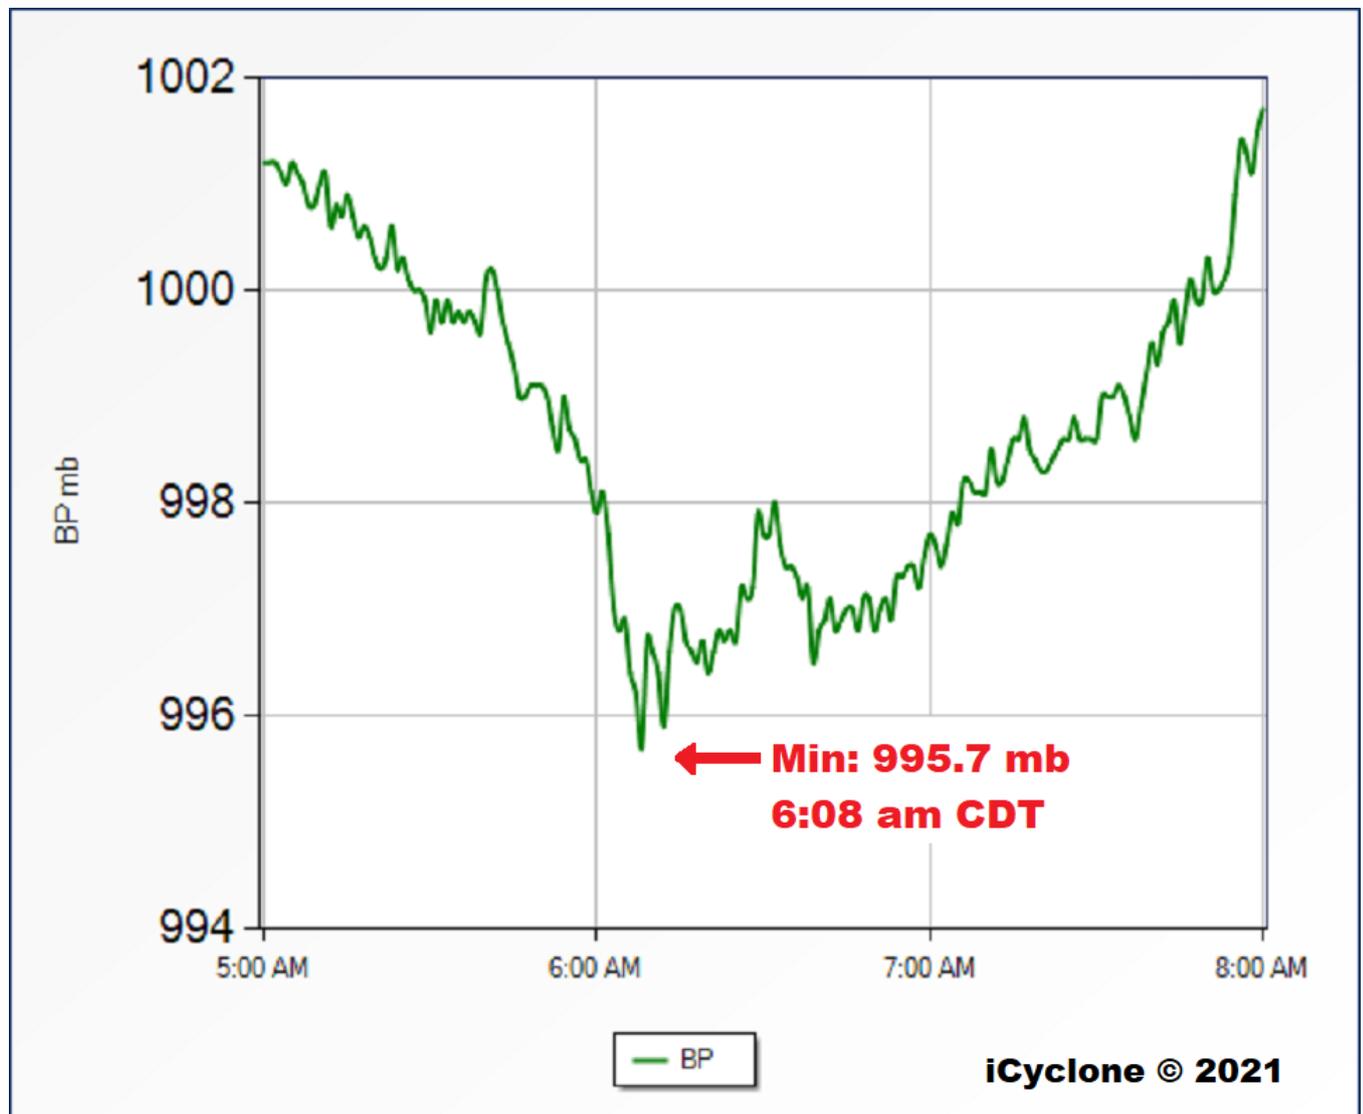
**Figure 6: Barogram—Location B—Lazaro Cardenas, Michoacan (DETAILED)**

*A more detailed view of the Lazaro Cardenas pressure data shows an extremely sharp dip preceding the minimum value, followed by a sharp rise and then another big dip within the hour. This jagged pressure trace, along with heavy damage to the building, suggests the possible occurrence of a mesovortex.*

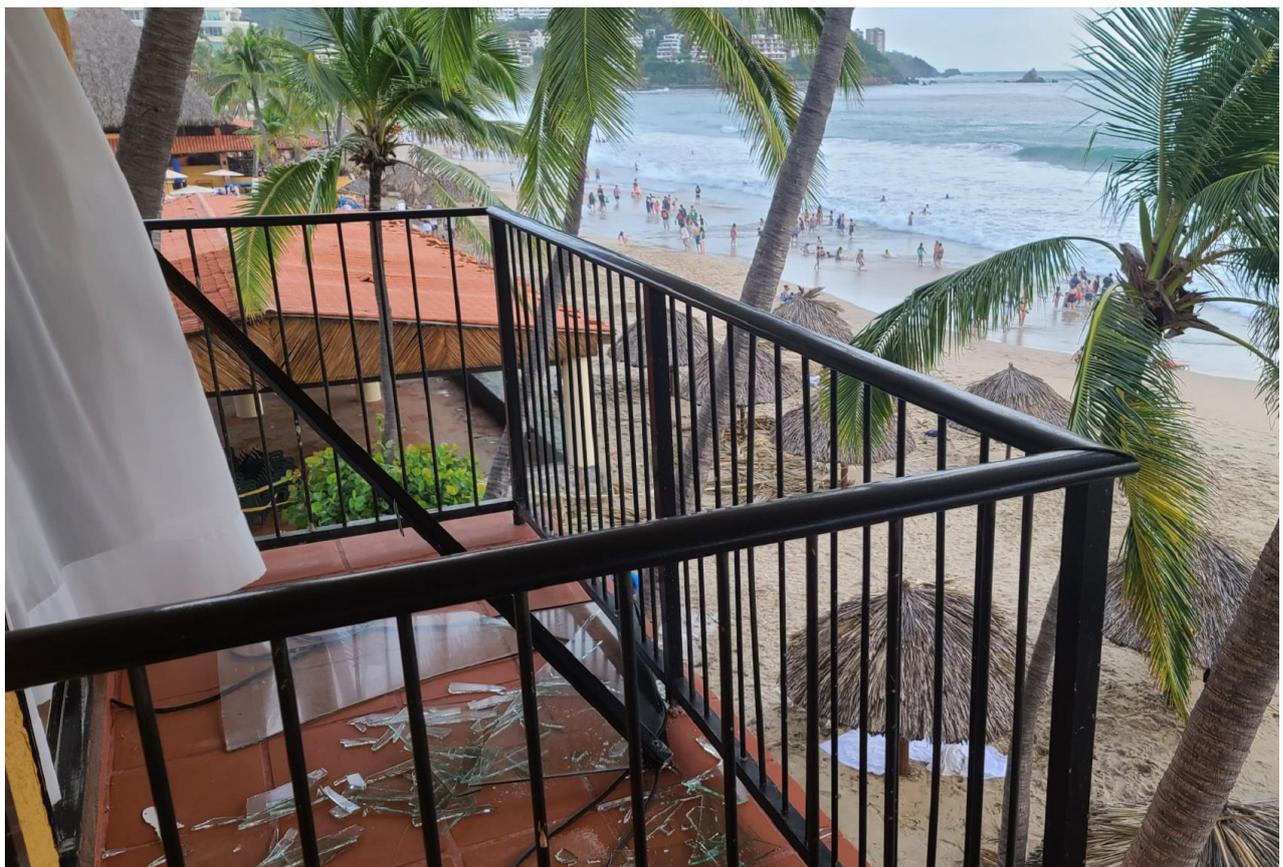
- The stormiest conditions occurred between 2 and 4 am CDT, with the apparent peak winds happening **approximately** 2:30 to 3:30 am. (Please note this is a subjective estimate.) At 3:13 am, the glass doors of the room next to the author's tore out of their frames violently, and the howling of the wind was especially loud at this time.

***Ixtapa: The glass doors of the room next to the author's (Location A) were torn out of their frames and smashed at the height of the storm.***

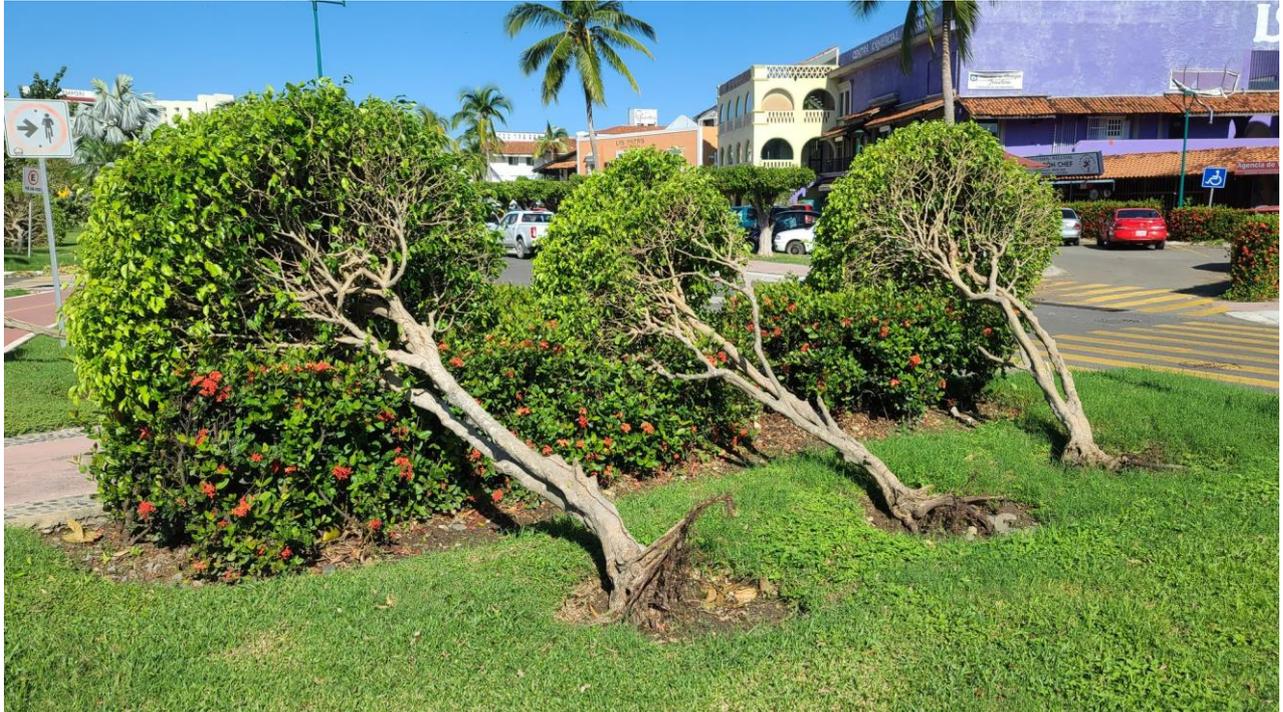
In **Ixtapa, Guerrero**—which was apparently in the right eyewall—many, many trees went down. These included not just shallow-rooted, decorative trees but also older, larger ones. After the storm passed, every street around Ixtapa was blocked. Furthermore, the seaside resort where the author rode out the hurricane (Location A) lost about 20 windows (out of 431 units).

***Ixtapa: Shallow-rooted decorative trees were no match for Hurricane RICK's winds.***

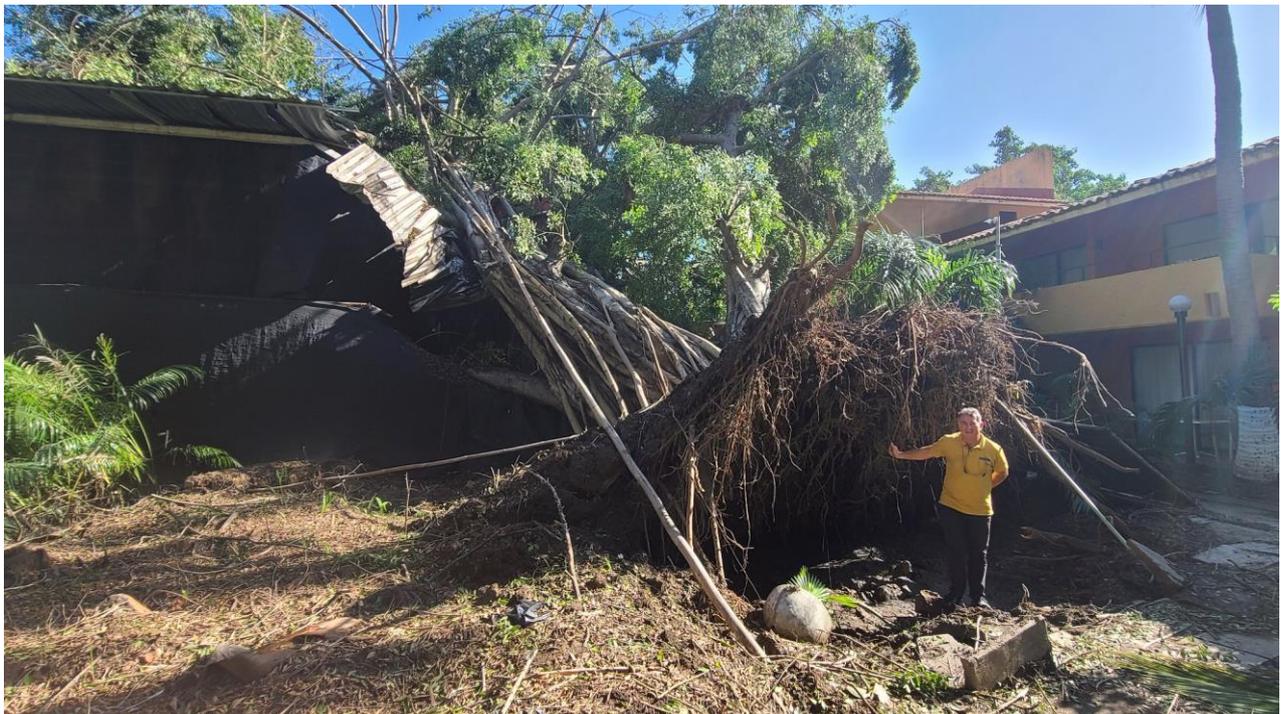
***Ixtapa: This huge tree went down and heavily damaged the building next to it.***

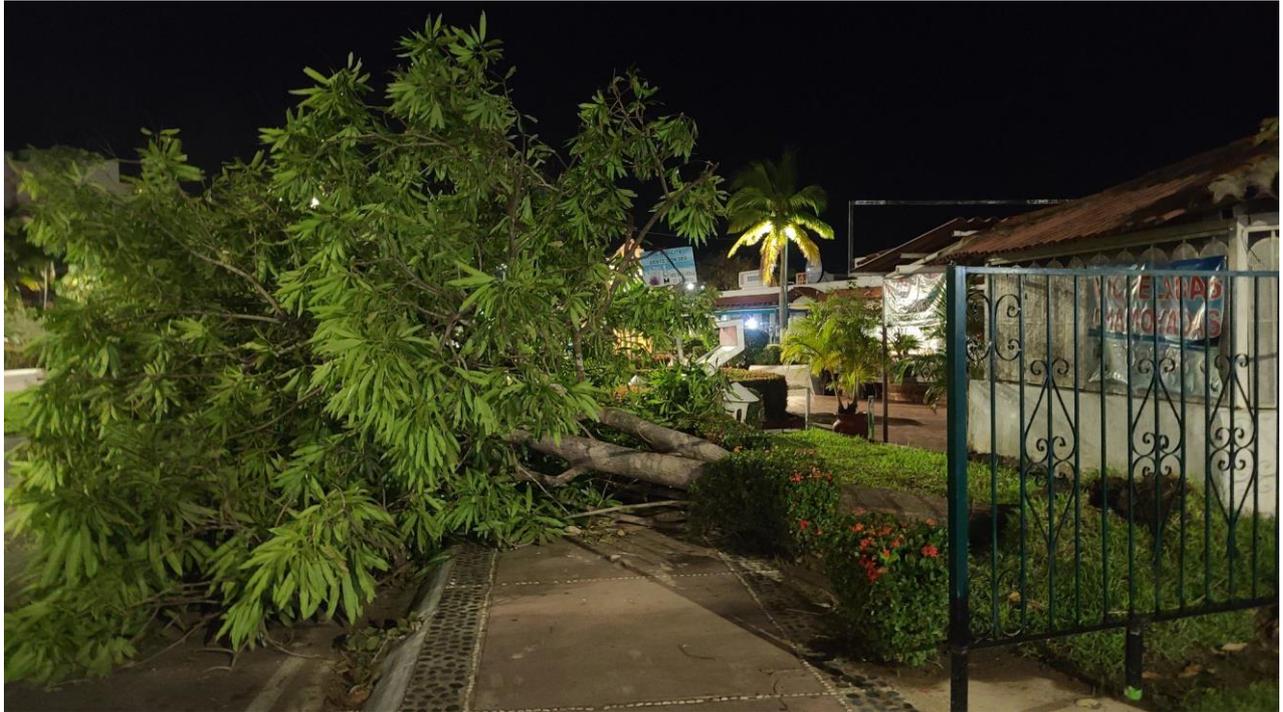
*Ixtapa: Another uprooted tree.*

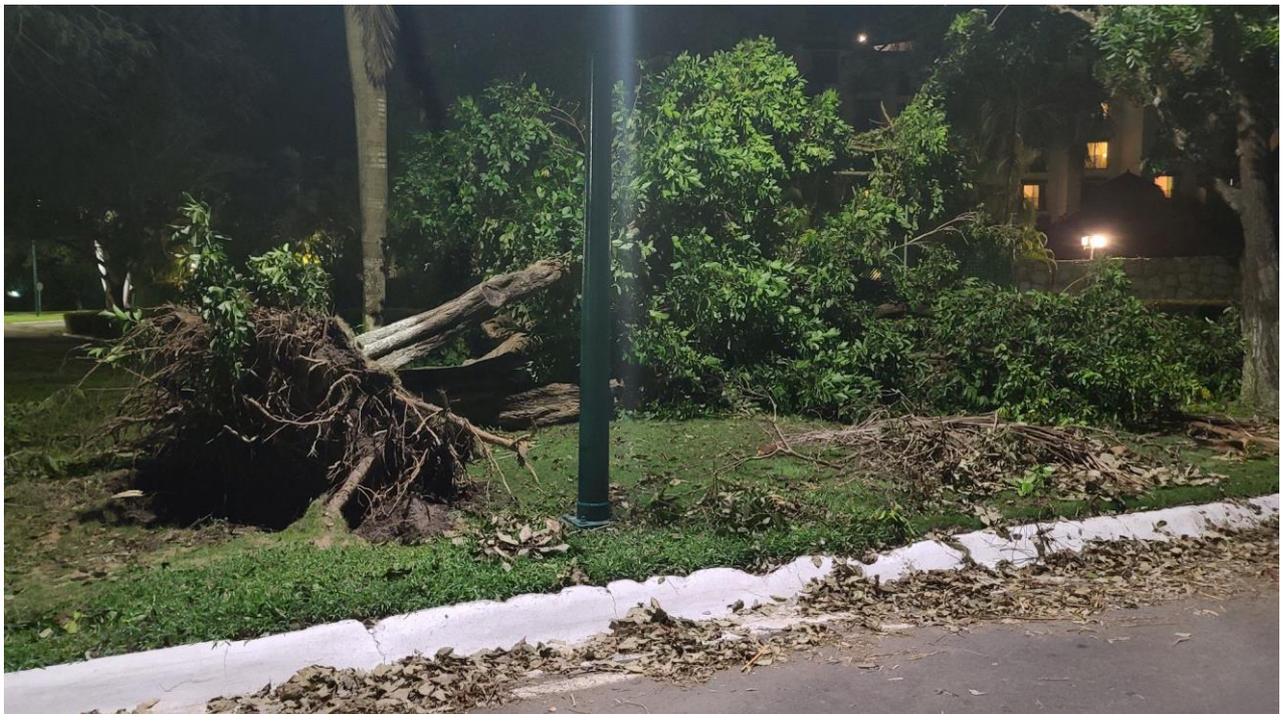
*Ixtapa: Another uprooted tree.*

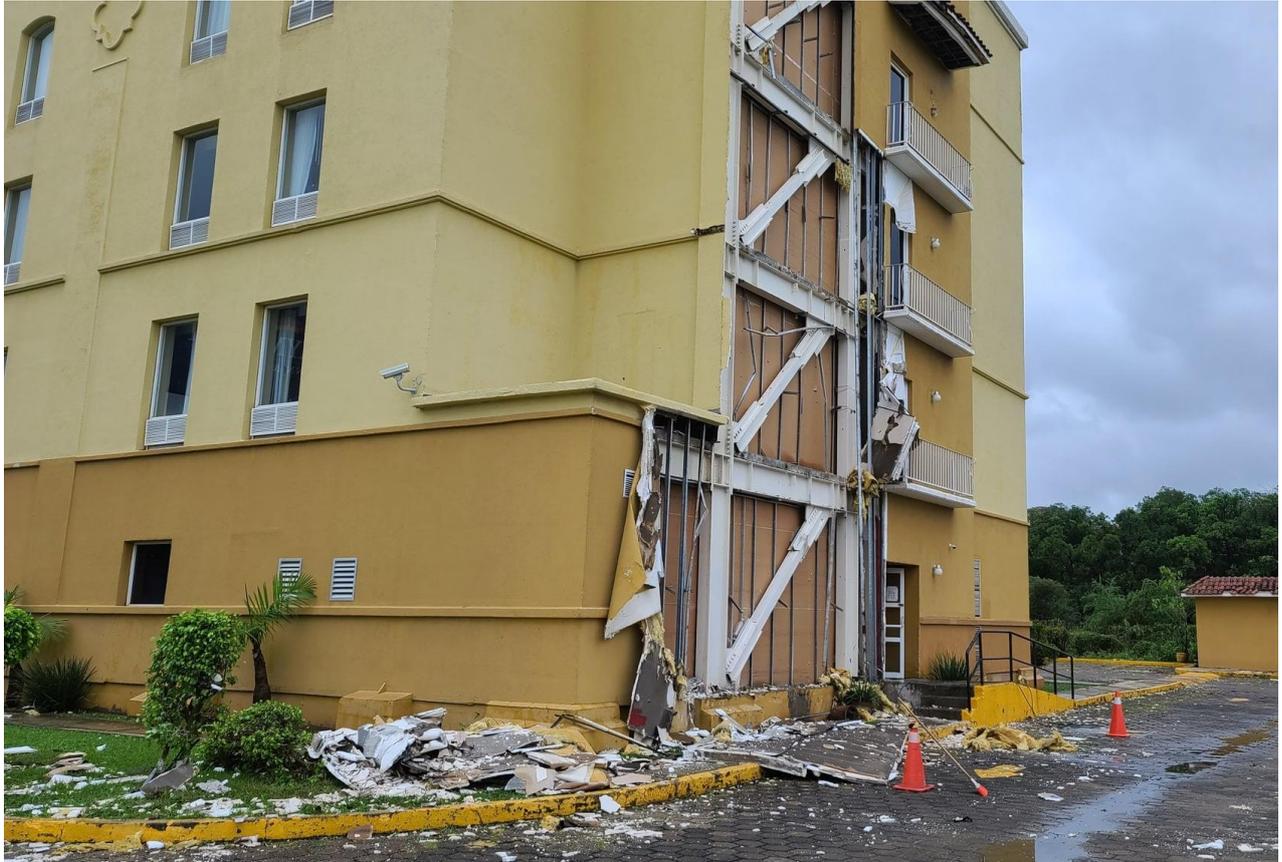
- The pressure trace is quite irregular between around 6 and 7 am CDT, showing a sudden, sharp plunge preceding the minimum value, followed by a sudden rise and then another sharp plunge within the hour. This jagged pressure trace, along with freakishly heavy damage to the building (much worse than the damage to nearby buildings), hints at the occurrence of a mesovortex or other localized disturbance. (See **Figure 6**, below, for a more detailed view of these pressure irregularities, and see **p. 12** for a photo of the building damage.)

Across the state line in Michoacan, **Lazaro Cardenas**—which was in the left eyewall—took a beating. Like Ixtapa, the city lost many trees, and power was out across the area. While most buildings seemed to withstand the hurricane winds satisfactorily, the hotel where the author planted his sensor (Location B) had serious exterior damage—possibly caused by highly localized winds.

***Lazaro Cardenas: An exterior wall of this hotel (Location B) was heavily damaged by Hurricane RICK's winds. Most buildings in the city performed much better. This damage, along with a highly irregular air-pressure trace from this site, suggests the possible occurrence of a mesovortex or other localized disturbance.***
