# ICYCLONE CHASE REPORT

storm	Hurricane ROSLYN		
location	Santa Cruz, Nayarit, Mexico		
date	23 October 2022		
chasers	Josh Morgerman, Erik Sereno	author	Josh Morgerman

Hurricane ROSLYN was a small, violent Category-3 hurricane that struck the Pacific coast of Mexico, in the state of Nayarit, just before dawn on 23 October 2022.

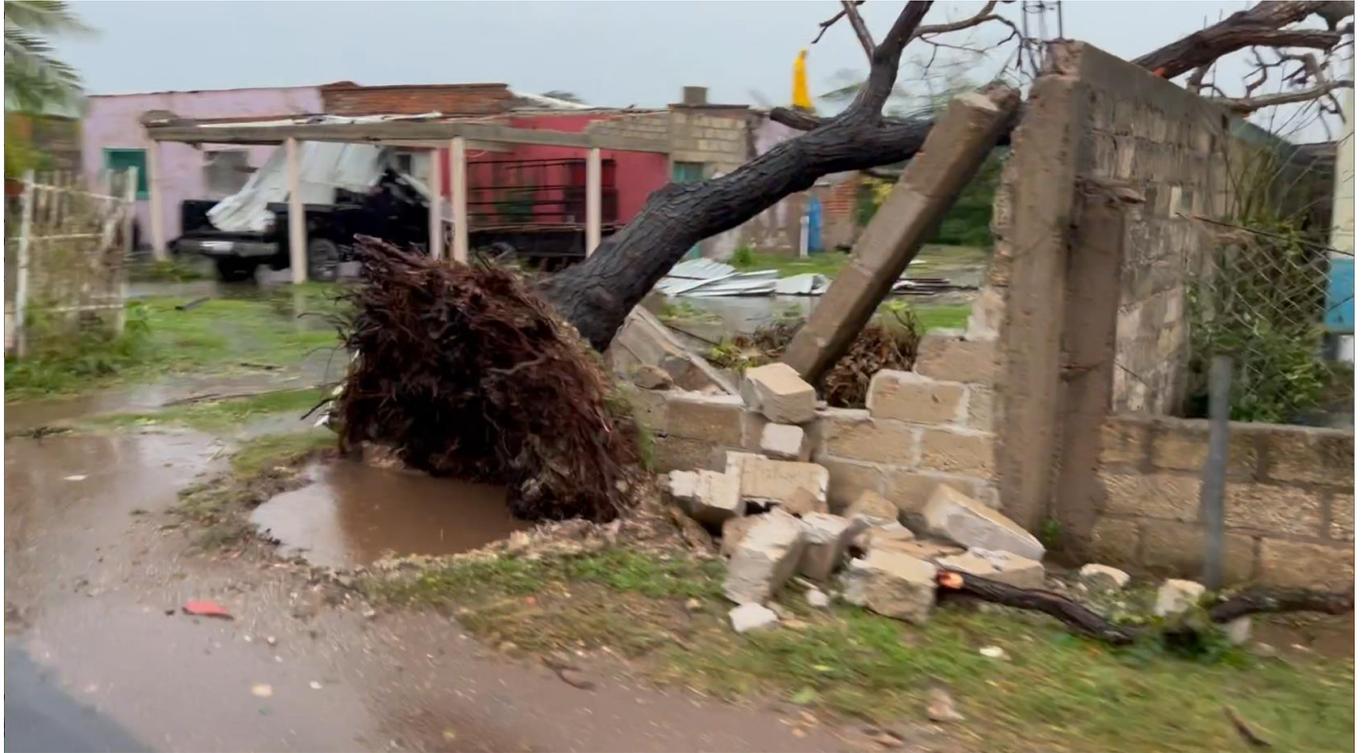
***Santa Cruz. ROSLYN's winds felled many trees across town, and some inflicted secondary damage to homes, walls, and fences as they went down.***

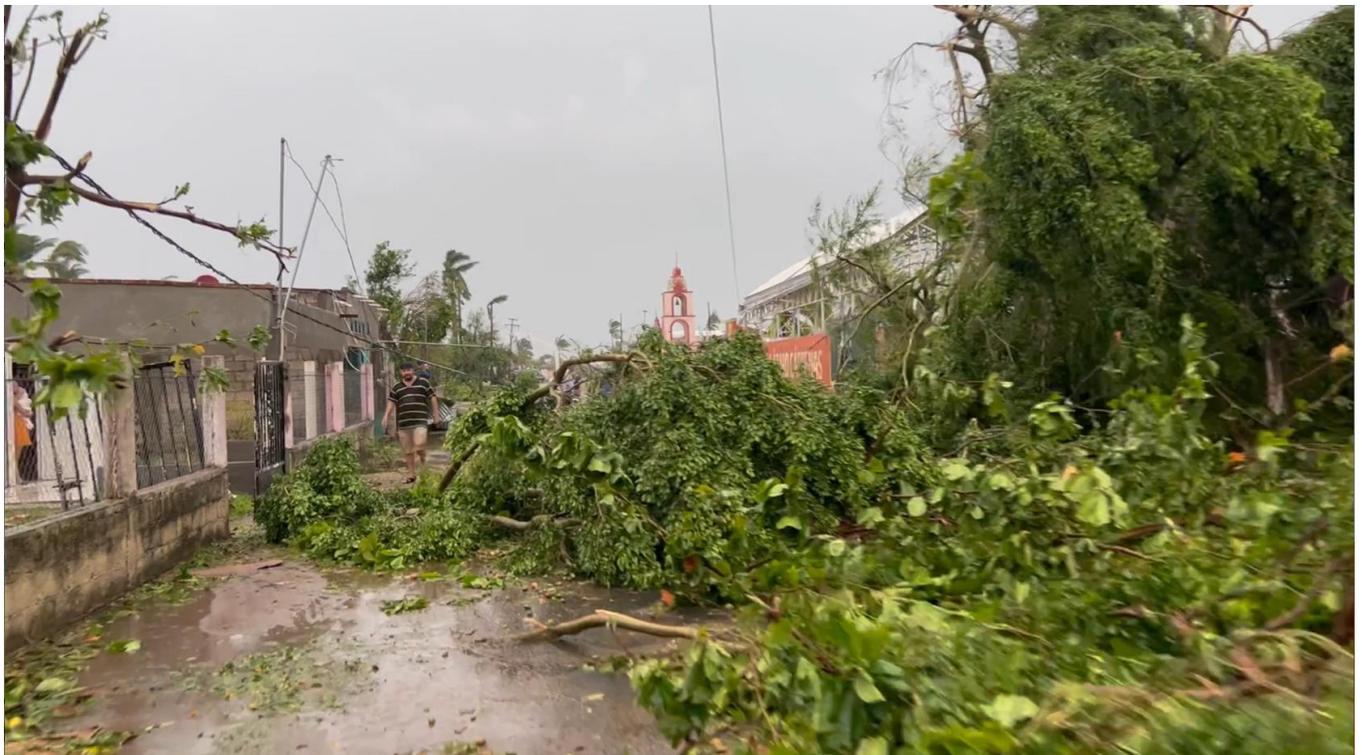
***Santa Cruz. In the hours immediately following ROSLYN, most streets around town were blocked by fallen trees and power poles.***

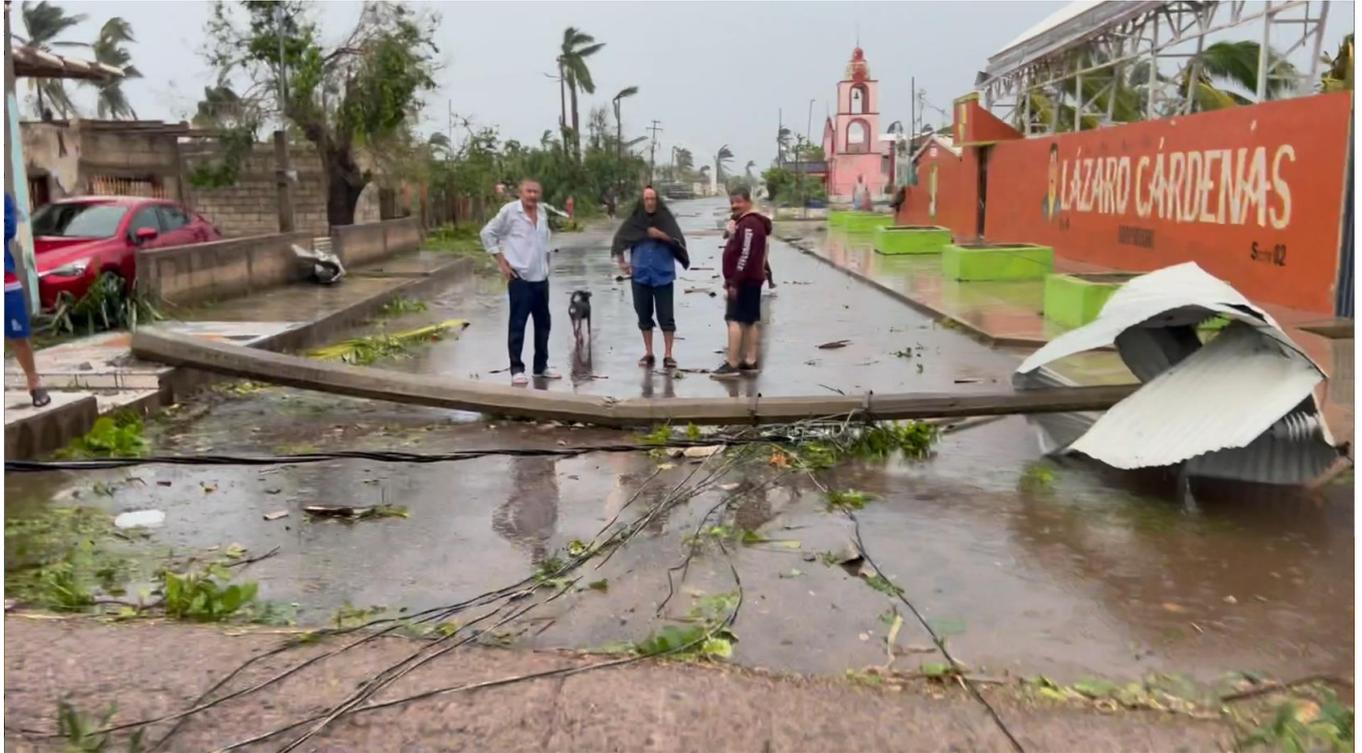
**Santa Cruz. ROSLYN's winds smashed many concrete power poles.**

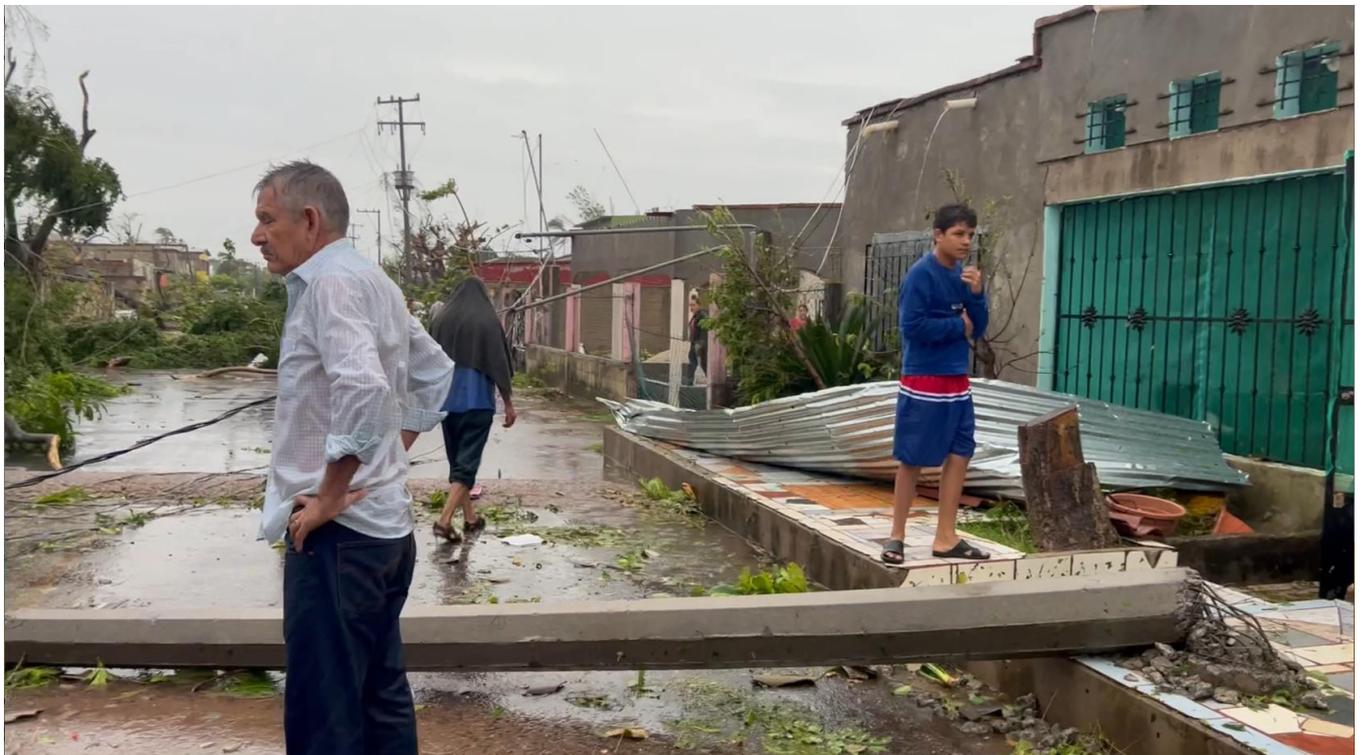
**Santa Cruz. Many of the concrete power poles that went down snapped off at the base.**

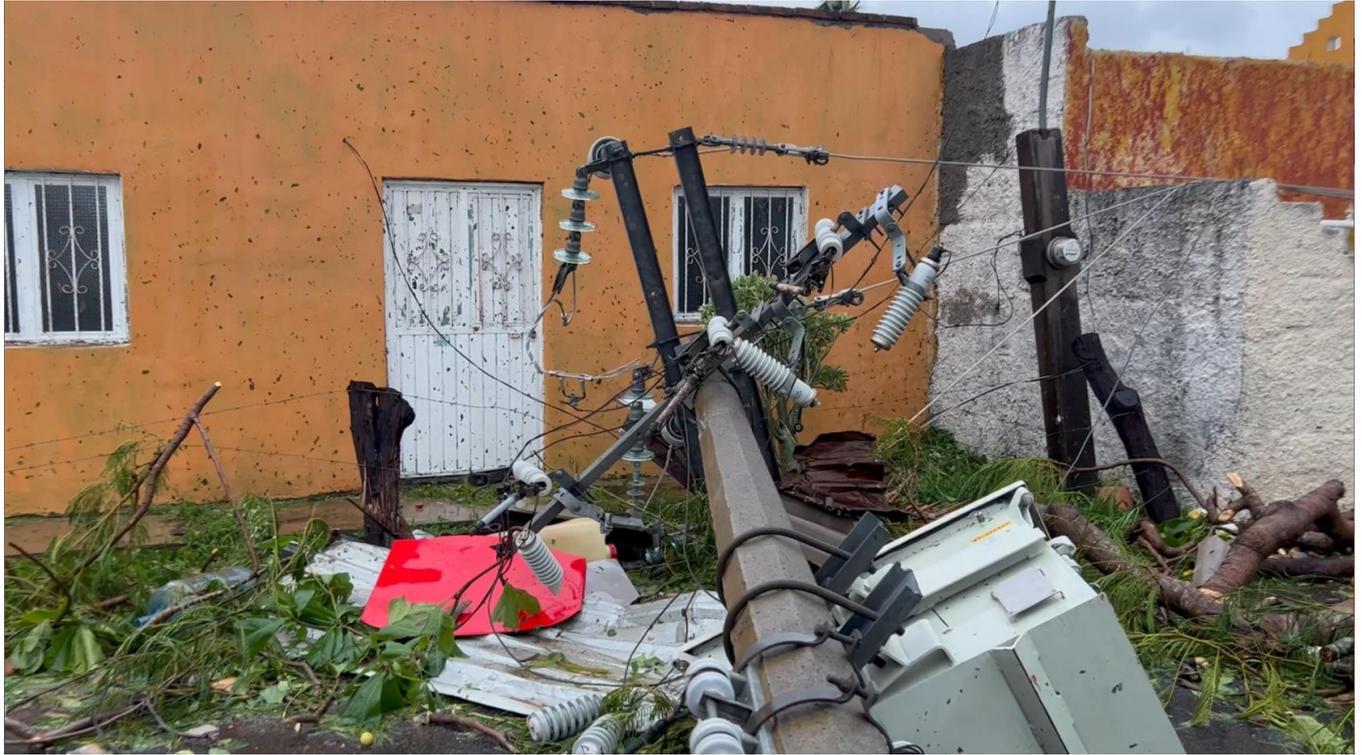
**Santa Cruz. ROSLYN's winds toppled this power pole, which very narrowly missed a house.**

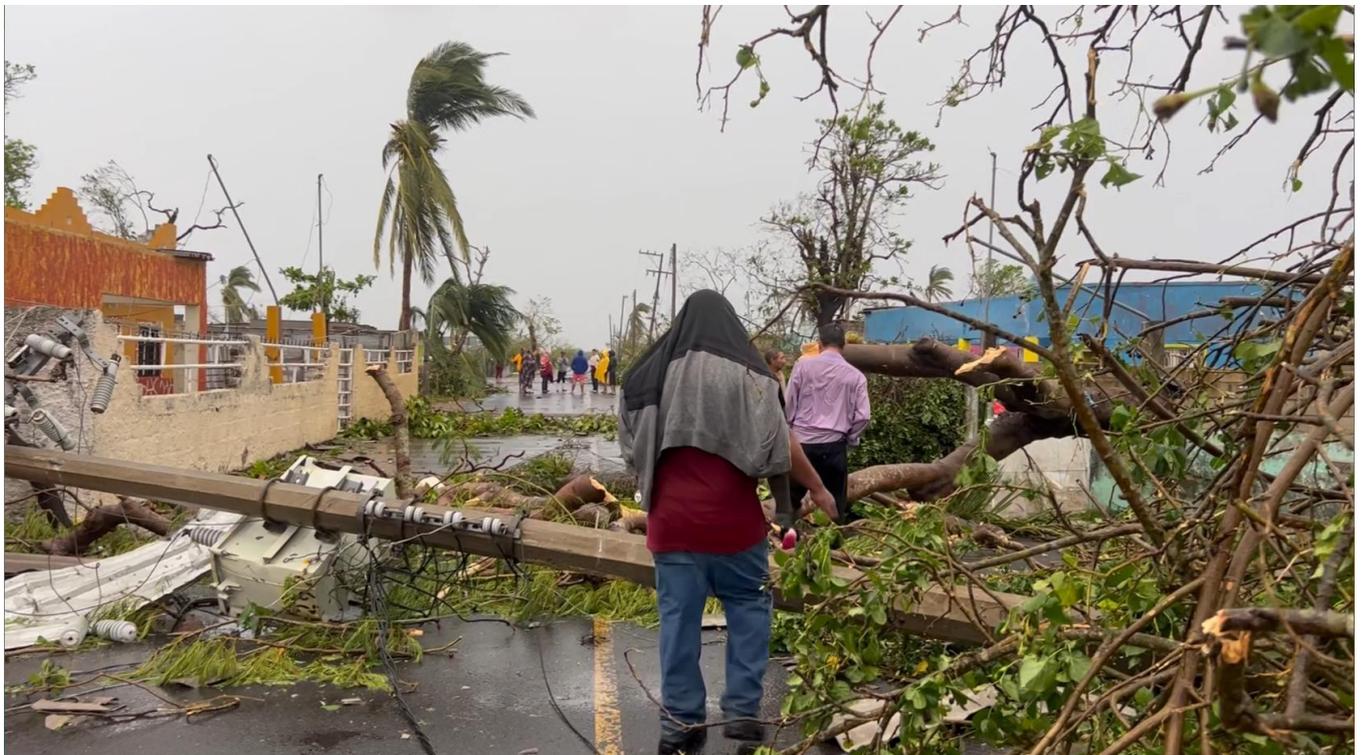
**Santa Cruz. Streets all around town were blocked by fallen trees, power poles, and other debris.**

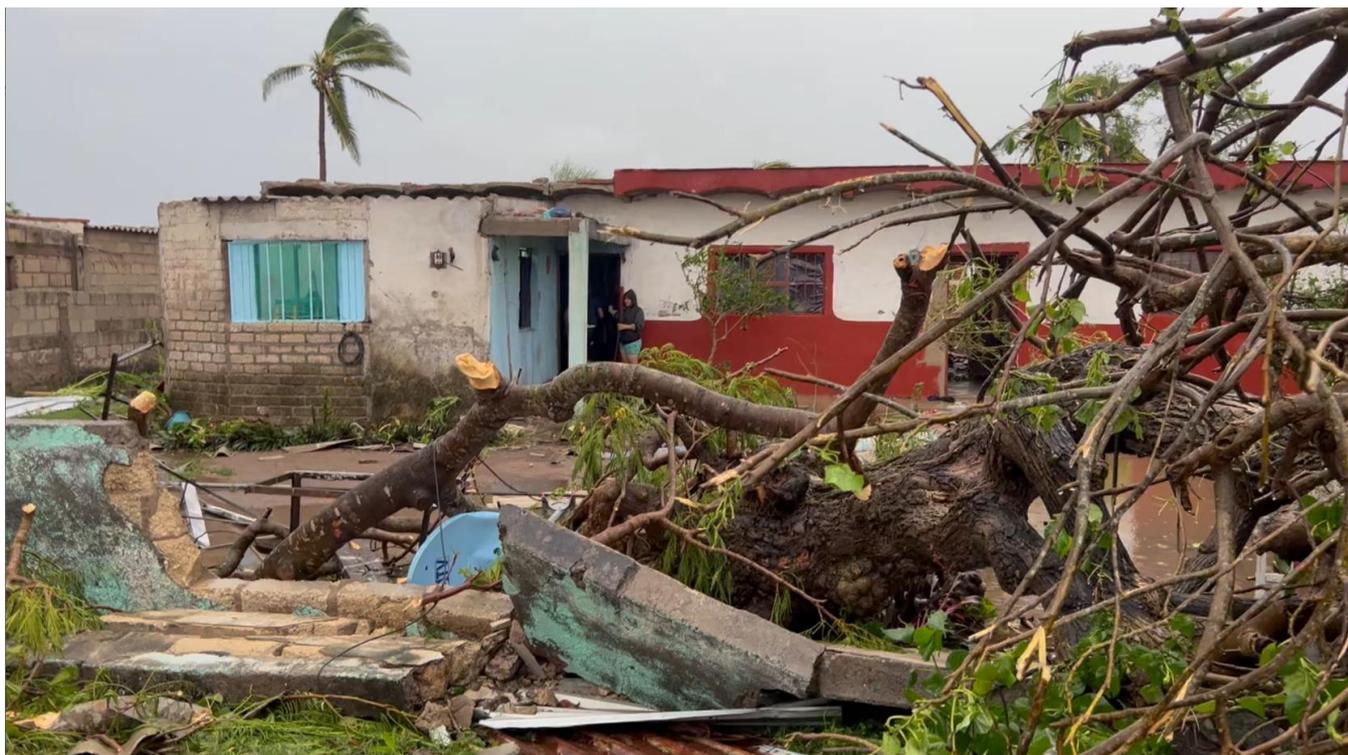
***Santa Cruz. ROSLYN left large, tangled piles of fallen trees and wreckage.***

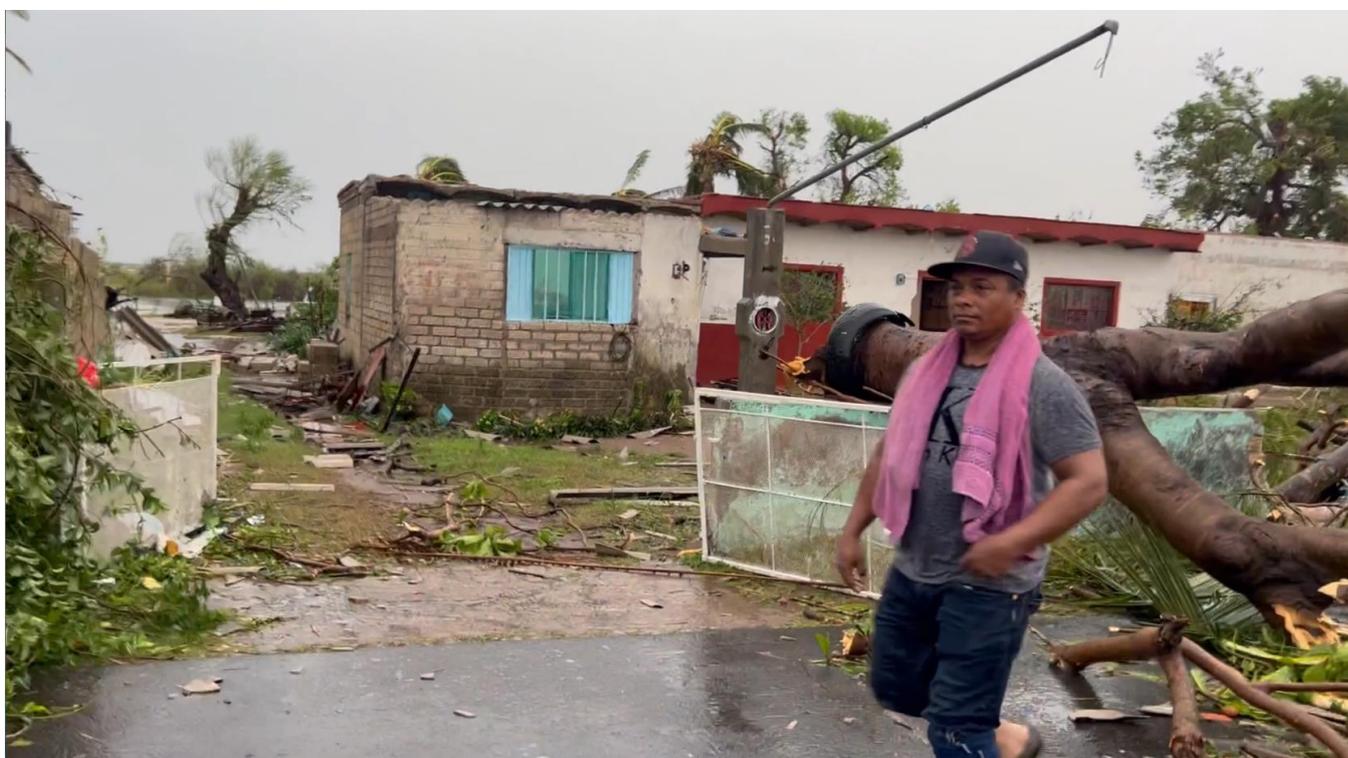
***Santa Cruz. A resident walks past a large tree that was felled by ROSLYN's winds.***

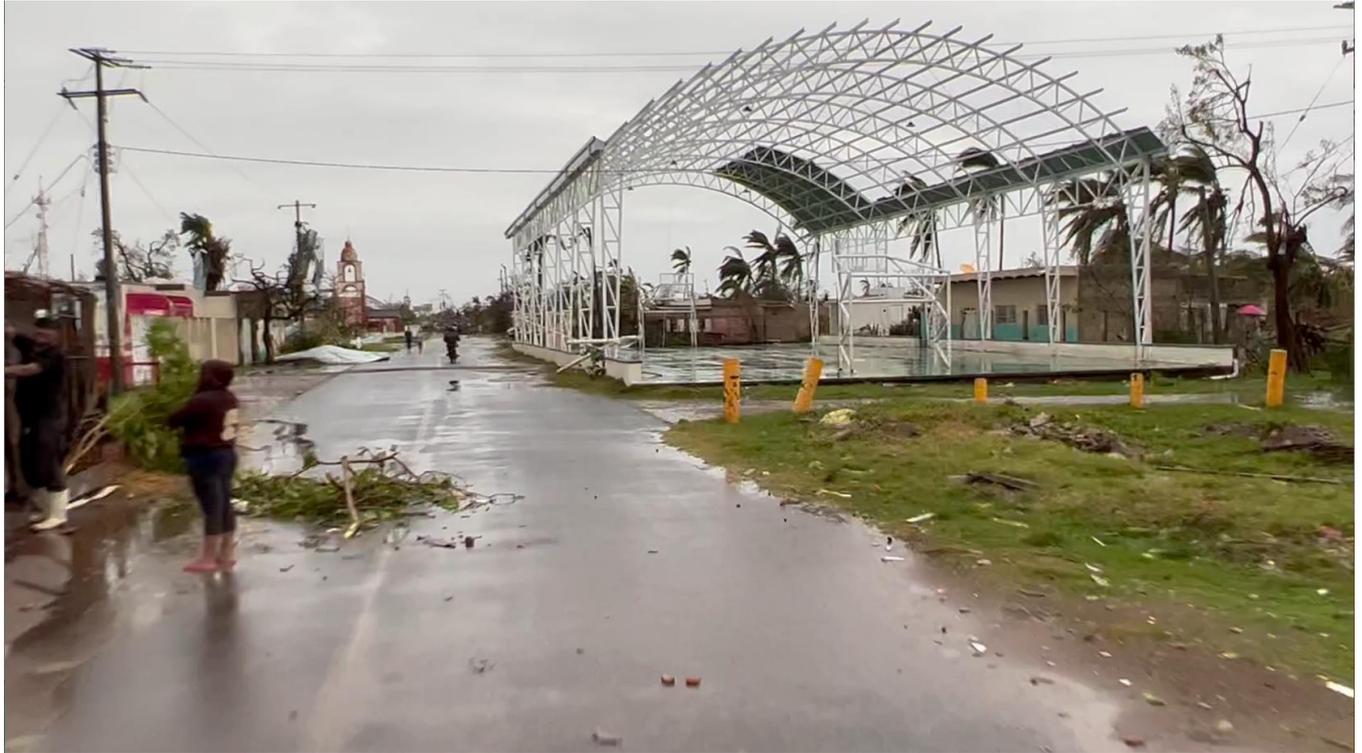
**Santa Cruz. This large, open-air athletic facility lost almost all of its metal roofing. The wind scattered the pieces across the neighborhood.**

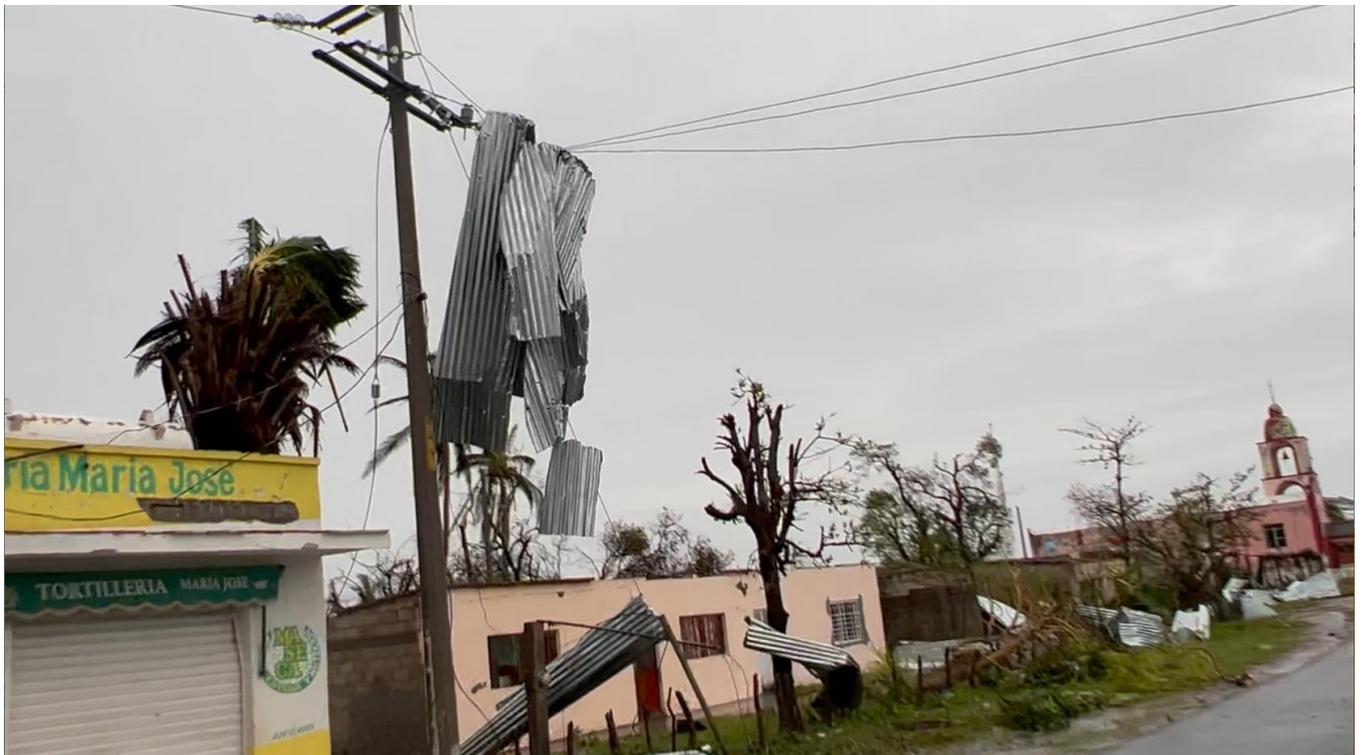
**Santa Cruz. Metal roofing from the nearby athletic facility was scattered across the neighborhood, with much of it tangled in powerlines and trees.**

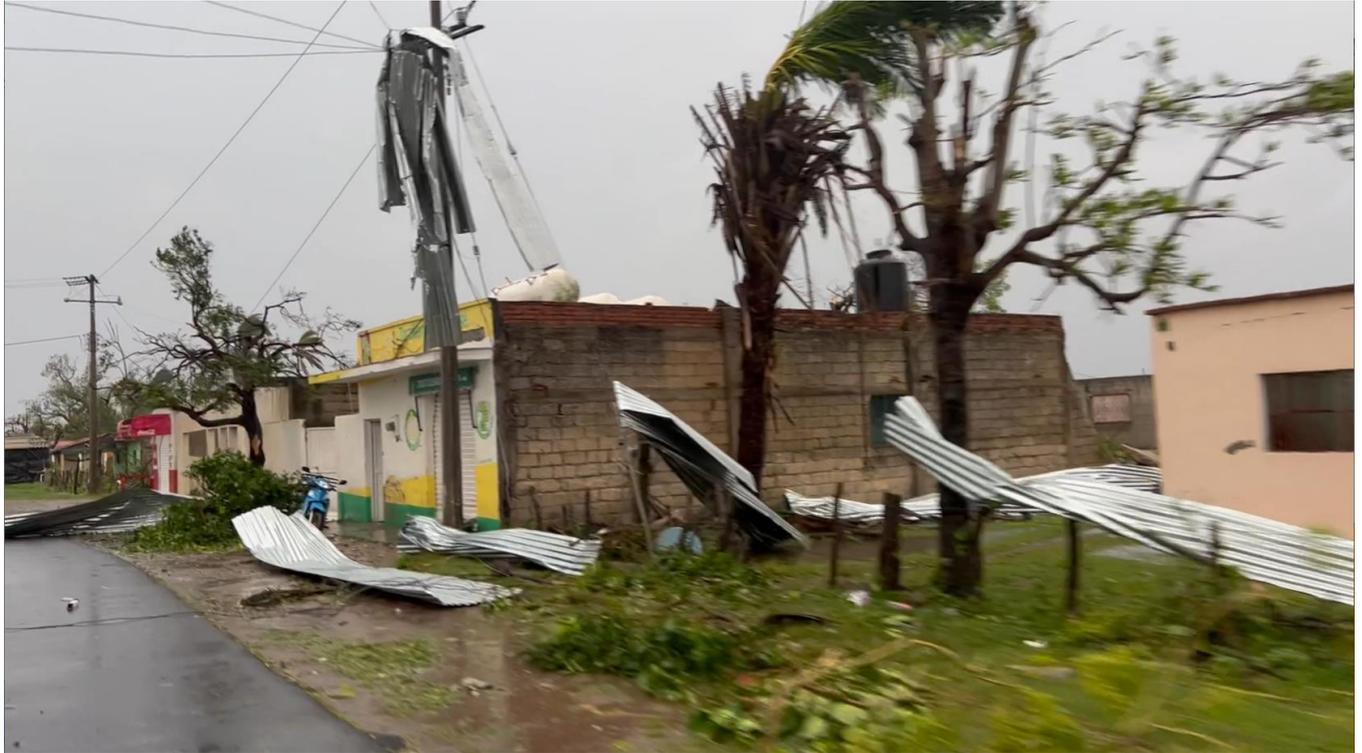
***Santa Cruz. Another look at the metal roofing from the nearby athletic facility. The pieces were scattered across the neighborhood, much of it tangled in powerlines and trees.***

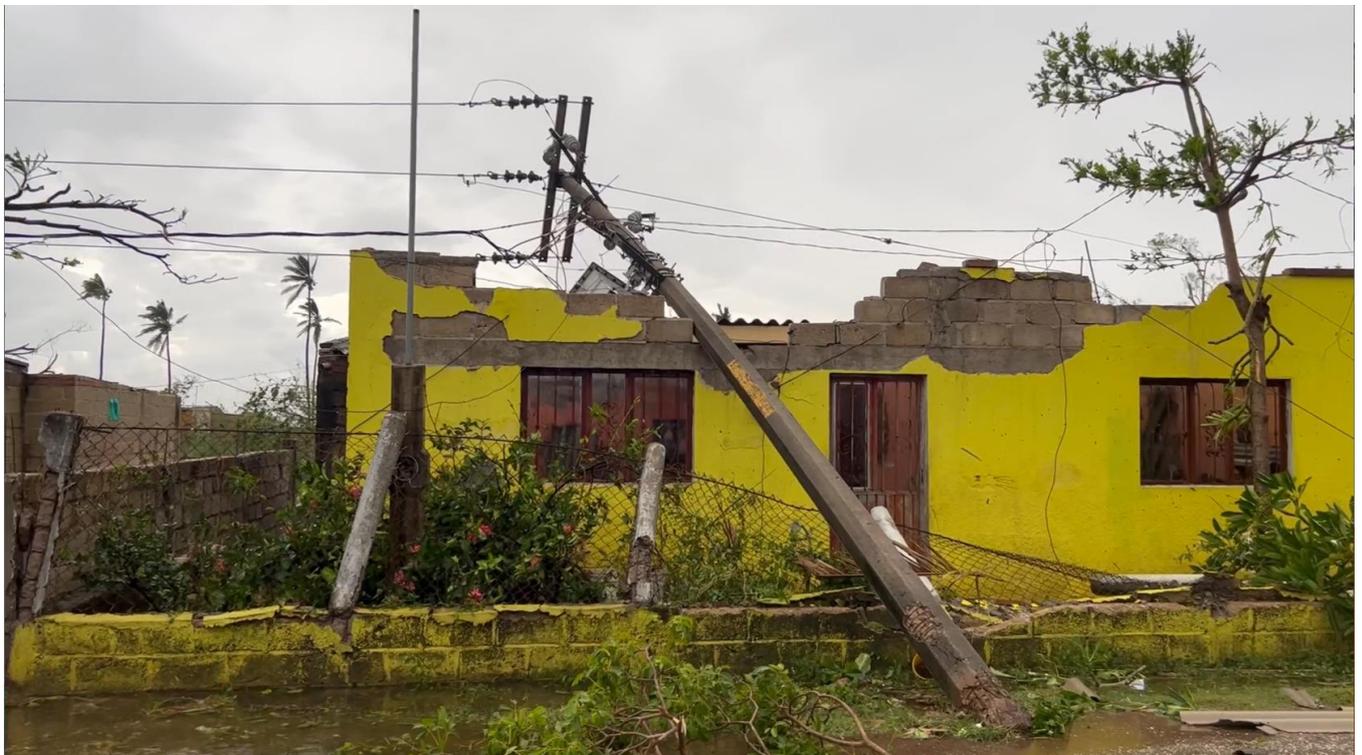
***Santa Cruz. Hurricane ROSLYN's wind felled scores of concrete power poles—and many of them inflicted serious secondary damage as they struck houses, walls, and fences.***

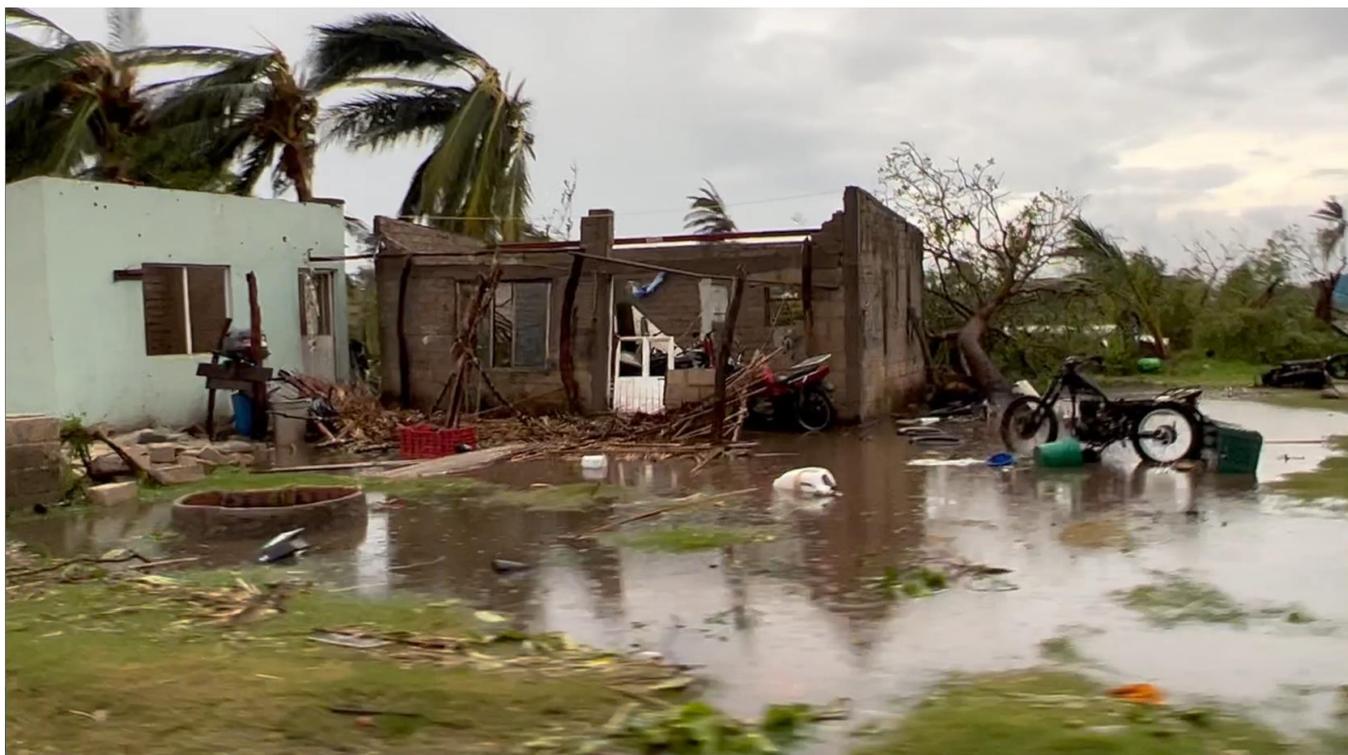
***Santa Cruz. ROSLYN's winds tore away this house's roof and also inflicted heavy damage to the walls.***

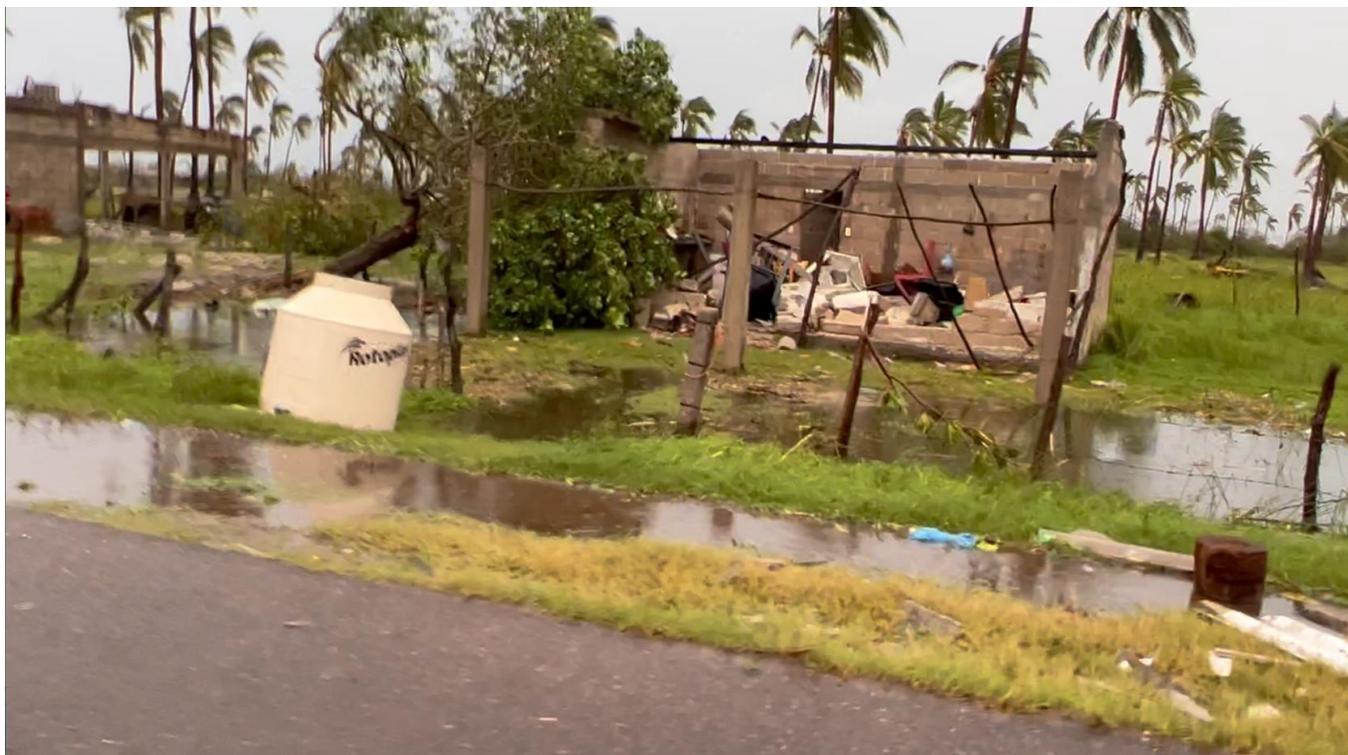
***Santa Cruz. Heavy wind damage to a house.***

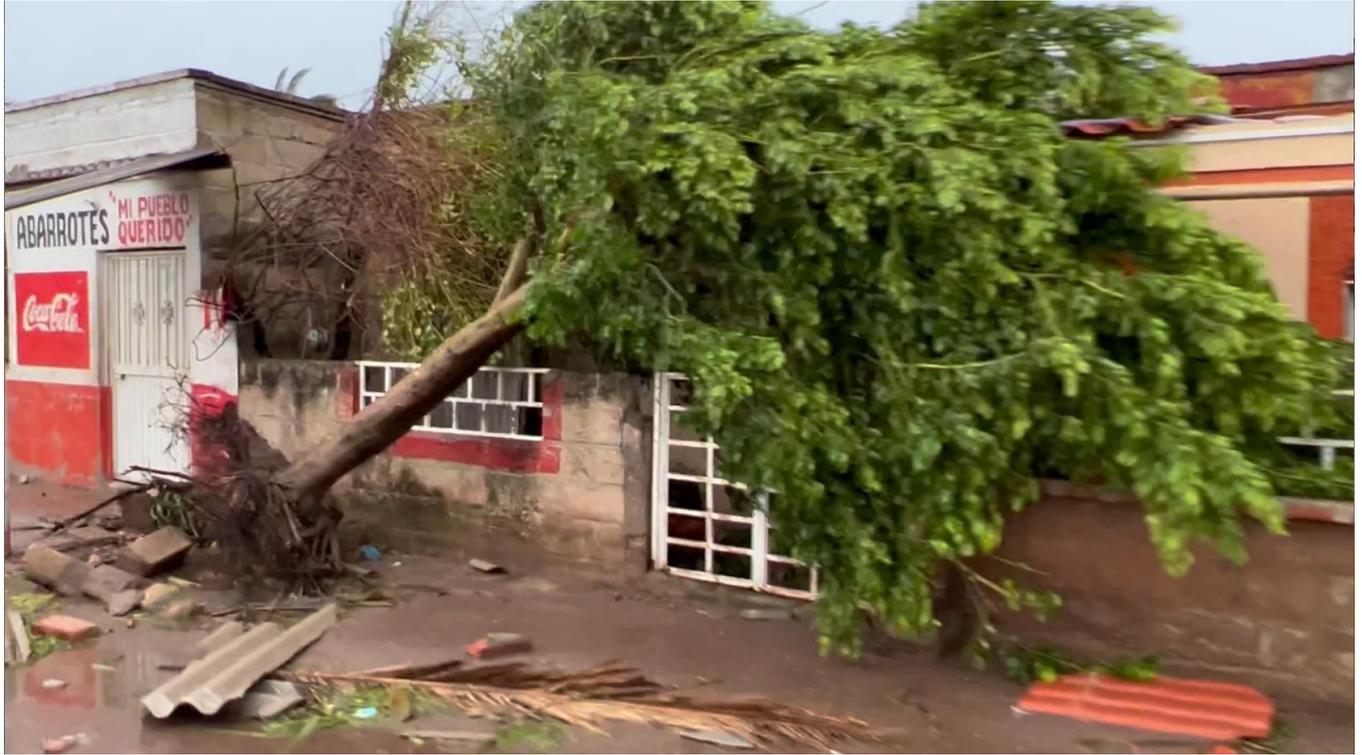
**Santa Cruz. ROSLYN's fierce winds uprooted many trees all across town.**

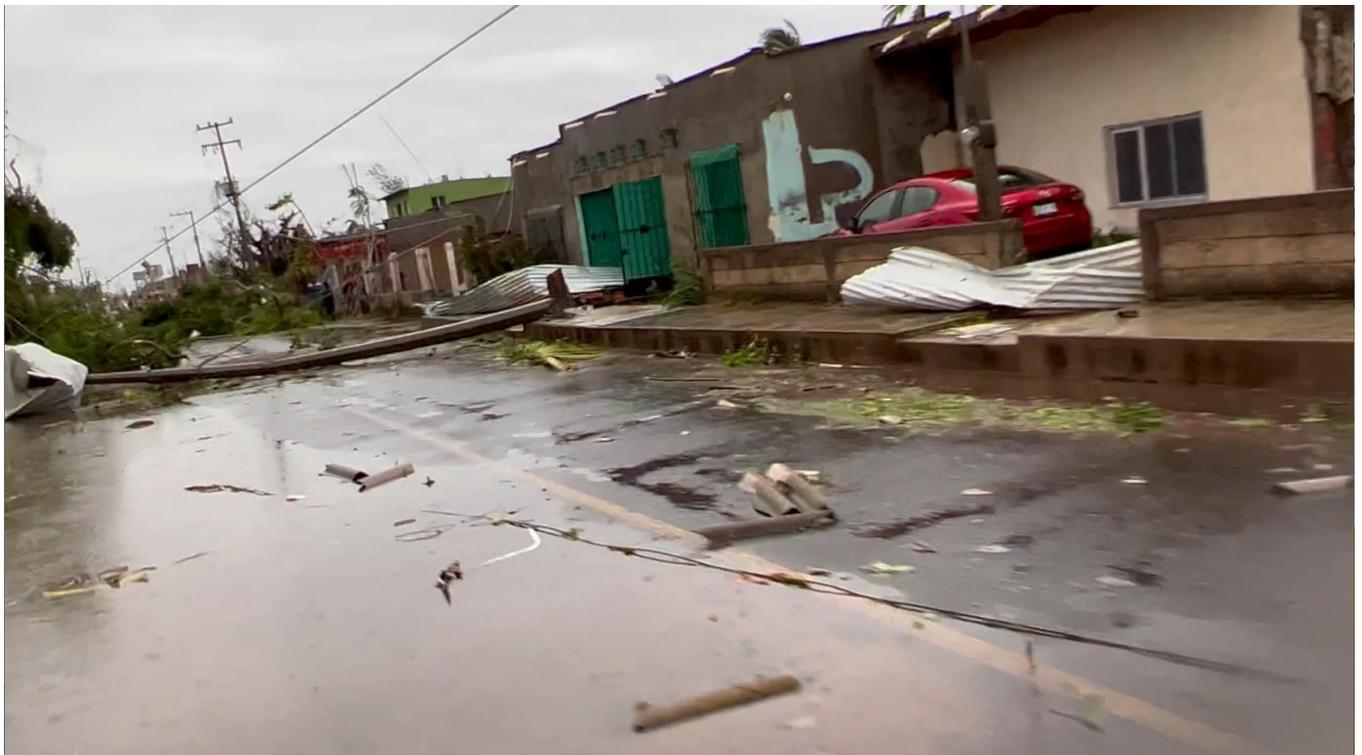
**Santa Cruz. A typical street scene just hours after Hurricane ROSLYN: downed trees, a felled power pole, and scattered debris.**

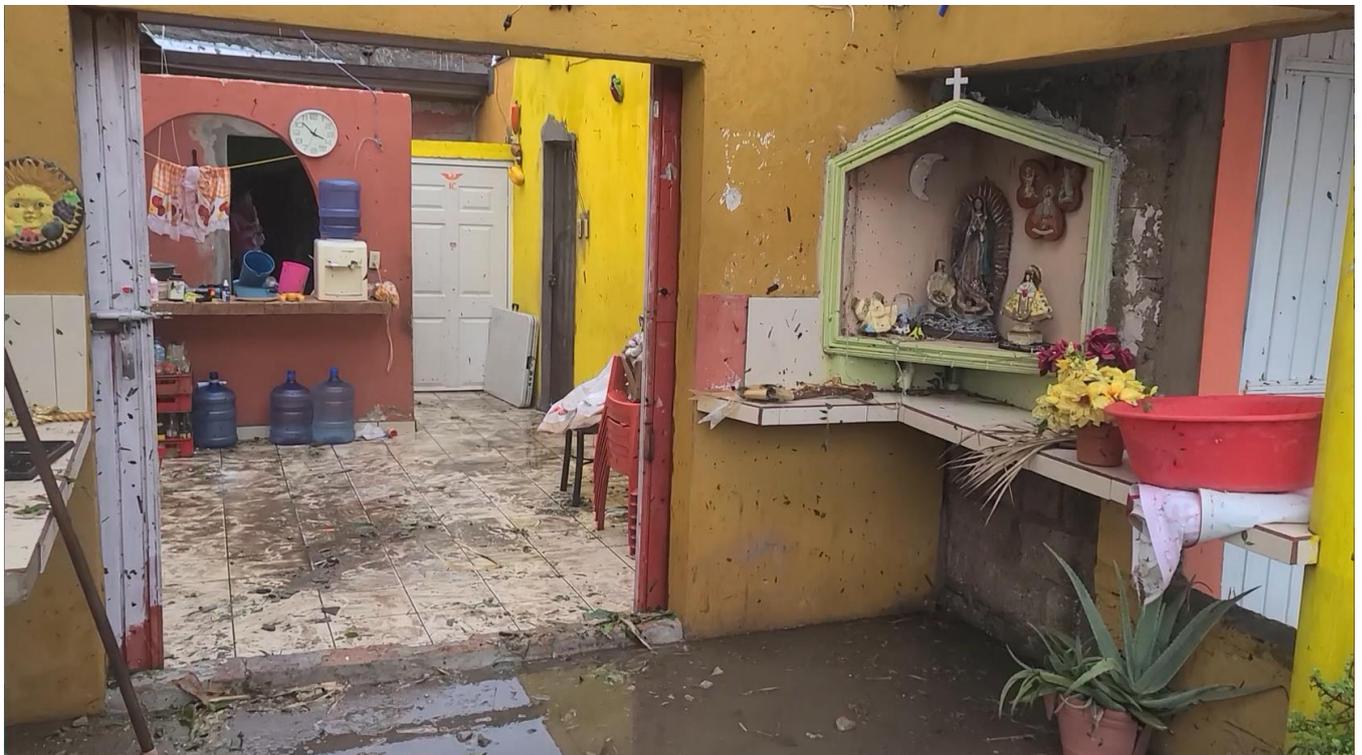
5:07 am	979.4	E/ESE	Powerful winds. Big gusts accompanied by high-pitched howl. Lightning. Very heavy rain.
5:10 am	977.3	E/ESE	Winds becoming violent. Patio roof starts to break apart & blow away. Lightning. Very heavy rain.

**Santa Cruz. As ROSLYN's violent eyewall arrived, the author and his partner stood on this restaurant's covered patio, pressed against the front entrance. When winds started tearing away the roof and dangerous wreckage rained down, they took cover under the counter on the right (beneath the religious statue). They remained in this tiny makeshift shelter until the eye arrived.**

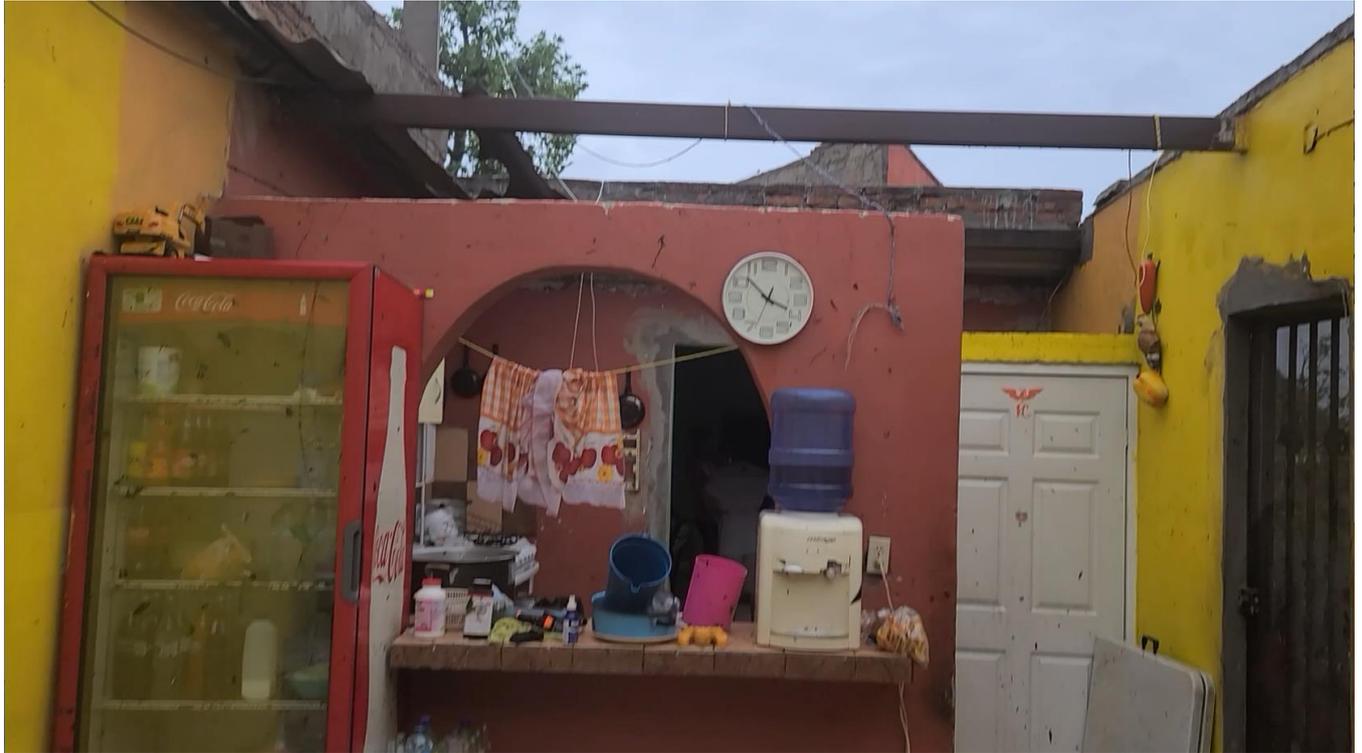
**Santa Cruz. View from inside the restaurant in front of which the author and his partner rode out the front side of Hurricane ROSLYN. Fierce winds tore away the entire roof.**

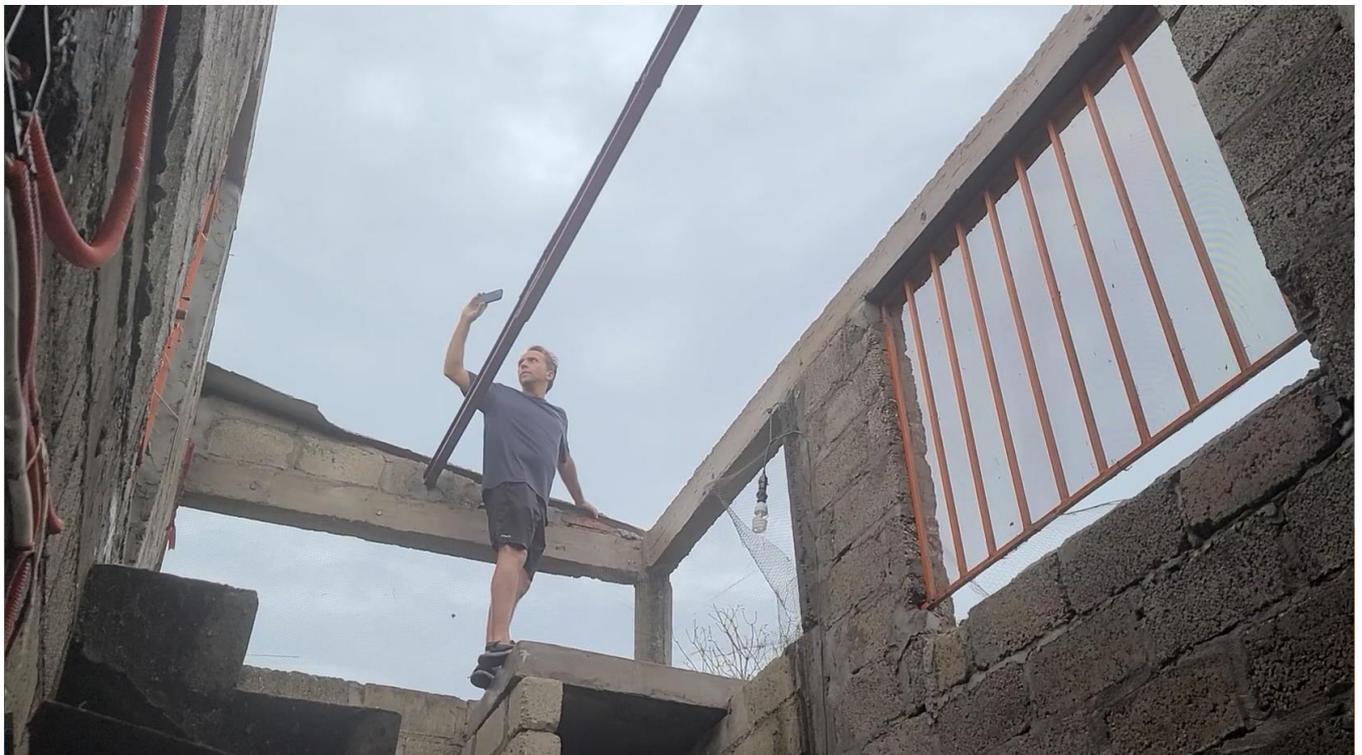
**Santa Cruz. The author and his partner, Erik, rode out Hurricane ROSLYN pressed against the entrance of a restaurant that lost much of its roof. The back of the building, which serves as residential quarters for the restaurants' owners, was also badly damaged: winds tore the entire roof off the second floor. Here, Erik surveys the damage.**

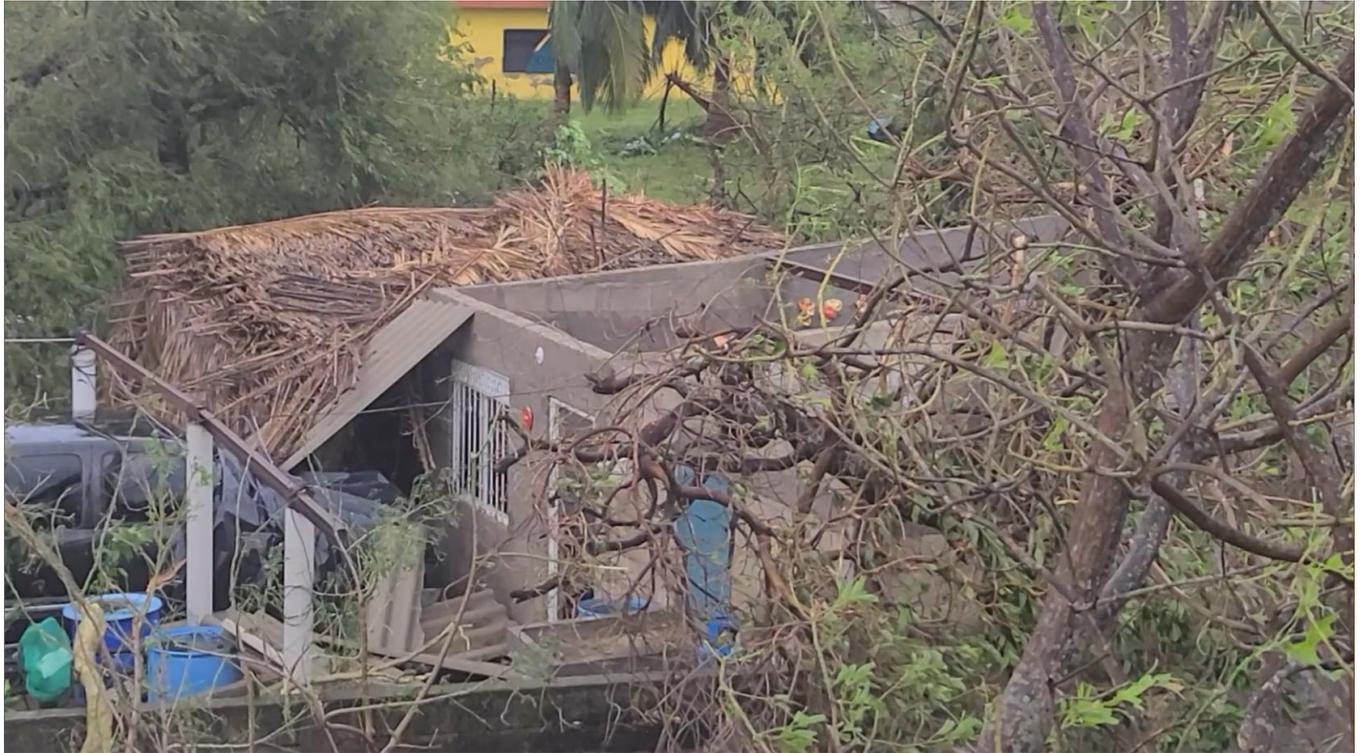
***Santa Cruz. Another house that lost its roof to Hurricane ROSLYN's fierce winds.***

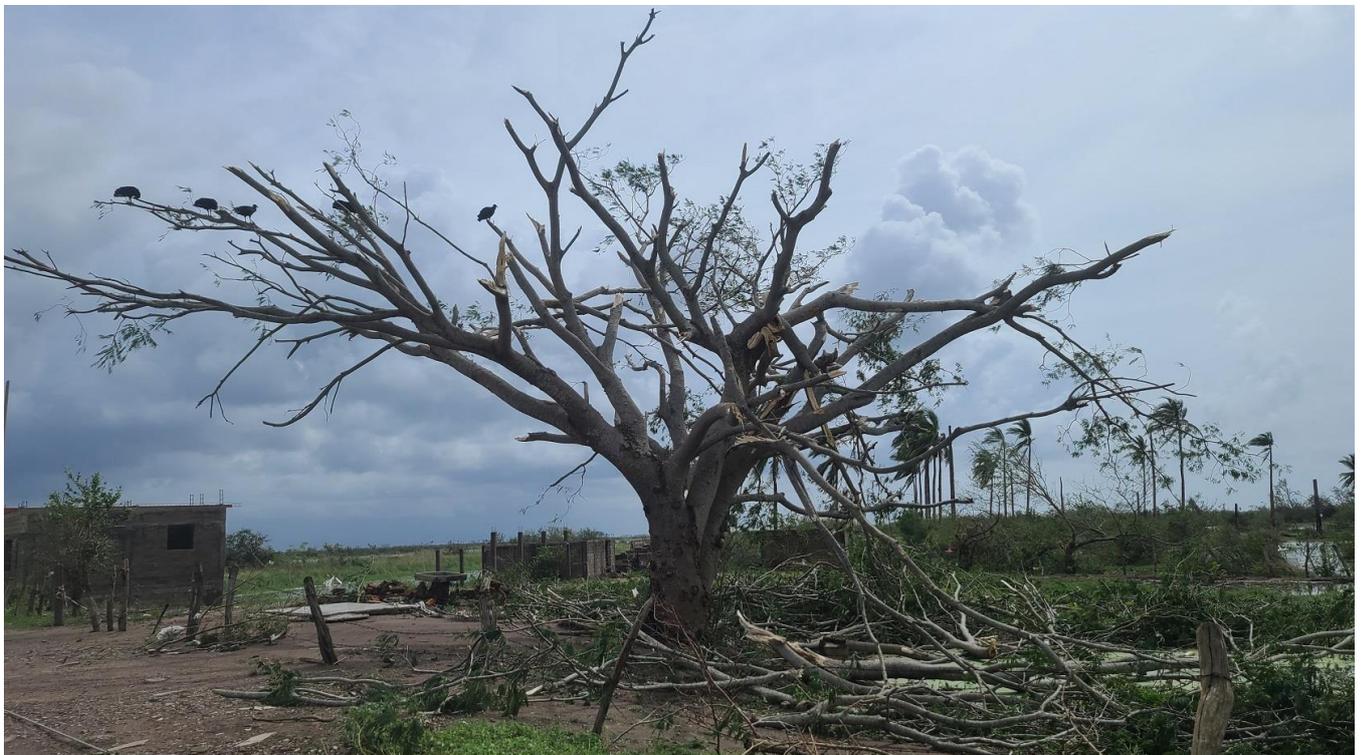
***Santa Cruz. Hurricane ROSLYN's winds inflicted heavy damage on trees. Many were uprooted and felled. Others, like this one, remained standing but were defoliated and brutally stripped of branches.***
