# ICYCLONE CHASE REPORT

storm	Hurricane ROSLYN		
location	Santa Cruz, Nayarit, Mexico		
date	23 October 2022		
chasers	Josh Morgerman, Erik Sereno	author	Josh Morgerman

Hurricane ROSLYN was a small, violent Category-3 hurricane that struck the Pacific coast of Mexico, in the state of Nayarit, just before dawn on 23 October 2022.

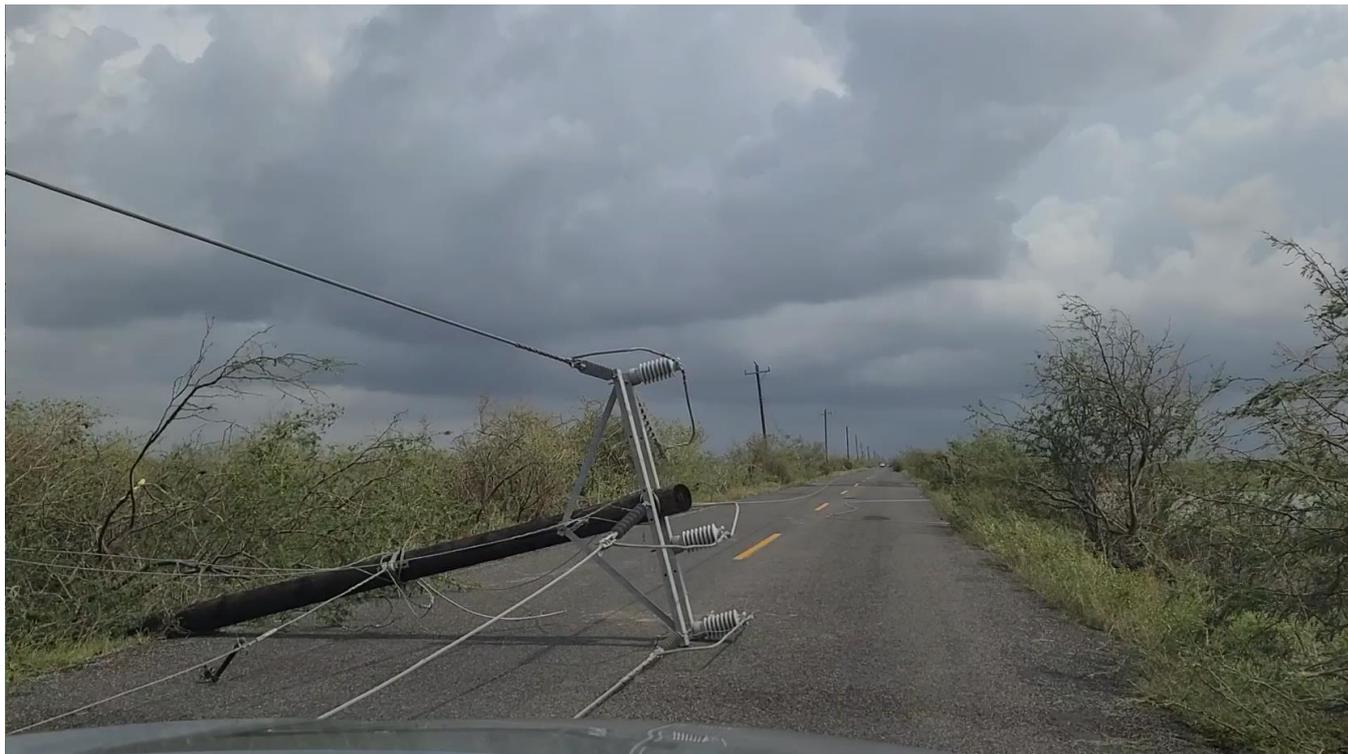
The E/W highway connecting Santa Cruz with the rest of Nayarit was left impassable by a thick tangle of fallen trees, power poles, and wires. (Fortunately, by midday a narrow path was cleared for traffic.)

***Just E of Santa Cruz. Many power poles fell across the E/W highway connecting Santa Cruz with the rest of Nayarit.***

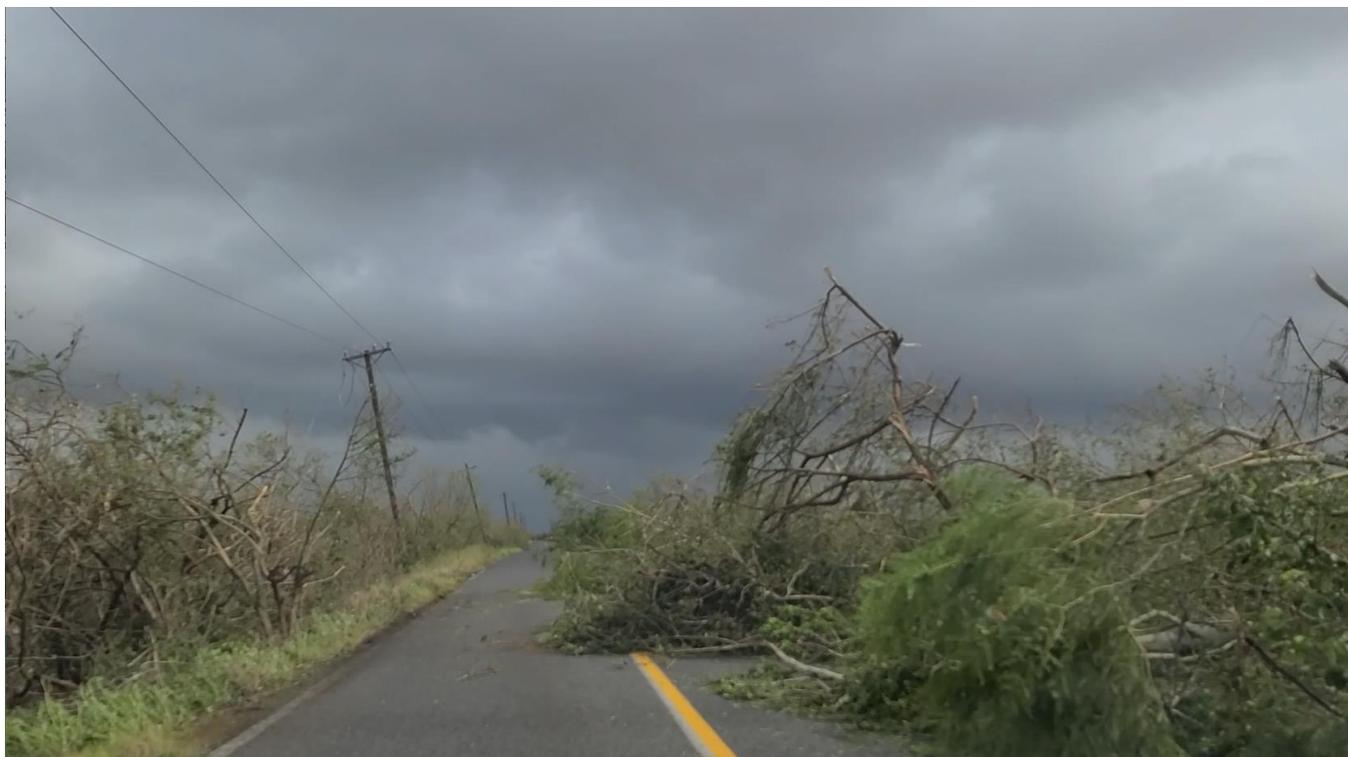
***Highway E of Santa Cruz. So many trees fell across the road, it resembled a jungle.***

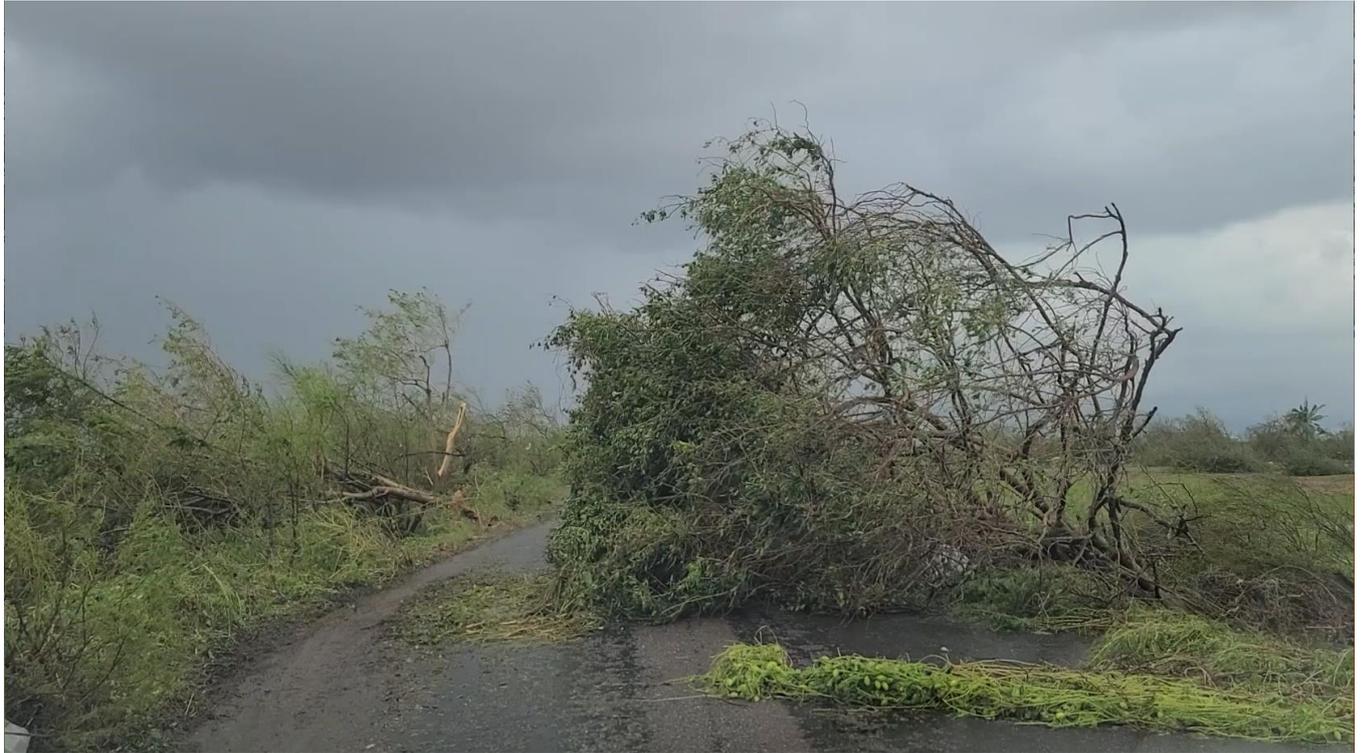
***Highway E of Santa Cruz. Massive tree blowdown occurred along the E/W highway connecting Santa Cruz with the rest of Nayarit.***

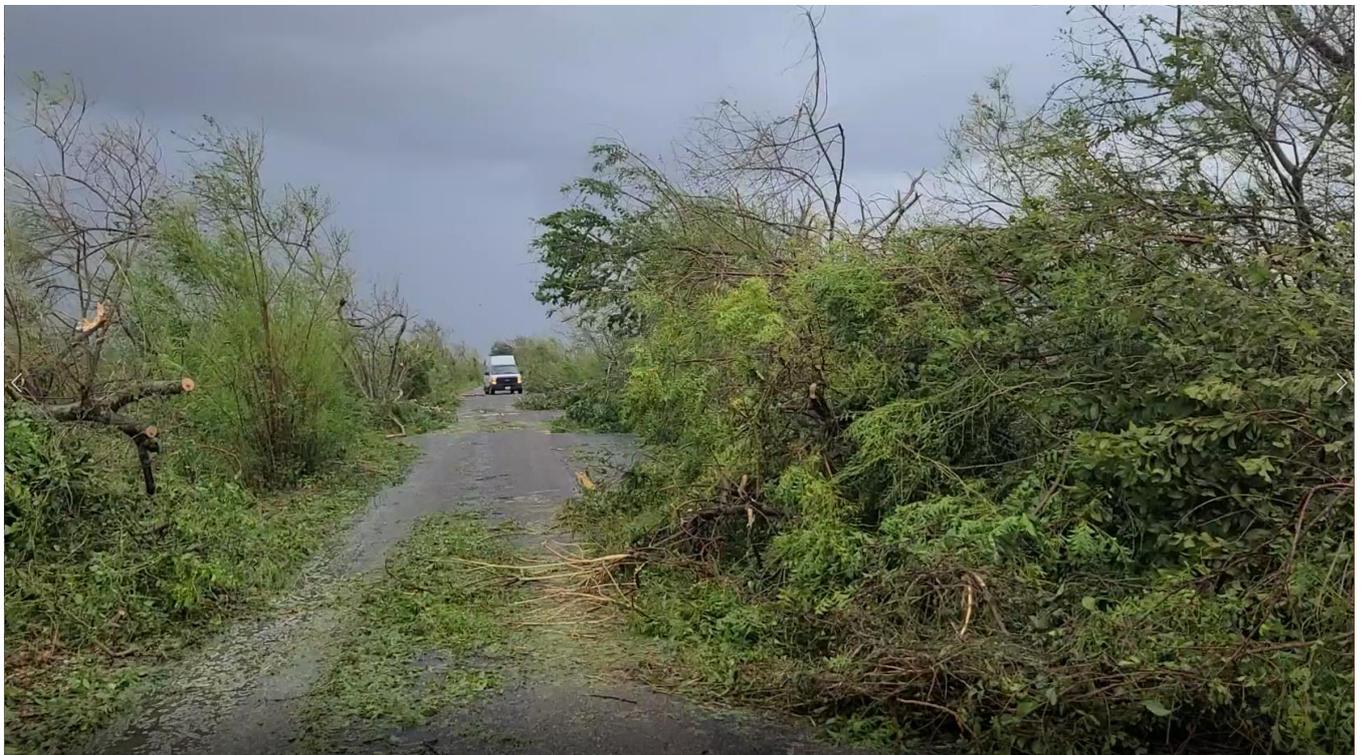
***Highway E of Santa Cruz. Another shot of massive tree blowdown along the E/W highway connecting Santa Cruz with the rest of Nayarit.***

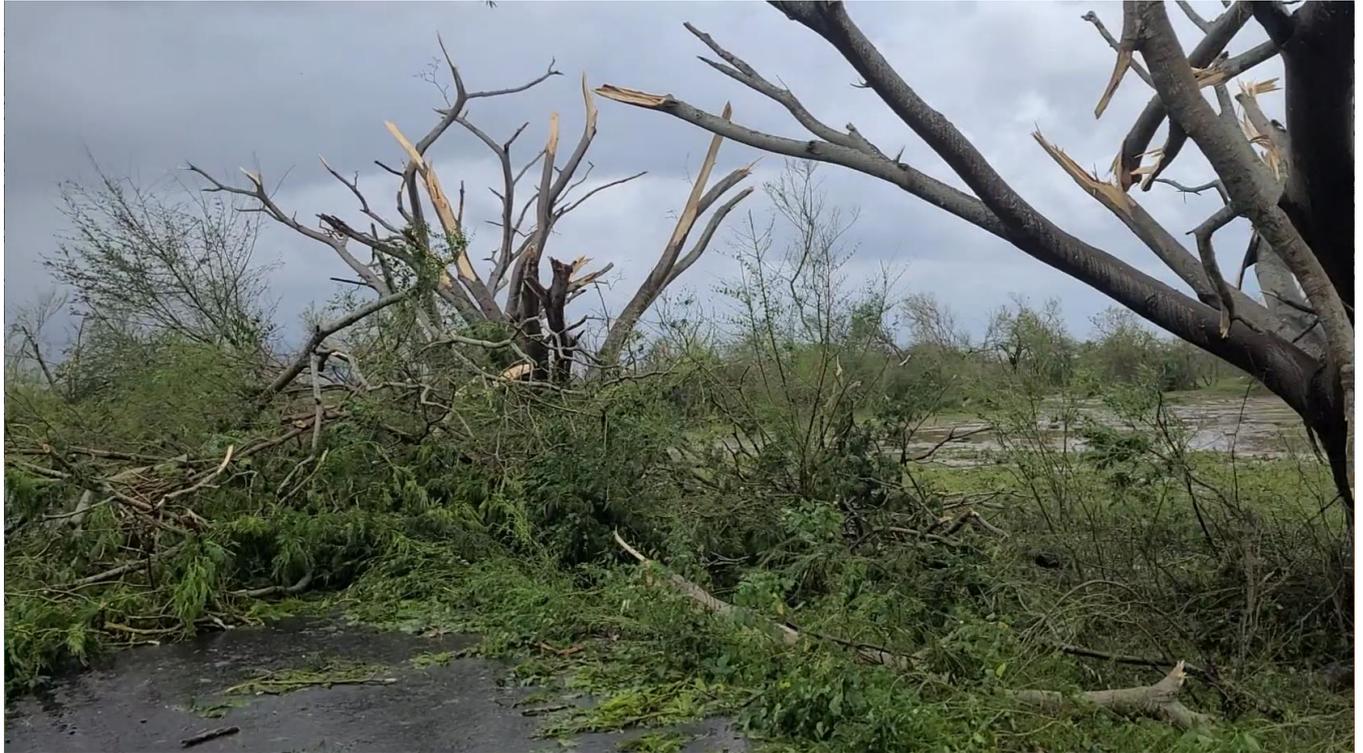
***Highway E of Santa Cruz. Hurricane ROSLYN's winds were cruel to trees along the highway. Those that remained standing were defoliated and stripped of branches.***

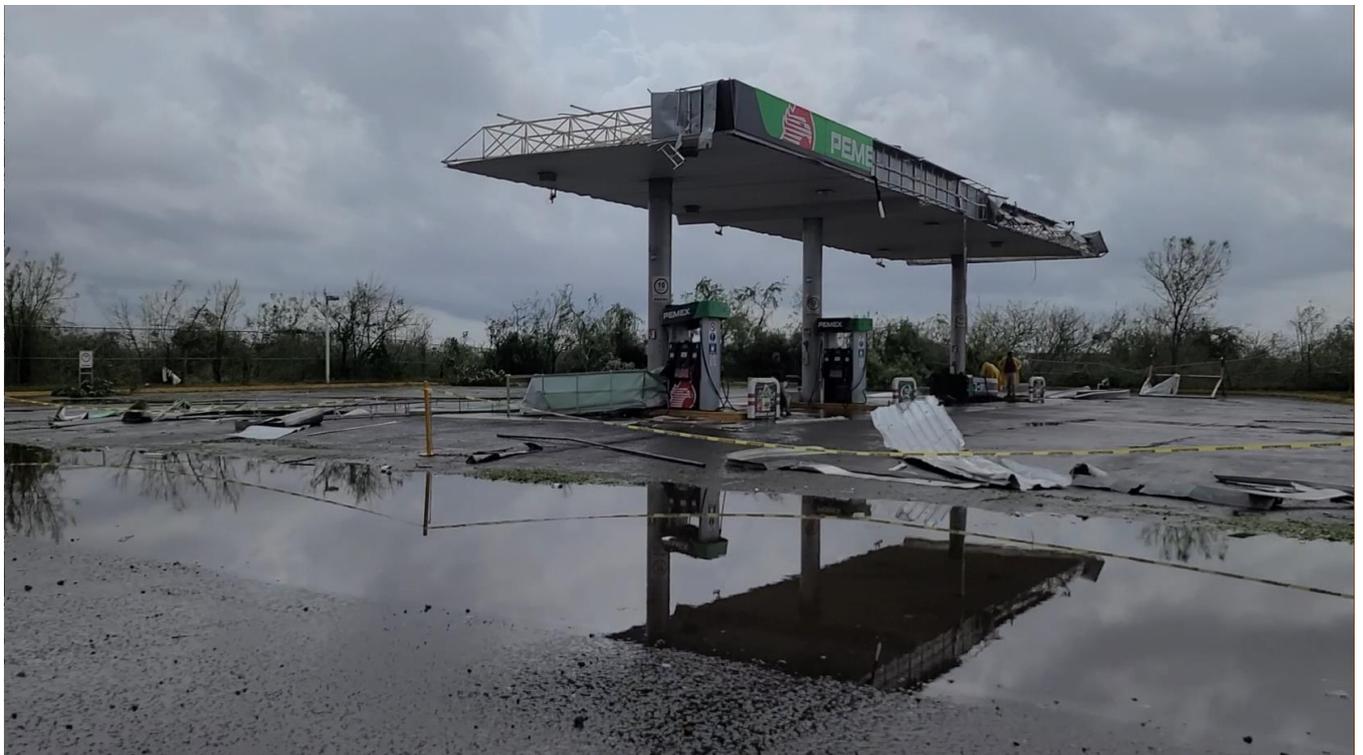
Significant wind damage extended E of Santa Cruz and seemed especially heavy in and around **Pimientillo, ~7 n mi SE of the hurricane's center** (at its point of closest approach). Here, it seemed most of the trees and power poles fell the same way—generally toward the N—suggesting this location stayed in the E eyewall, never entering the eye and never seeing a significant shift in wind direction.

***Pimientillo. Damaged gas station. Wind damage seemed especially heavy near this town, which was ~7 n mi SE of the hurricane's center (at its point of closest approach).***

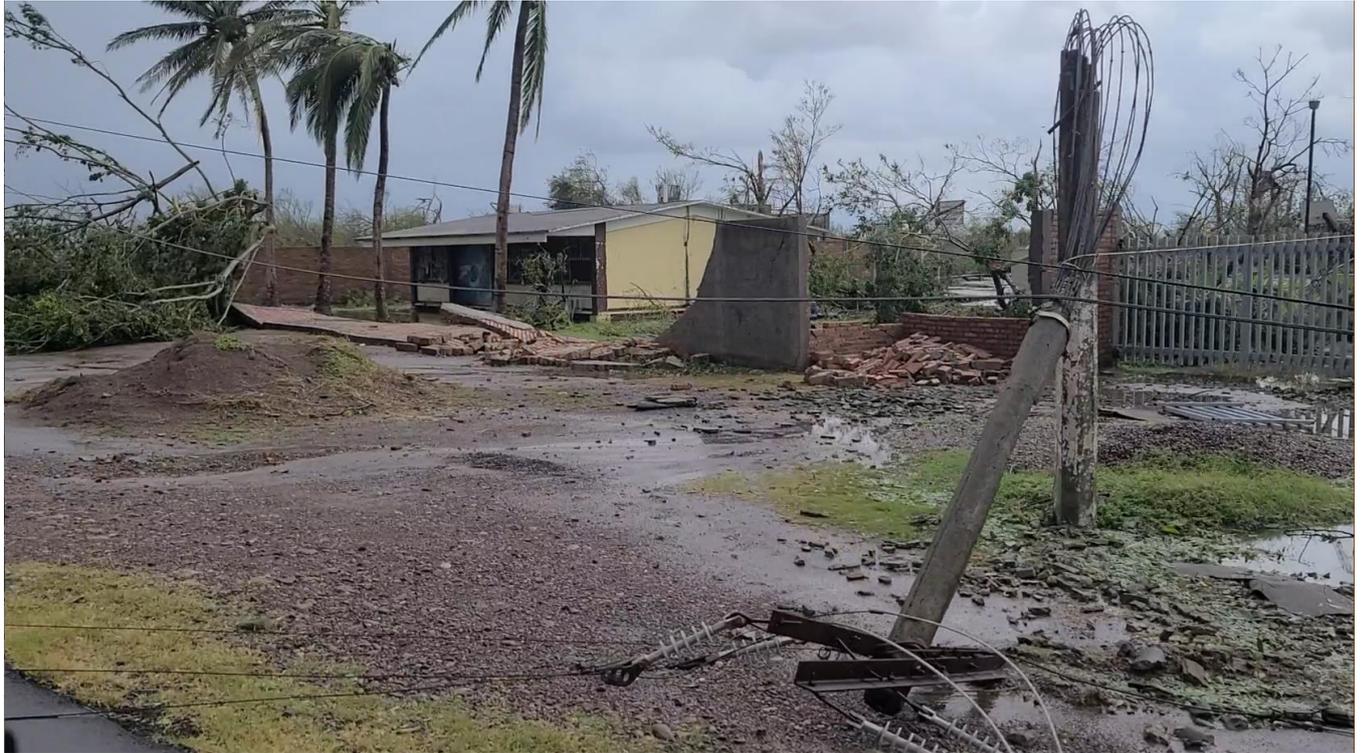
***Pimientillo. Smashed concrete power pole, collapsed wall, and shredded trees. ROSLYN's winds were especially fierce in this town ~7 n mi SE of the hurricane's center (at its point of closest approach).***

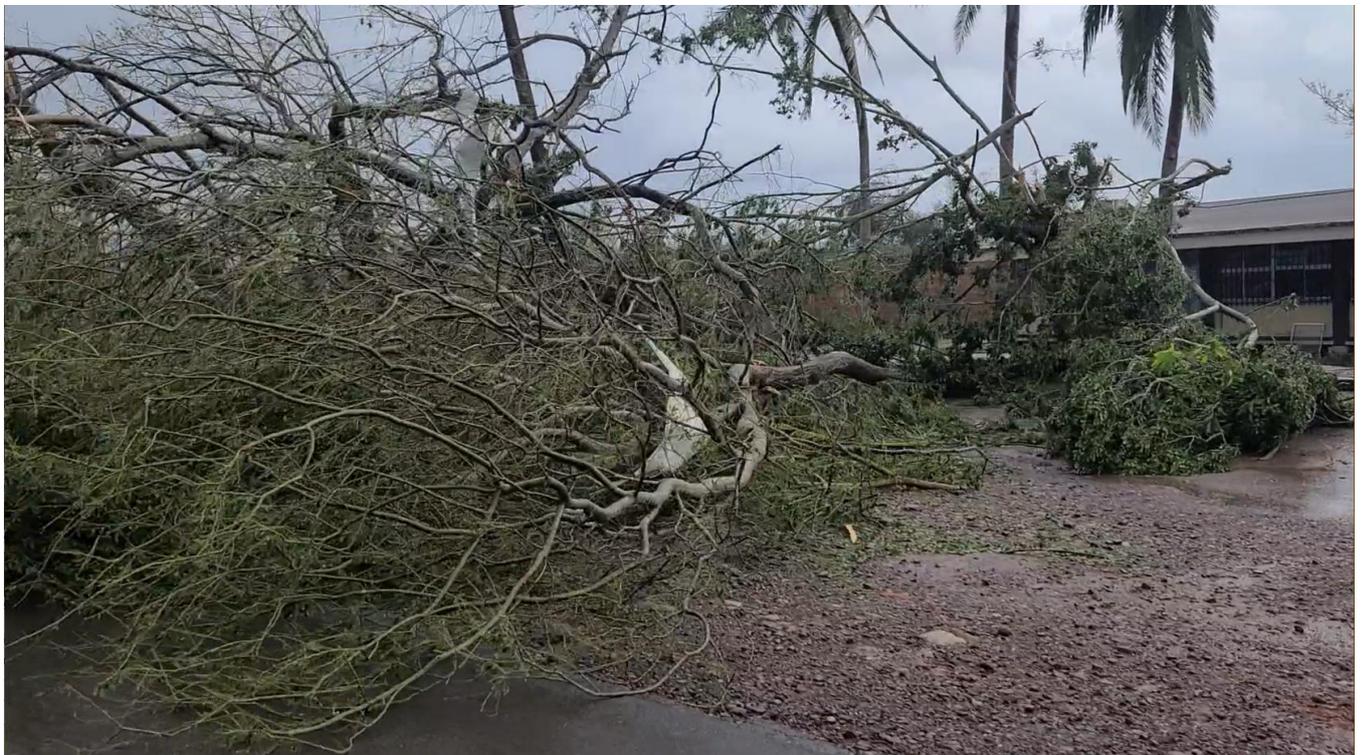
***Pimientillo. More heavy damage to trees.***

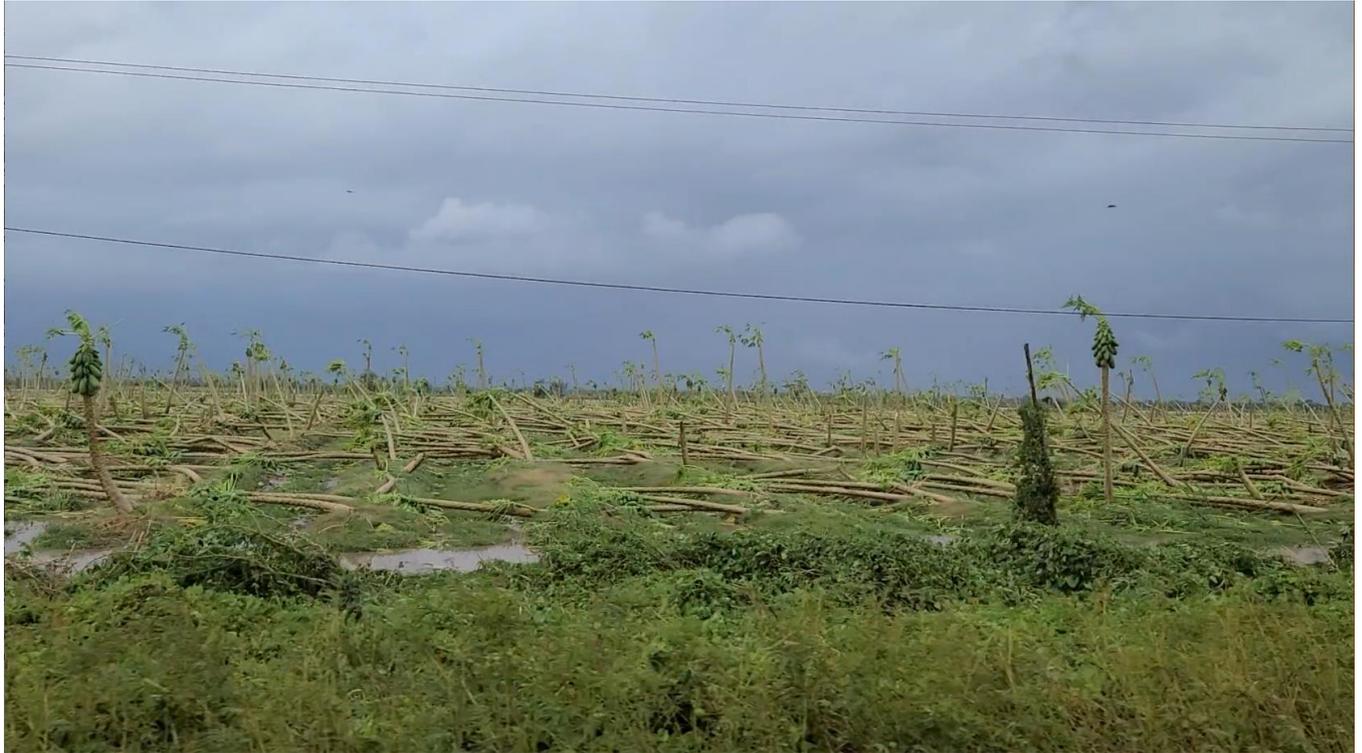
On the highway near **La Boquita, ~11 n mi SE of the hurricane's center** (at its point of closest approach), the wind damage appeared to be much less severe, suggesting this location was outside the hurricane's radius of maximum winds (RMW). But even here, the author estimated 90% of the papaya trees on a farm next to the highway were blown down.

*Near La Boquita. Wind damage seemed less severe at this location ~11 n mi SE of ROSLYN's center, leading the author to believe it was likely outside of the hurricane's RMW. Even so, the winds here were powerful enough to mow down most of the papaya trees.*
