iCYCLONE CHASE REPORT

storm	Hurricane PAMELA		
location	Sinaloa, Mexico		
date	13 October 2021		
chasers	Josh Morgerman, Erik Sereno	author	Josh Morgerman

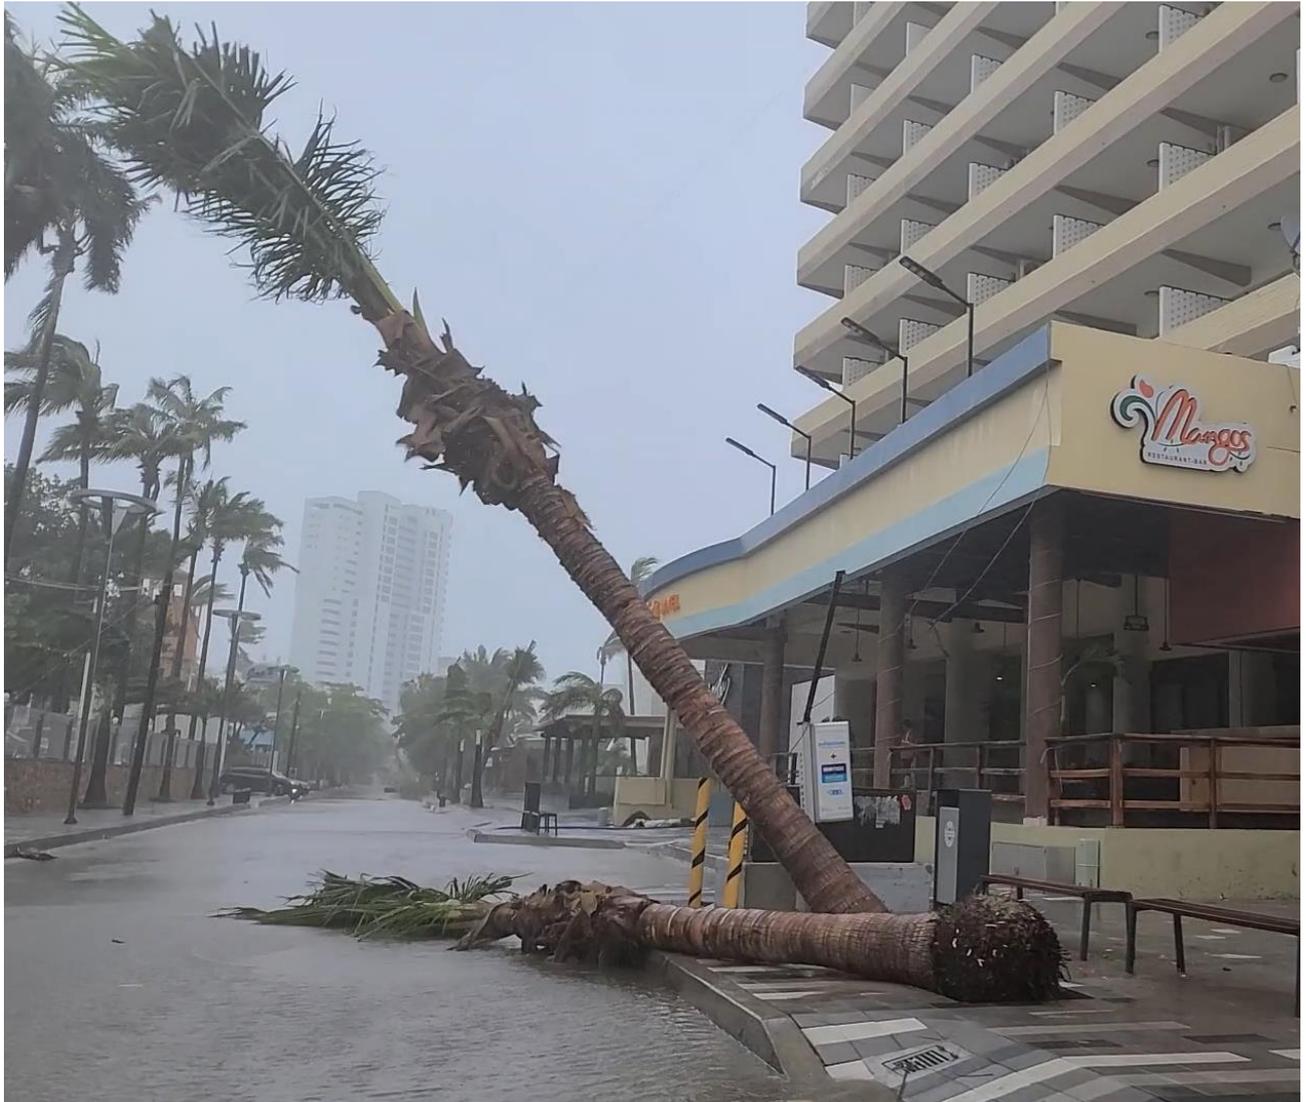
Normally wind-resistant palm trees took a beating in Hurricane PAMELA. Many throughout Mazatlan were felled during the storm.

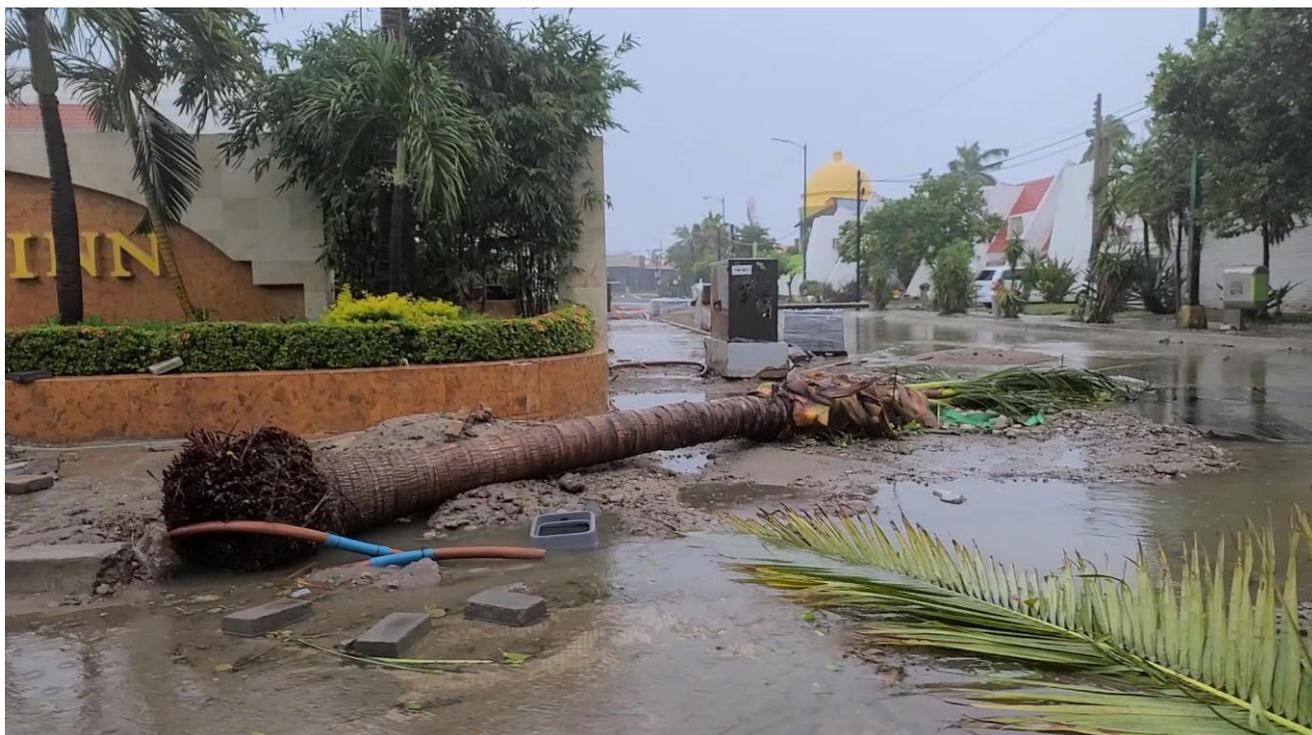
Tree damage in Mazatlan.

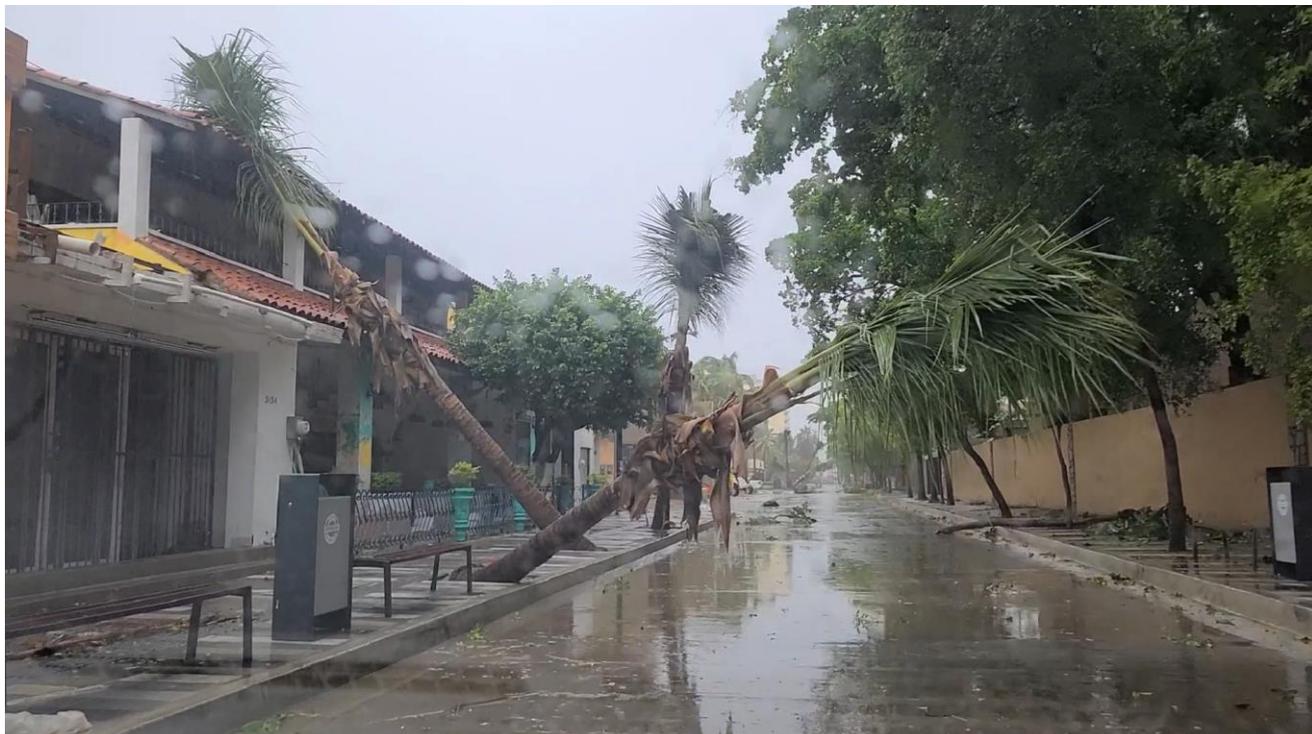
Tree damage in Mazatlan.

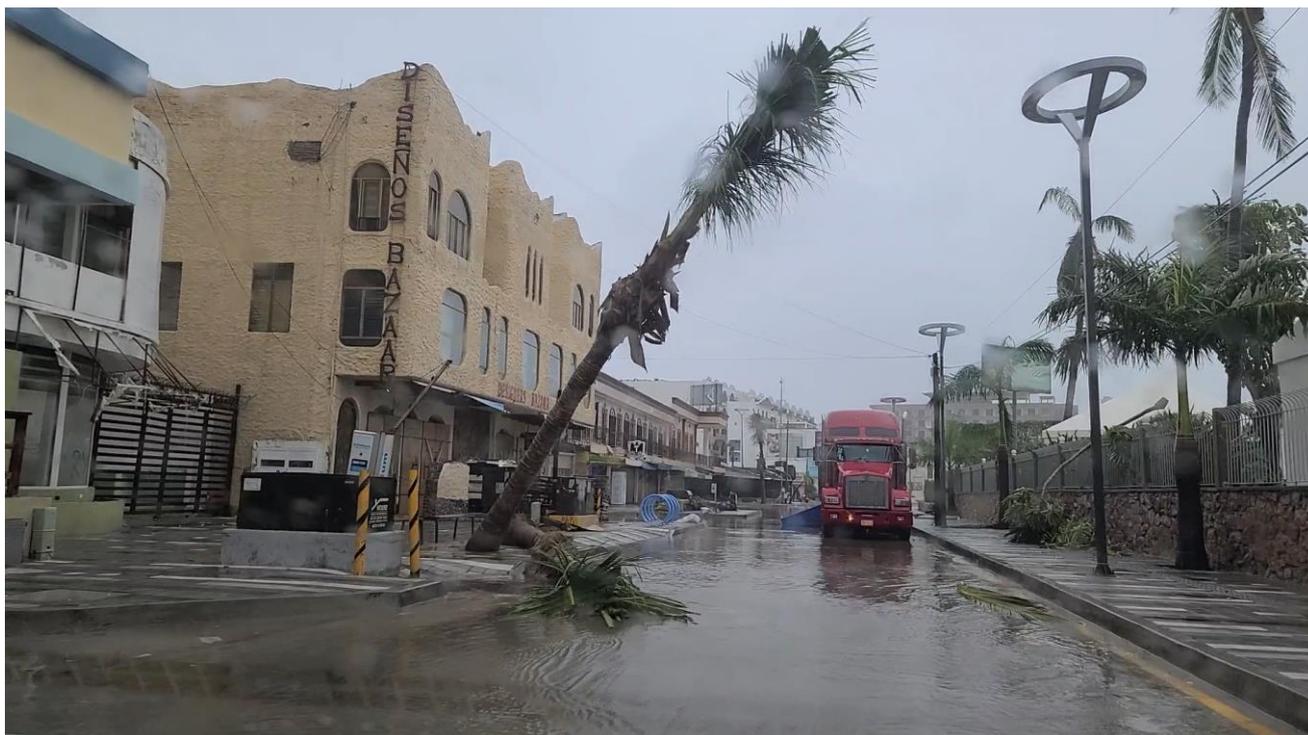
Tree damage and flooding in Mazatlan.

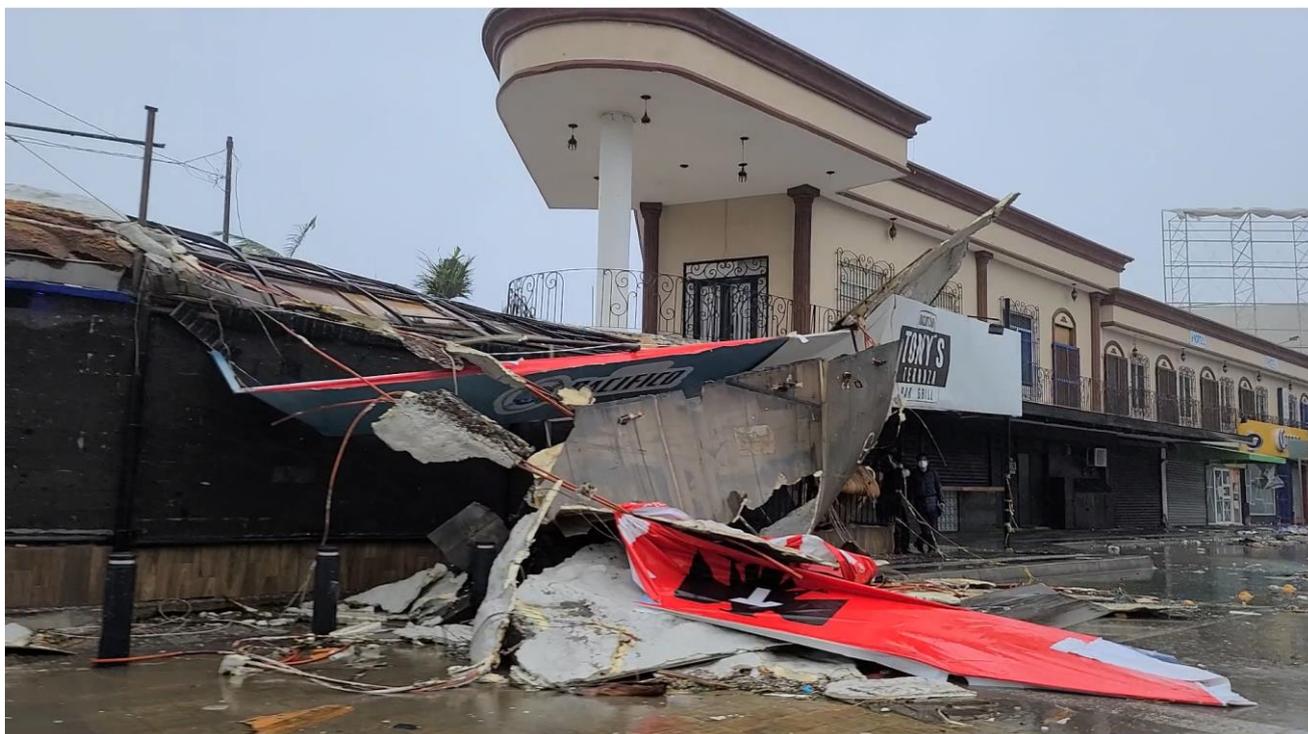
Destroyed restaurant signage in Mazatlan.

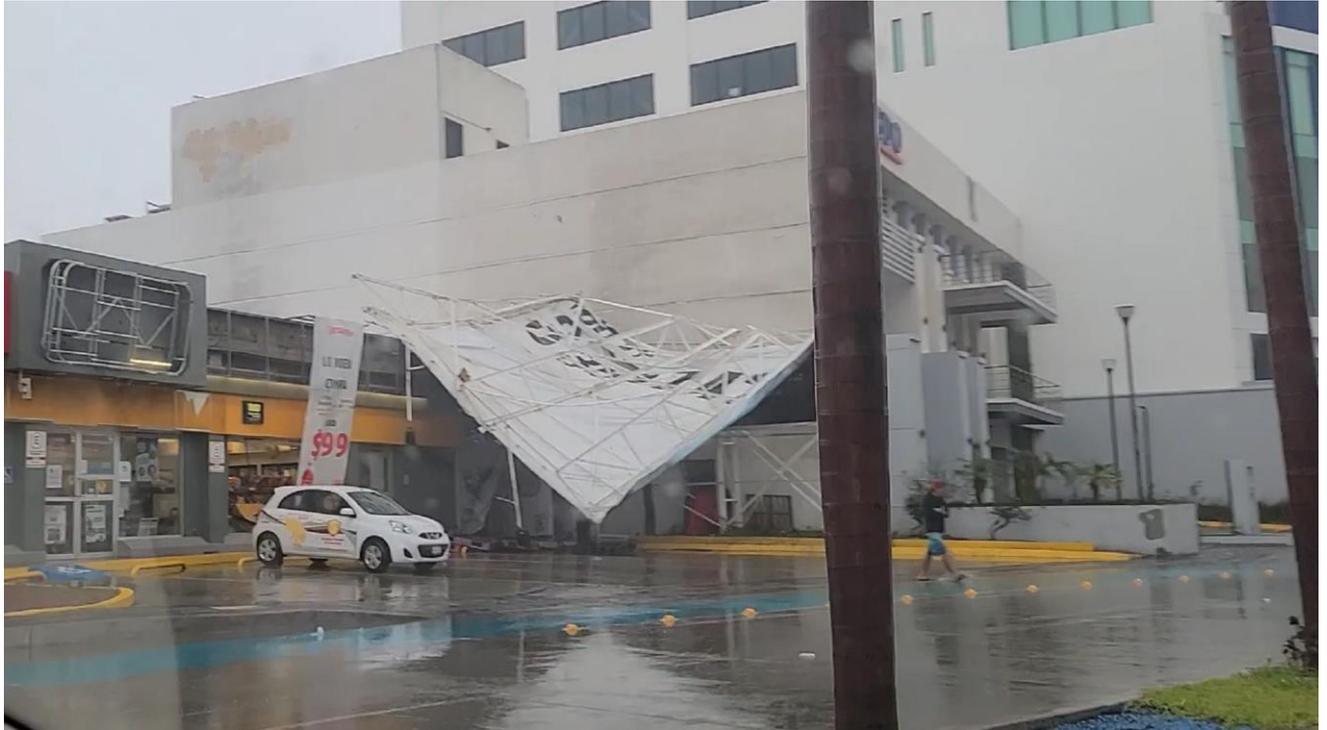
Destroyed signs in Mazatlan.

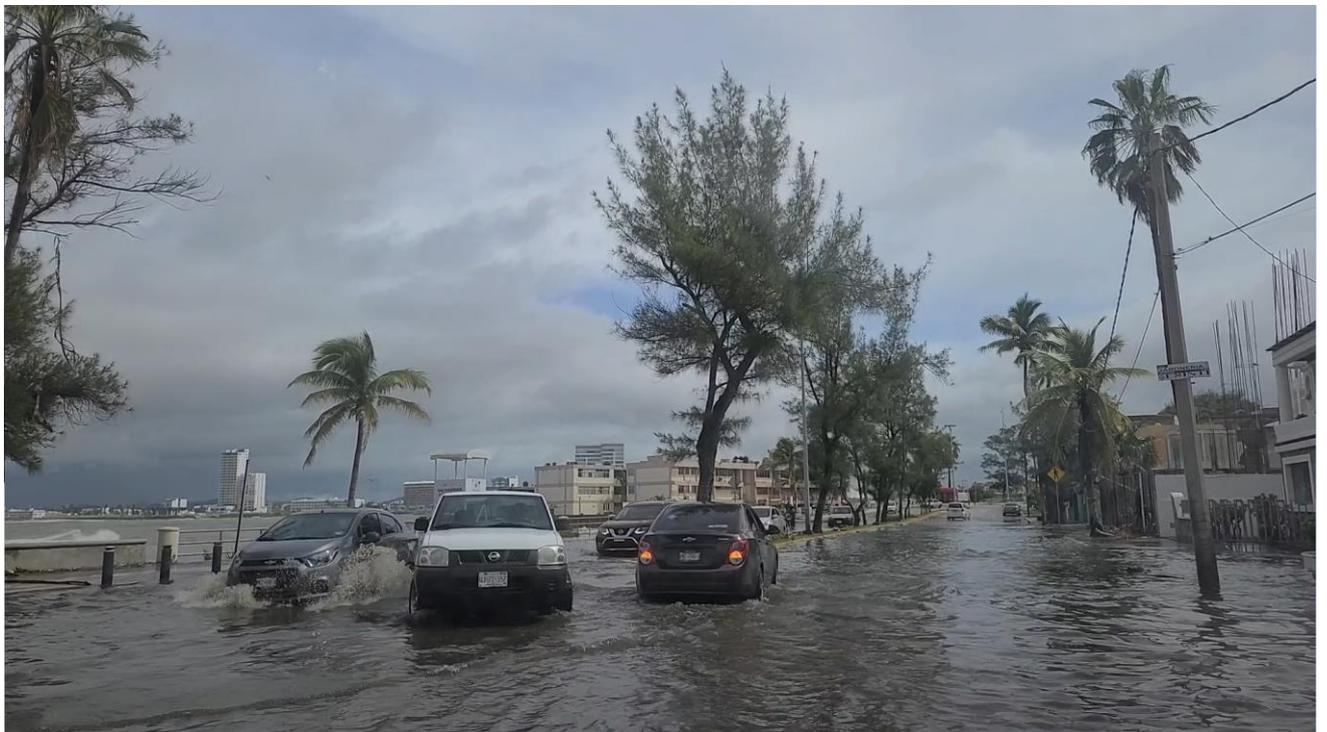
Extensive street flooding in Mazatlan.

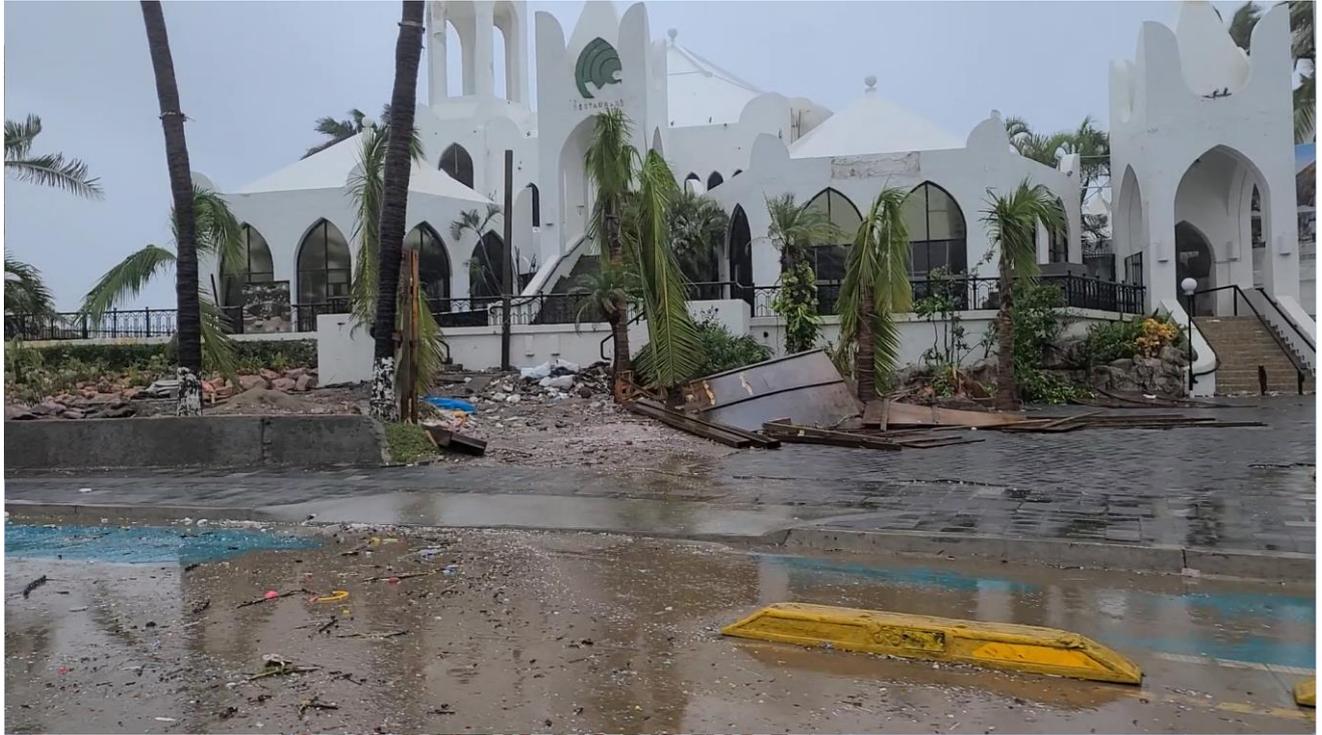
Thrashed pam trees and windblown debris were the main sights in this major intersection in Mazatlan's "Golden Zone" the morning after Hurricane PAMELA.

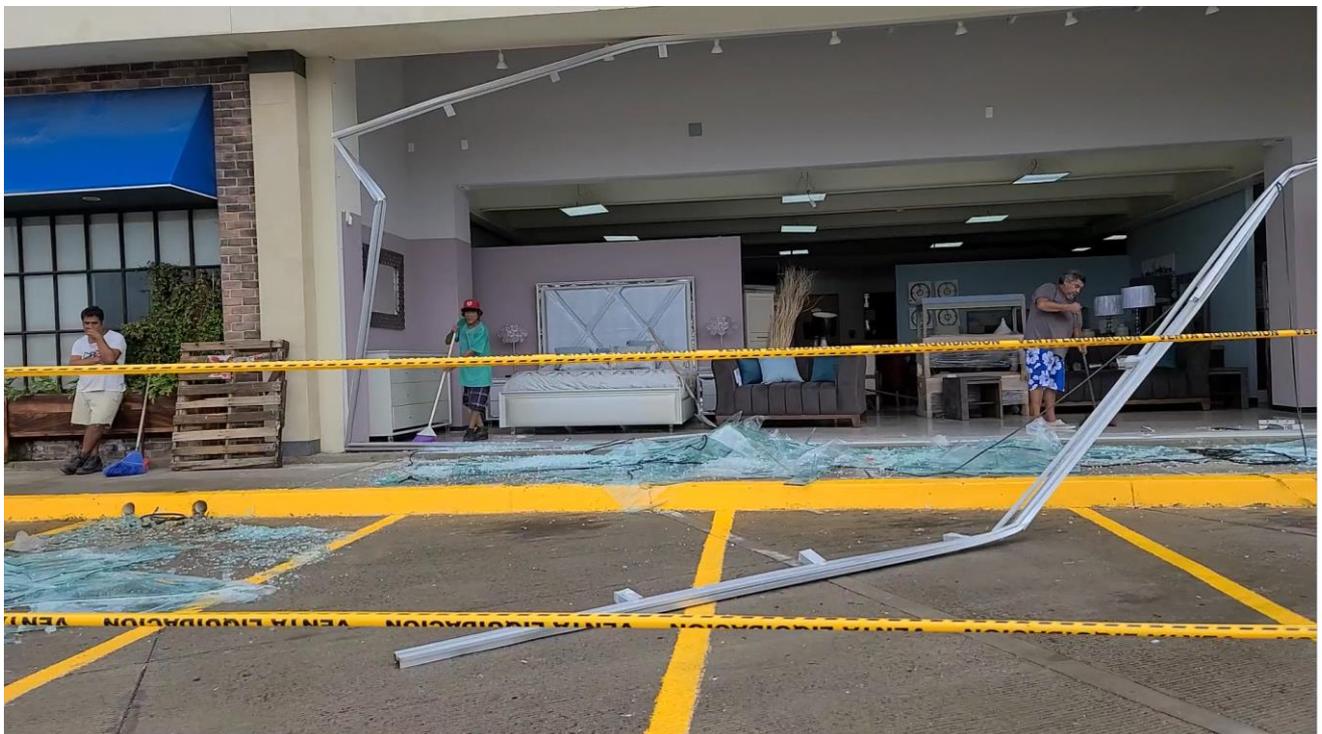
Destroyed storefront in Mazatlan. The owner reported the windows seemed to blow outward, as if pressure came from the interior of the building.

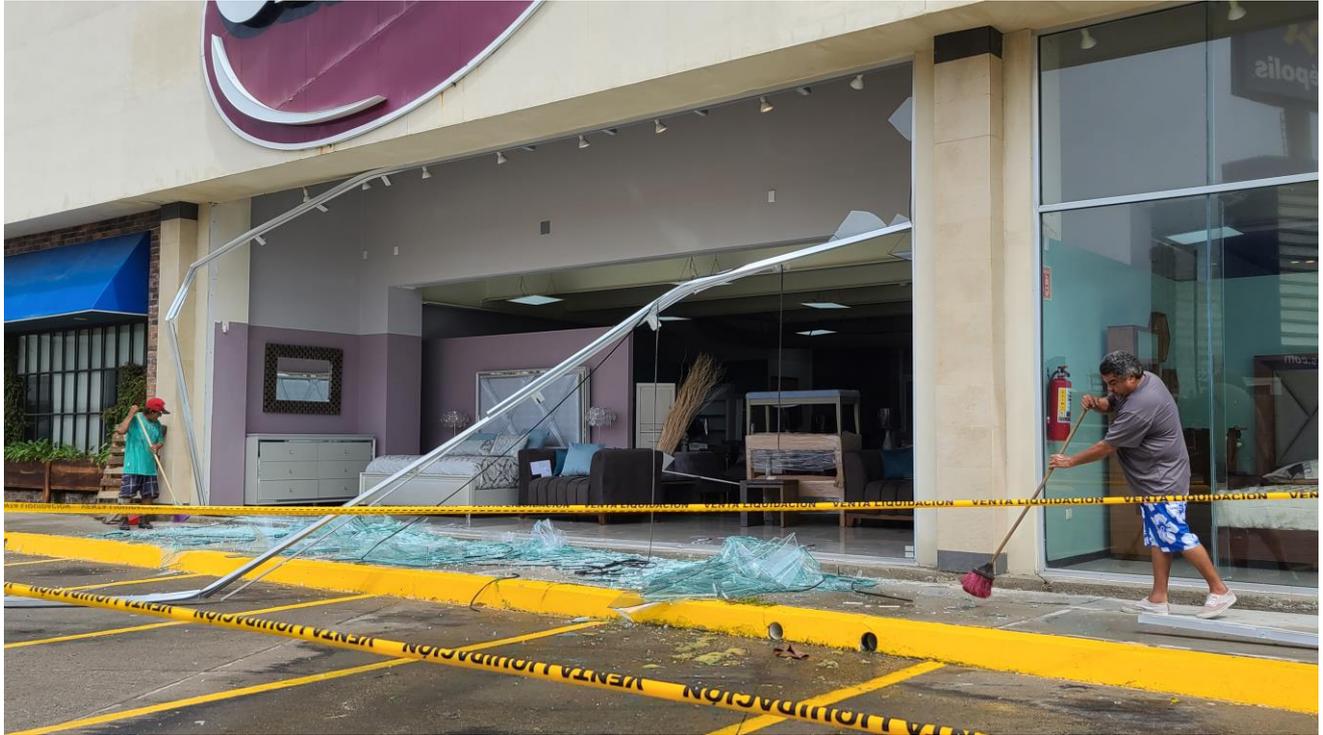
Another view of the destroyed storefront.

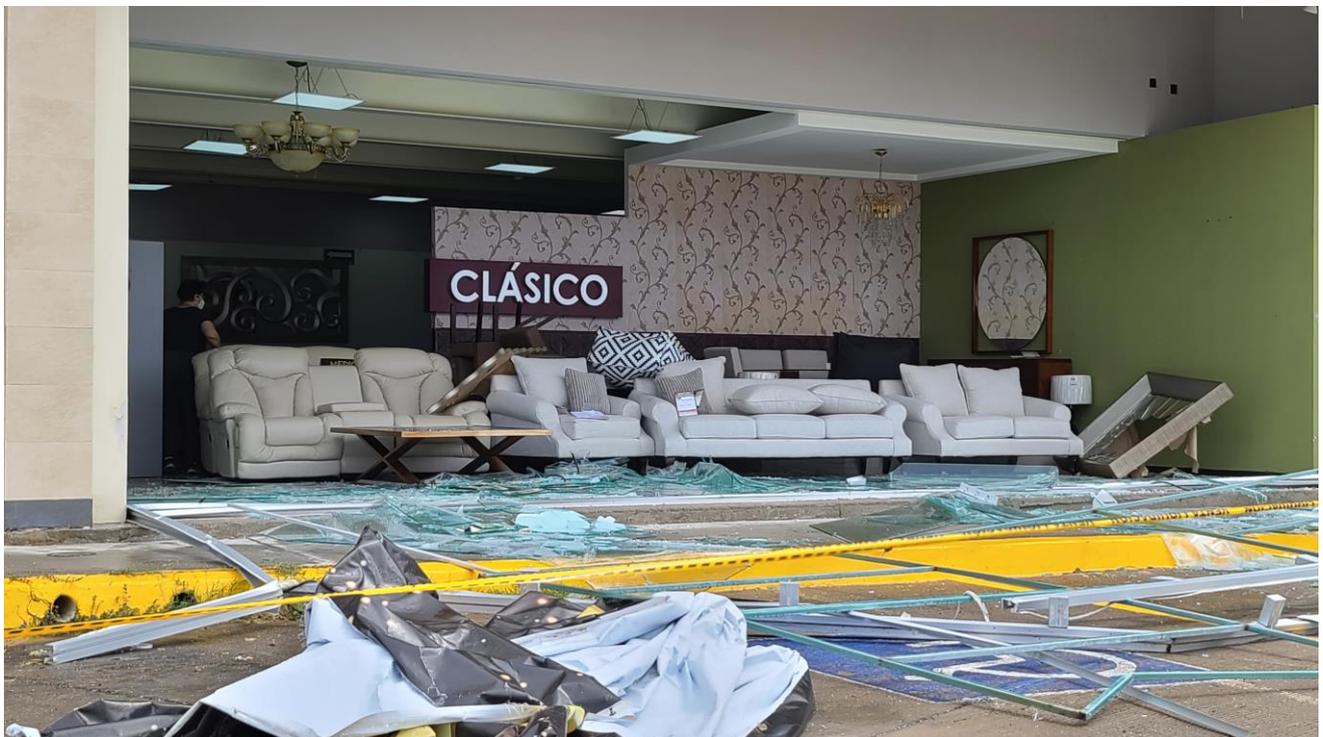
Another view of the destroyed storefront.

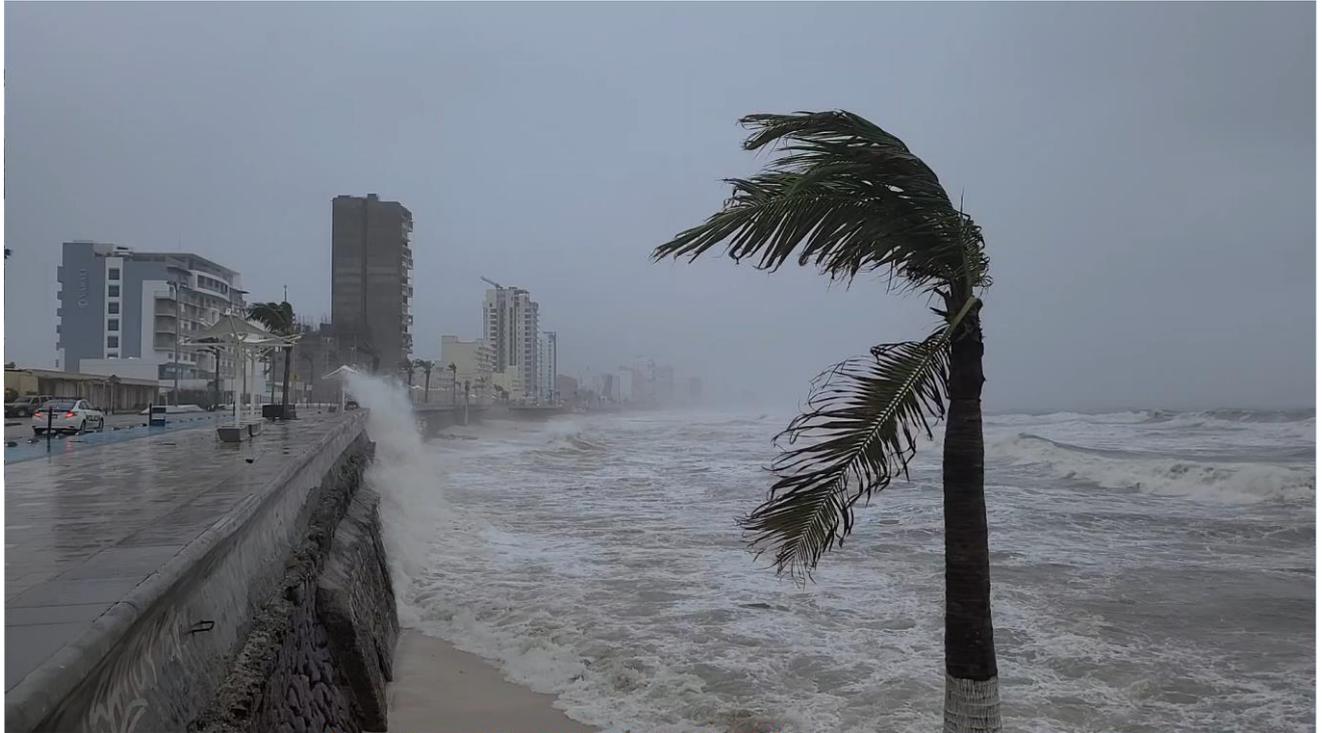
Waves continued to crash along Mazatlan's famous Malecon the morning after Hurricane PAMELA.

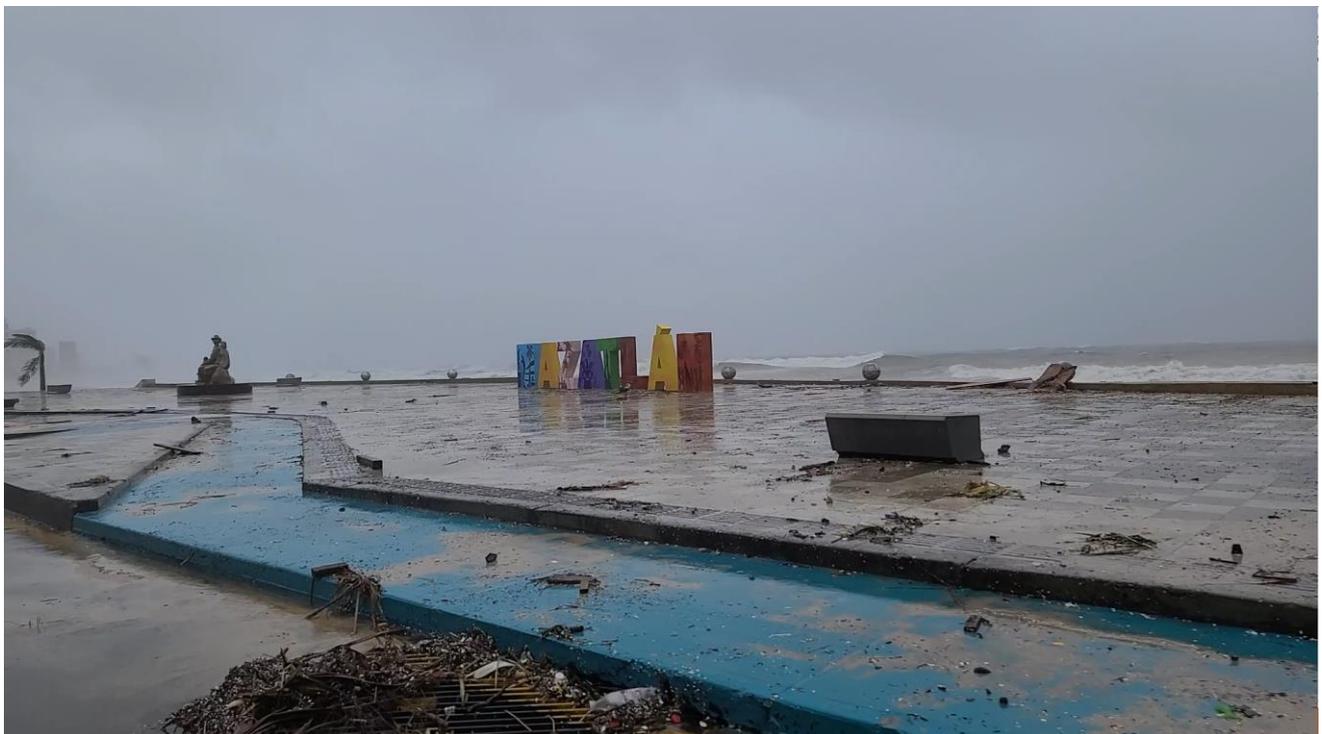
Roughed up but still there. Mazatlan's city letters withstood Hurricane PAMELA, despite waves apparently crashing up over the seawall and onto the Malecon. (Notice the debris deposits.)
