# iCYCLONE CHASE REPORT

<b>storm</b>	<b>Hurricane DORIAN</b>		
<b>location</b>	Marsh Harbour, Great Abaco Island, Bahamas		
<b>date</b>	01 September 2019		
<b>chasers</b>	Josh Morgerman	<b>author</b>	Josh Morgerman

**Hurricane DORIAN** was an extremely intense, Category-5 hurricane that made a direct hit on Great Abaco Island in the Bahamas on 01 September 2019.

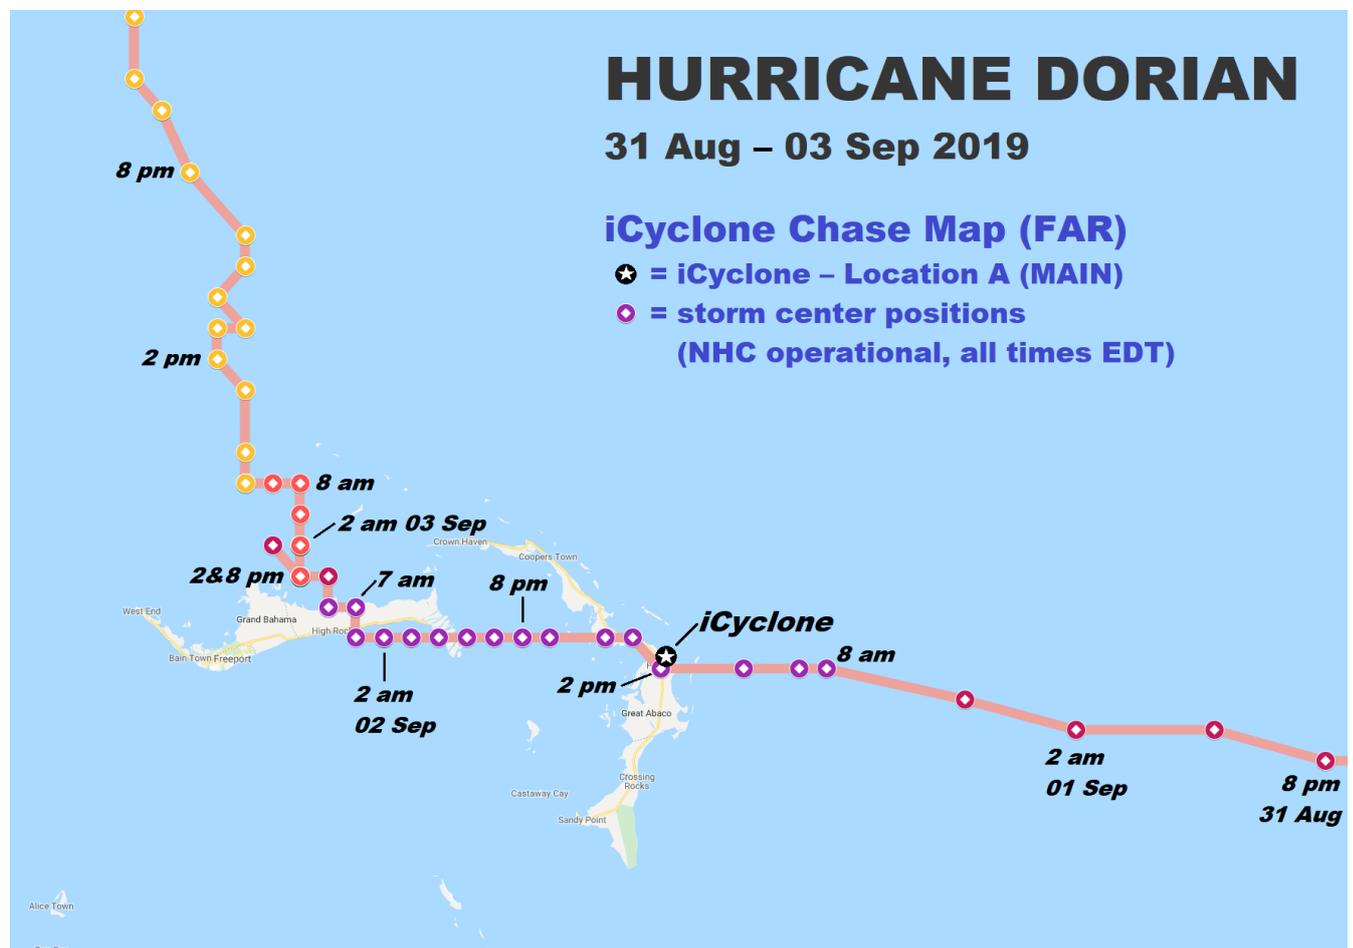
**Figure 1: Chase Map**

- **Fig 1: Chase Map** shows **the author’s main observation point (Location A—black star)** in relation to **DORIAN’s center (colored points)**, as per NHC advisory positions.
- **Fig 2: Chase Map (DETAILED)** is a closer view.
- **Fig 3: Chase Map (DETAILED 2)** is an even closer view, showing both the author’s main observation point (**Location A—black star**) and **where he relocated to** during the eye (**Location B—blue star**).

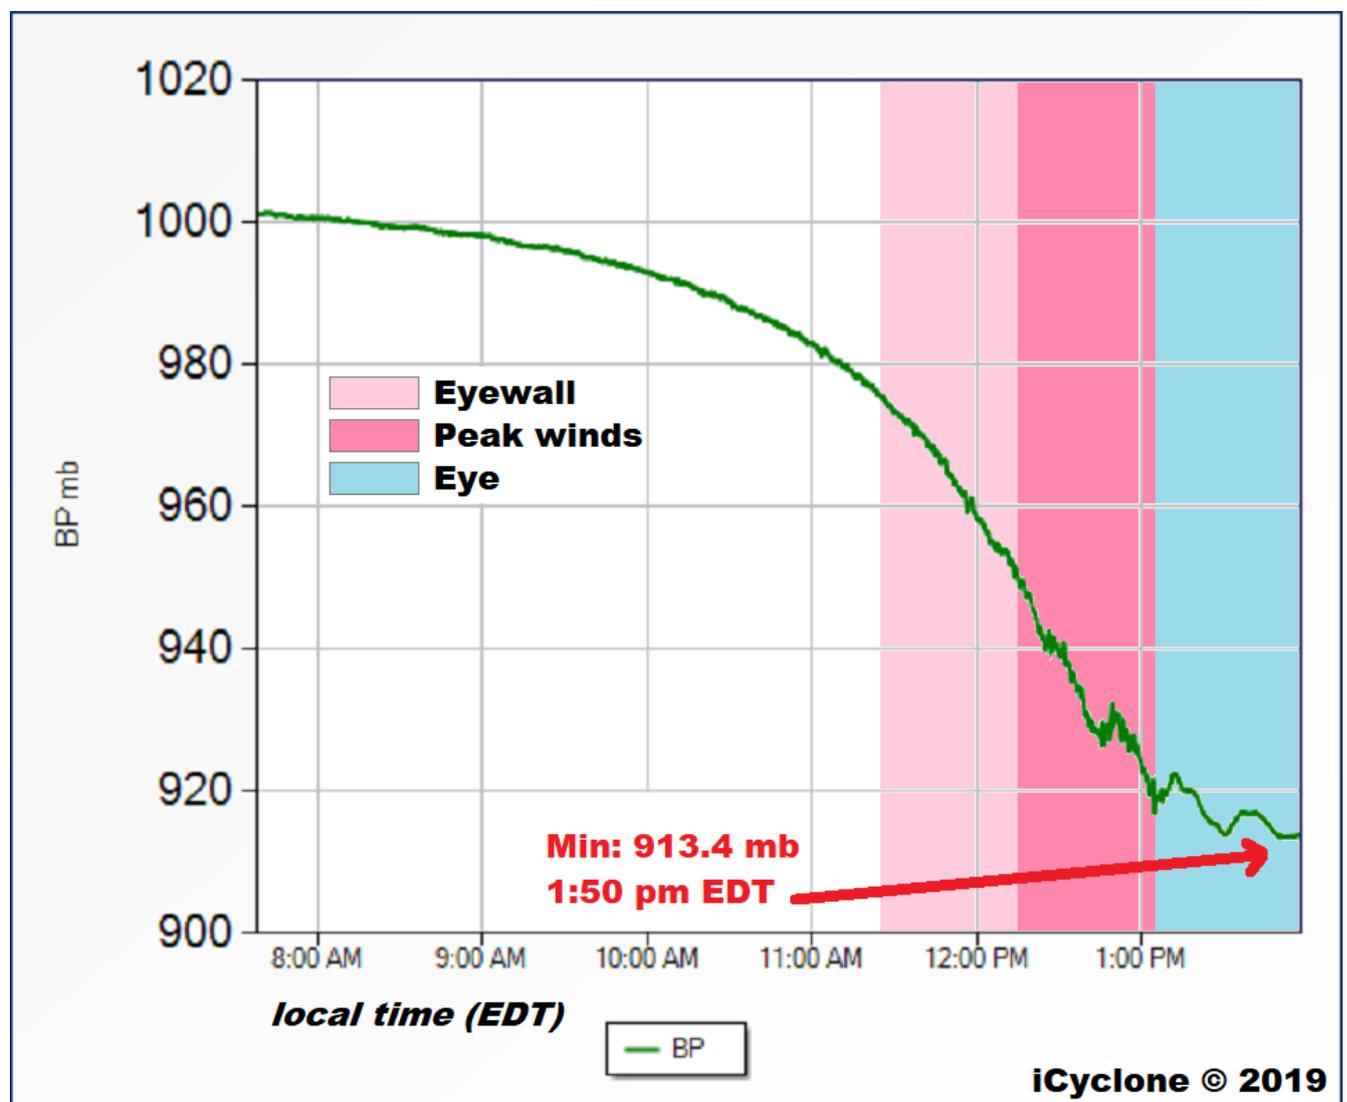
**Figure 4: Barogram—DEVICE A**

Air-pressure data reveal the minimum value of 913.4 mb occurred at 1:50 pm EDT, as the cyclone's eye was passing over the observation point. The approximate period of the eyewall is indicated in pink; the period of peak winds in the inner eyewall is emphasized with deep pink; the lull of the eye is indicated in blue.

The pressure traces for **Devices A and B** are below: **Fig 4: Barogram—DEVICE A** and **Fig 5: Barogram—DEVICE B**.

The complete data for both devices are graphed in **Figures 4 and 5**, below.

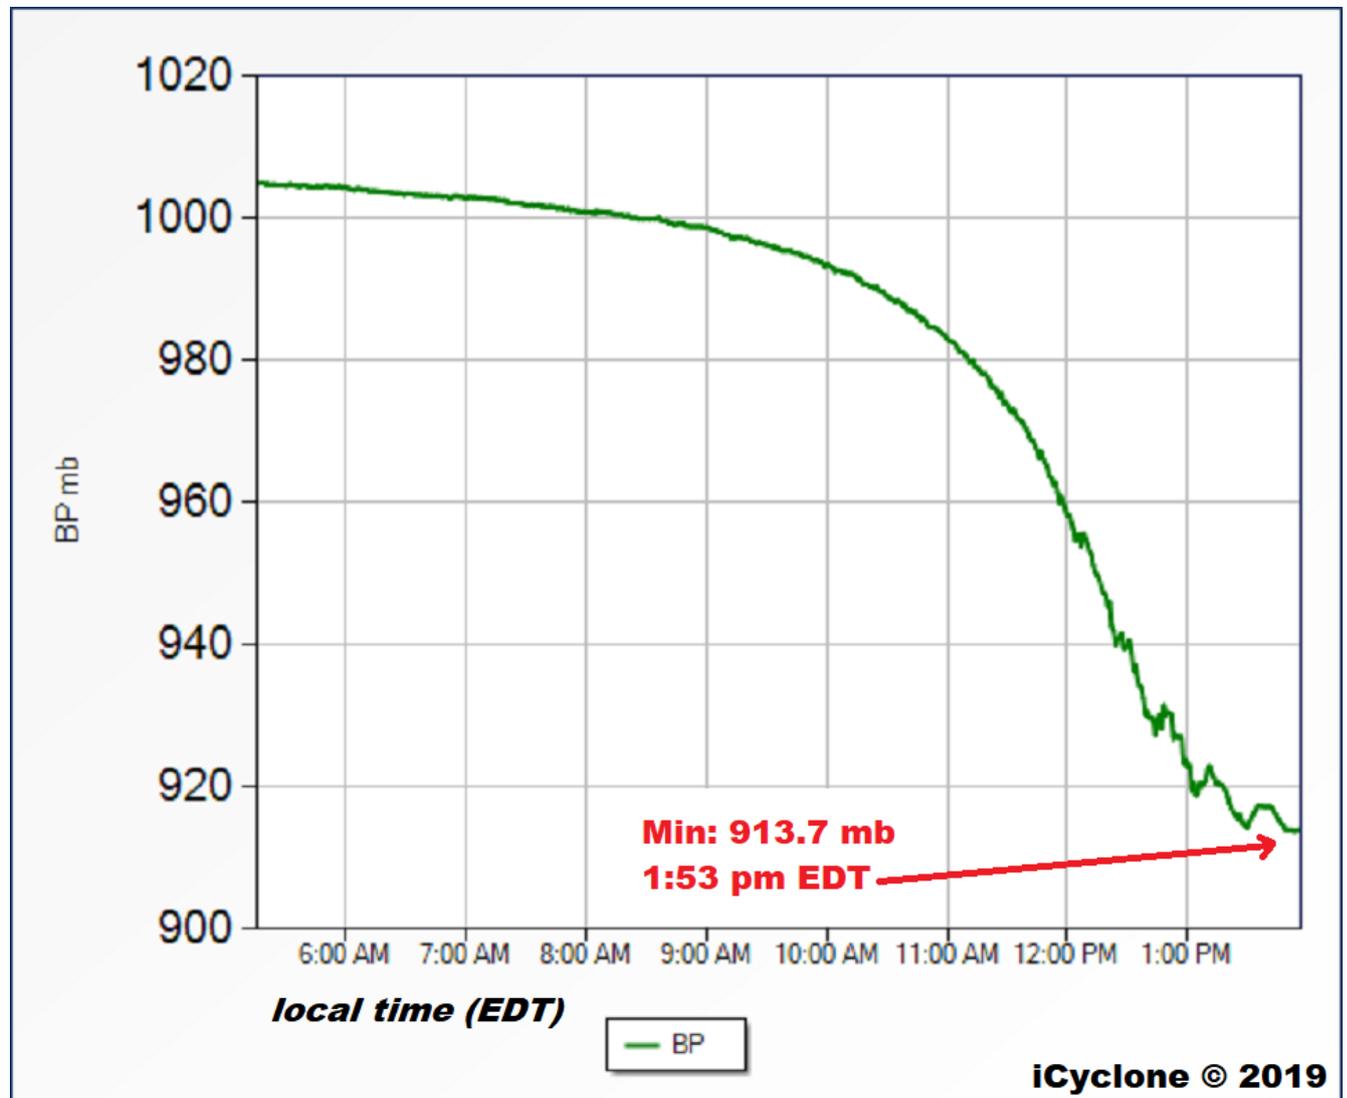
**Figure 5: Barogram—DEVICE B**

*Device B was deployed several hours before Device A, yielding a longer record. The data from Device B firmly corroborate the data from Device A, including not just the depth and timing of the minimum pressure (913.7 mb at 1:53 pm EDT), but also the inner-core fluctuations: the dips and spikes in this trace closely mirror the dips and spikes in the Device A trace.*

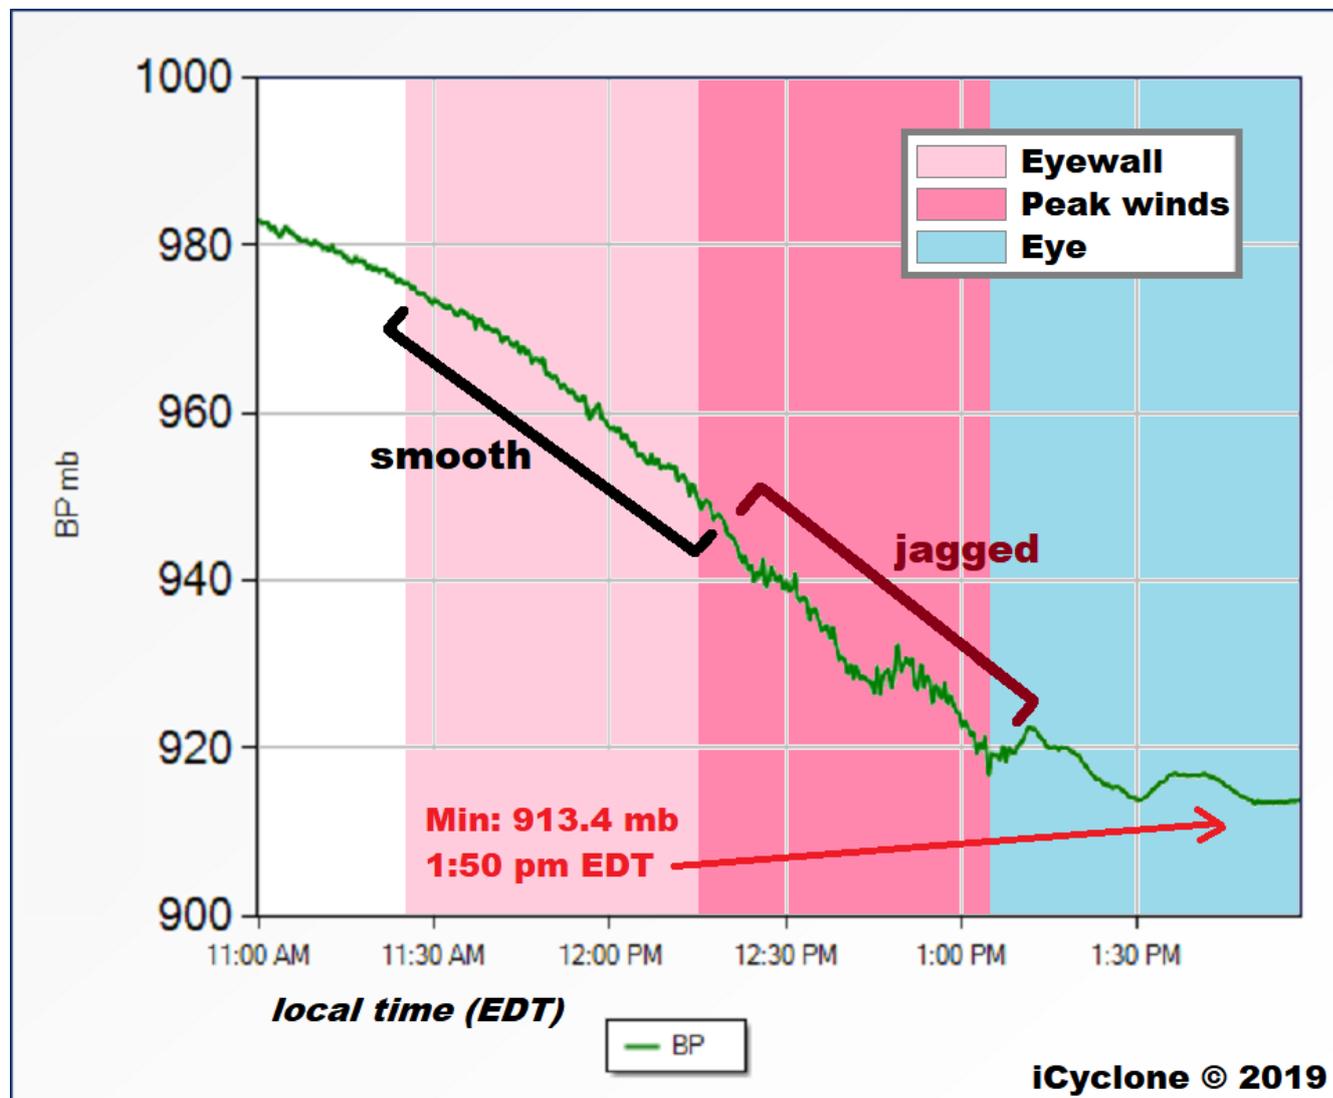
**Figure 6: Barogram—DEVICE A (Pressure Fluctuations)**

*A close view of the hours during which the core of the hurricane passed over Marsh Harbour. Notice the air-pressure fall is relatively steady in the outer portion of the eyewall, then becomes jagged and volatile in the inner portion of the eyewall. These pressure fluctuations suggest embedded eyewall mesovortices. (The time period is just under 3 hours—from 11 am to almost 2 pm EDT.)*

**Fig 6: Barogram—DEVICE A (Pressure Fluctuations)** is a close view of the data recorded by **Device A** during the passage of the cyclone's intense core, highlighting both the **smooth** pressure drop in the outer portion of the eyewall and the **jagged** drop in the inner portion.

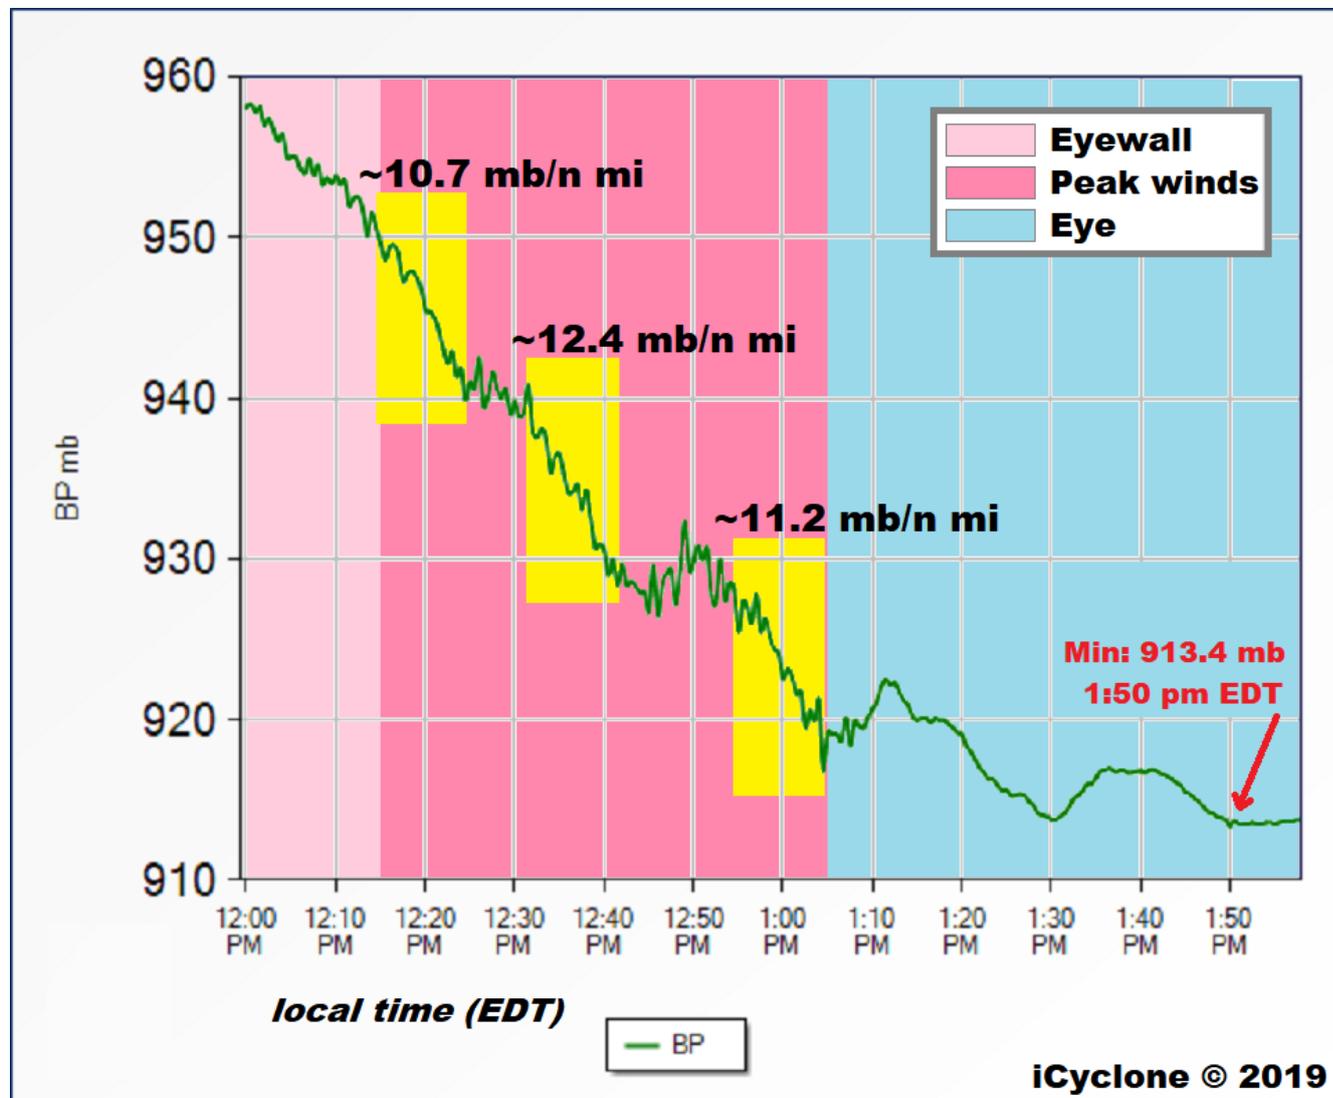
Figure 7: Barogram—DEVICE A (Peak Gradients)

A close view of the final 2 hours of data (from 12 noon to almost 2 pm EDT), during which time the violent inner core of the hurricane passed over the observation point. Notice the peak gradients (**yellow**) were all measured inside the inner portion of the eyewall (**deep pink**).

**Fig 7: Barogram—DEVICE A (Peak Gradients)** is a zoomed-in view of the data **Device A** collected in the inner portion of the cyclone’s eyewall, with the passage of these peak gradients indicated in **yellow**.

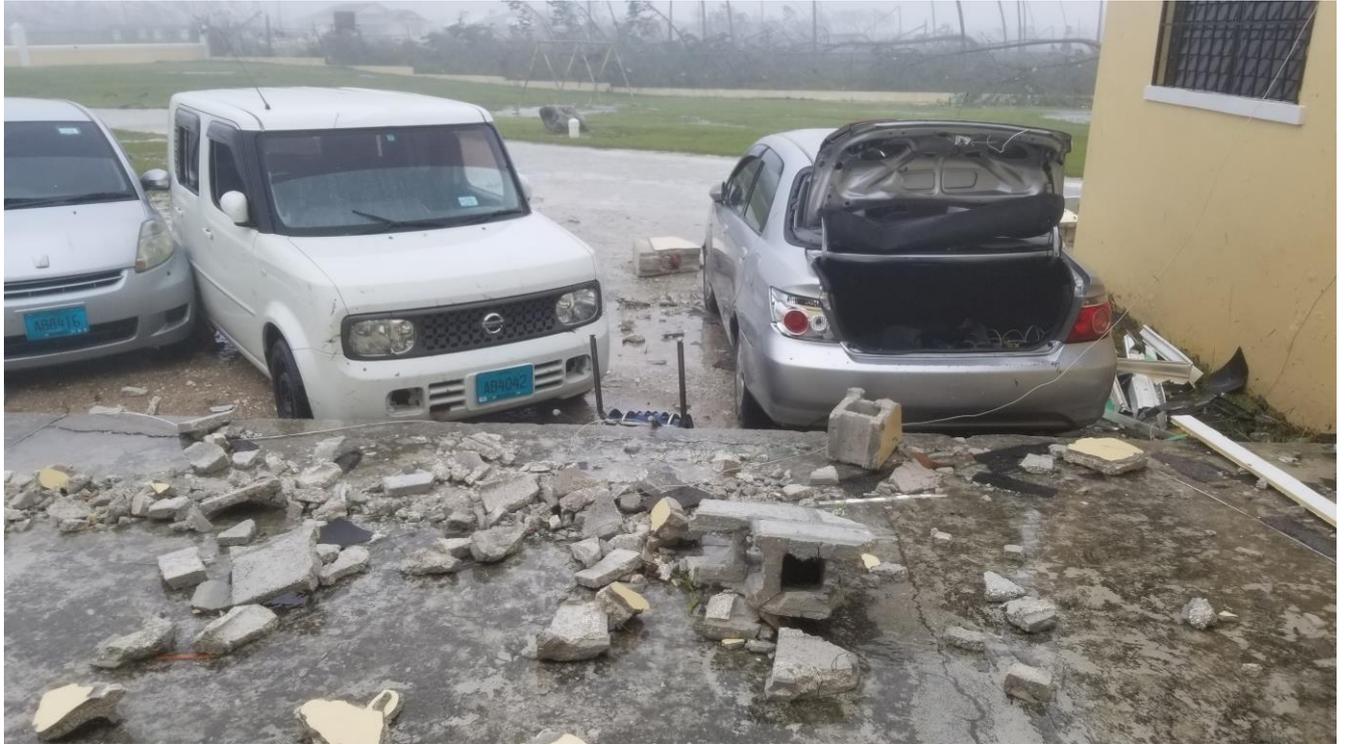
*The author's first sight when he stepped outside into the eye of Hurricane DORIAN: cars jumbled together and smashed concrete littering the ground. Concrete portions of the Great Abaco Primary School mostly withstood Hurricane DORIAN's winds—but not completely.*

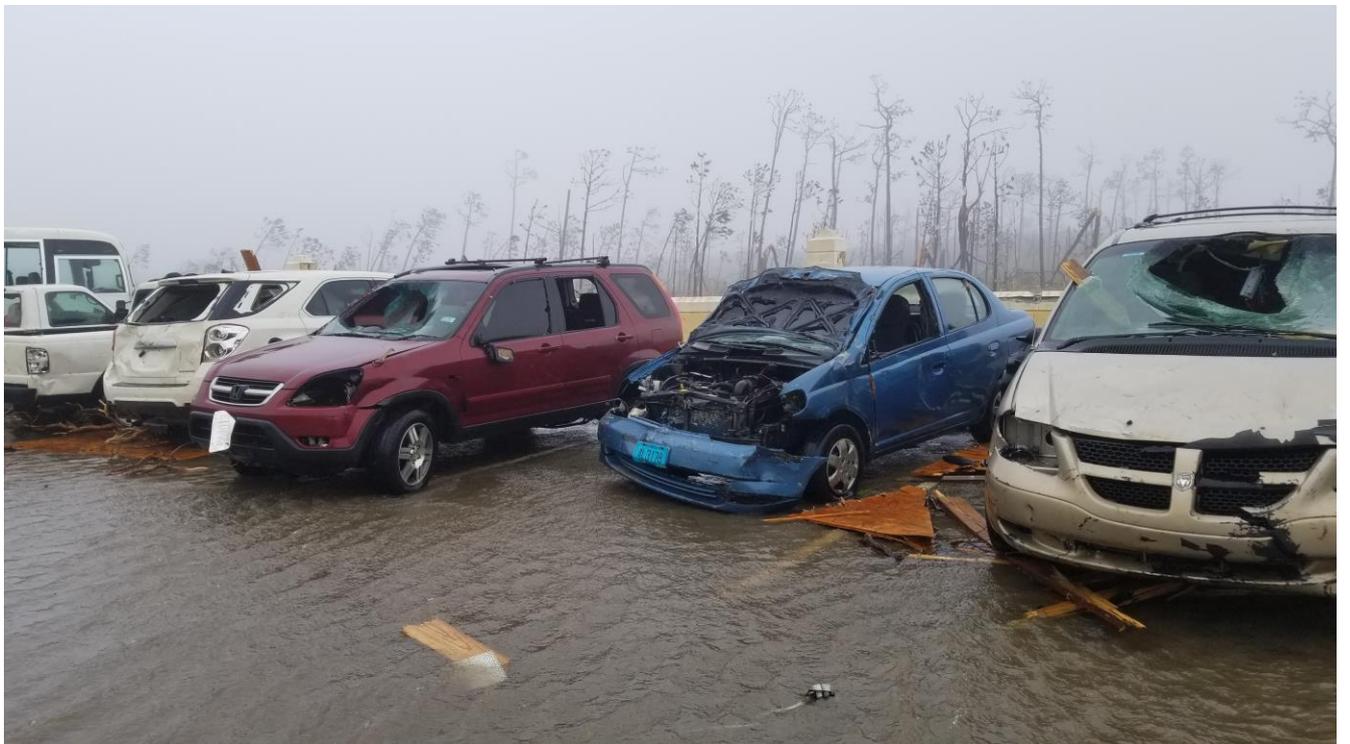
*In the eye Hurricane DORIAN. Cars were mutilated by the violent winds just minutes before.*

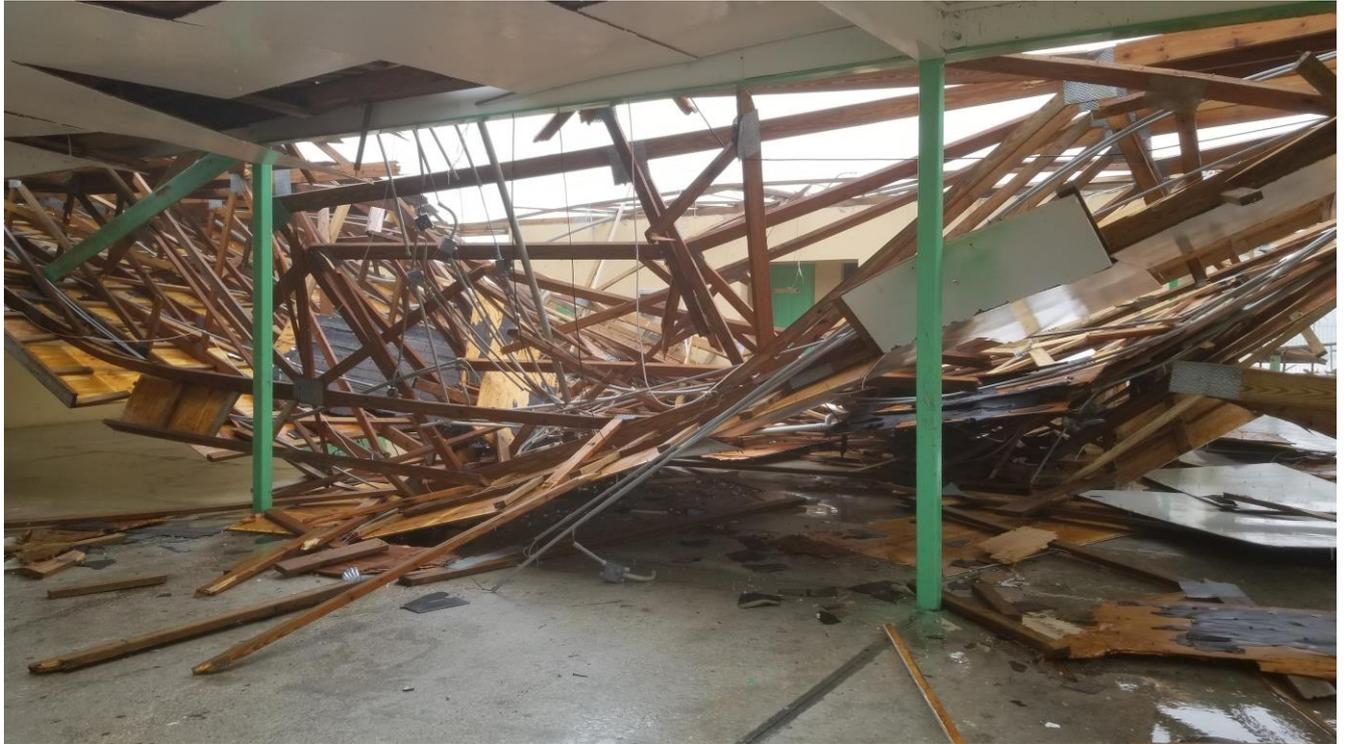
***Much of the Great Abaco Primary School is concrete—but not all of it. Wooden portions of the complex were no match for DORIAN’s winds.***

The winds so badly damaged the Great Abaco Primary School—a designated shelter, made of concrete, but with wood features—that its frightened occupants needed to relocate to the nearby Bahamas Government Complex during the calm of the eye.

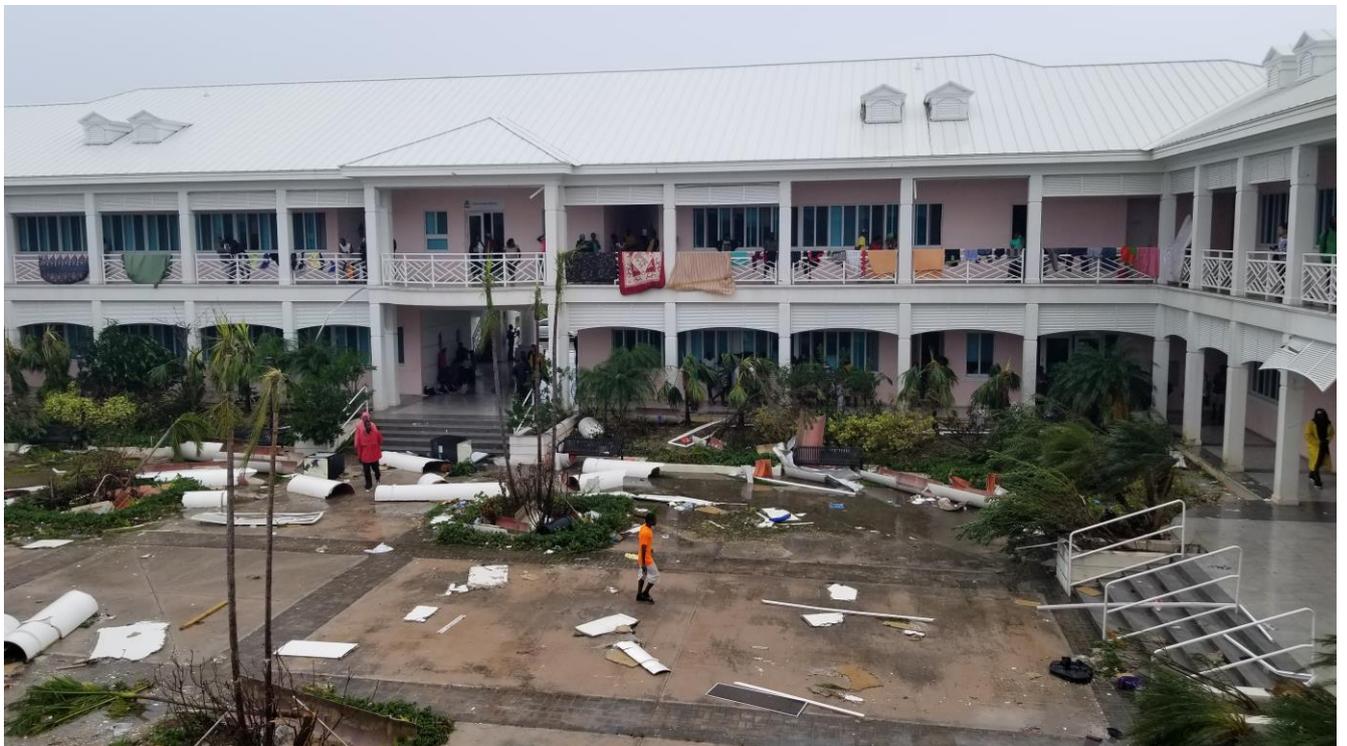
***The Bahamas Government Complex, days after the hurricane. While there was extensive cosmetic damage, the structure performed well—withstanding the hurricane’s tremendous winds and protecting the hundreds who sought shelter inside.***

Construction quality mattered. The Government Complex and nearby medical clinic **performed well**. While there was cosmetic damage—including stripped decorative columns and panels torn out of the exterior porticos—the structures withstood the winds: the roofs stayed on, the walls stayed up, and (as far as the author could tell) the impact-glass windows withstood the incredible assault of flying debris.

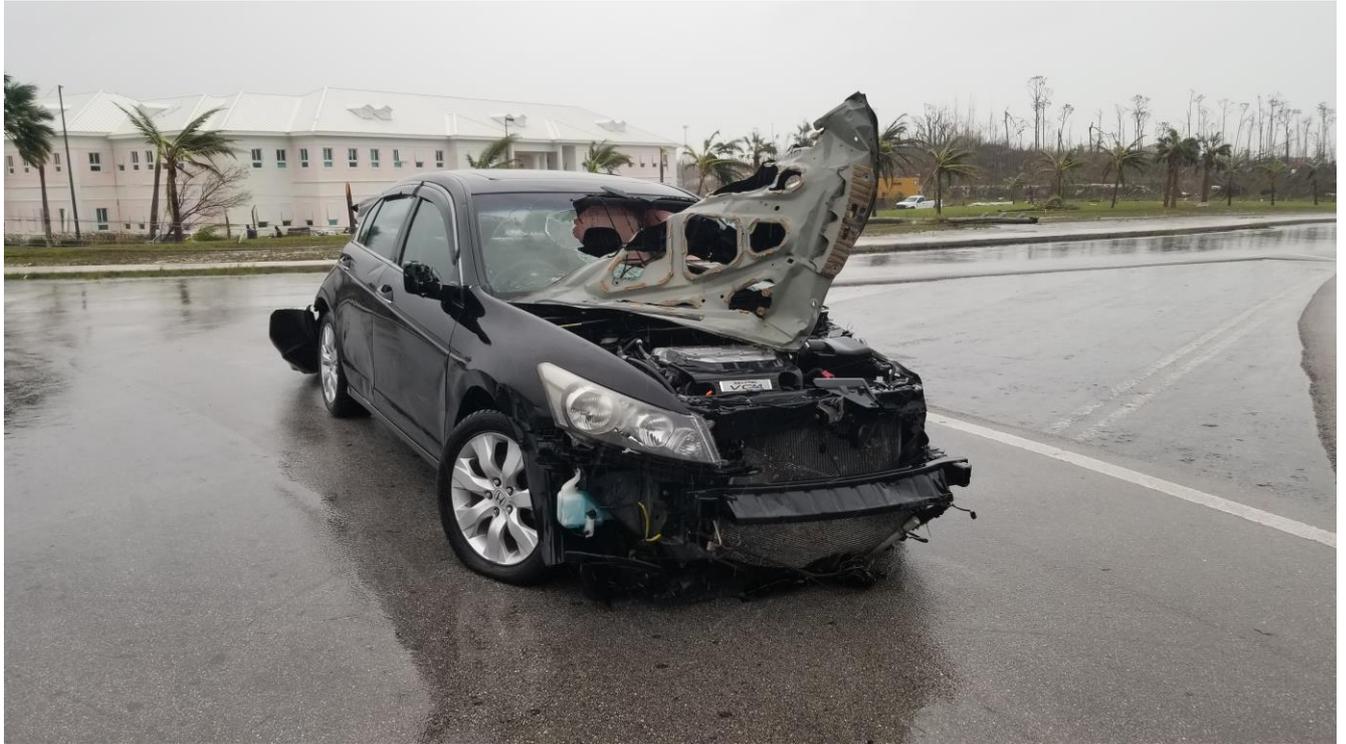
***Cars all over Marsh Harbour were thrown around and literally mutilated by the hurricane's powerful winds. Note the Bahamas Government Complex in the background: this apparently well-built structure withstood the storm.***

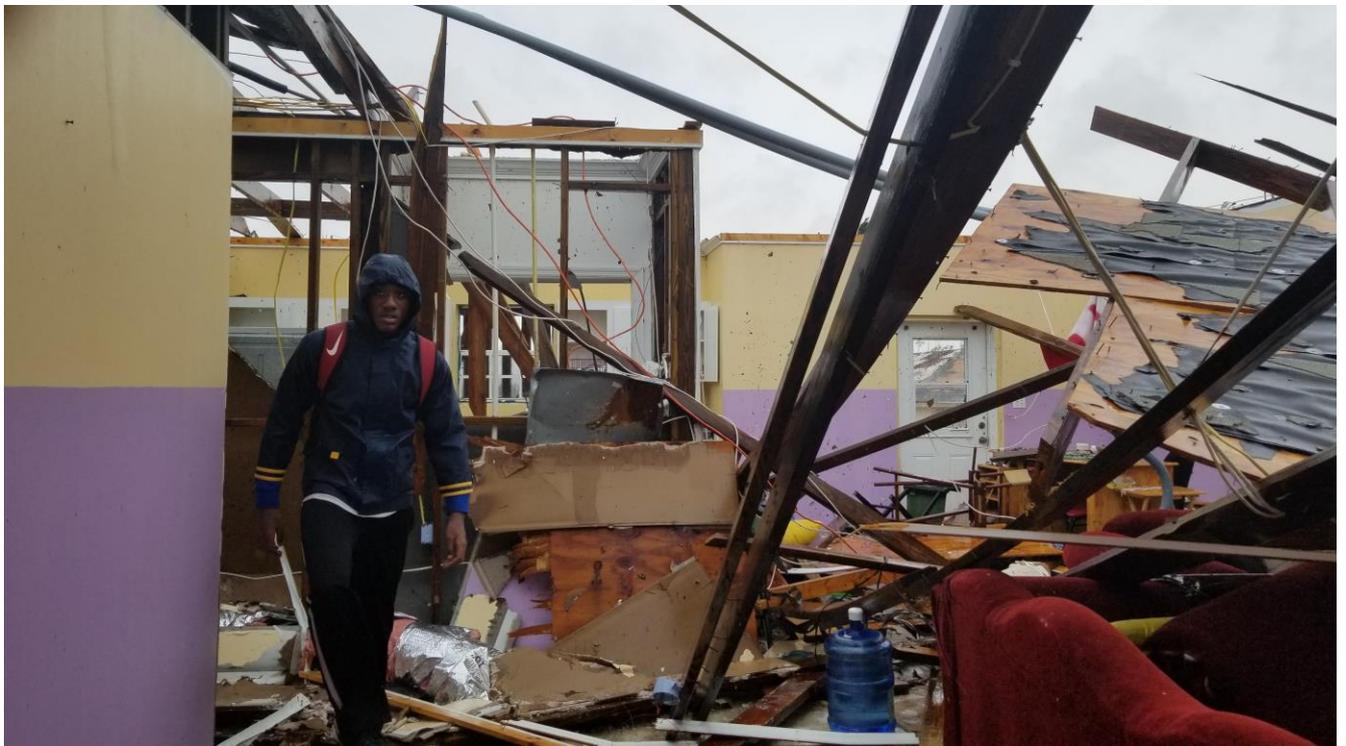
***A resident of the Central Pines subdivision salvages belongings from his destroyed home. Well above the storm surge, this neighborhood of Marsh Harbour suffered extreme wind damage.***

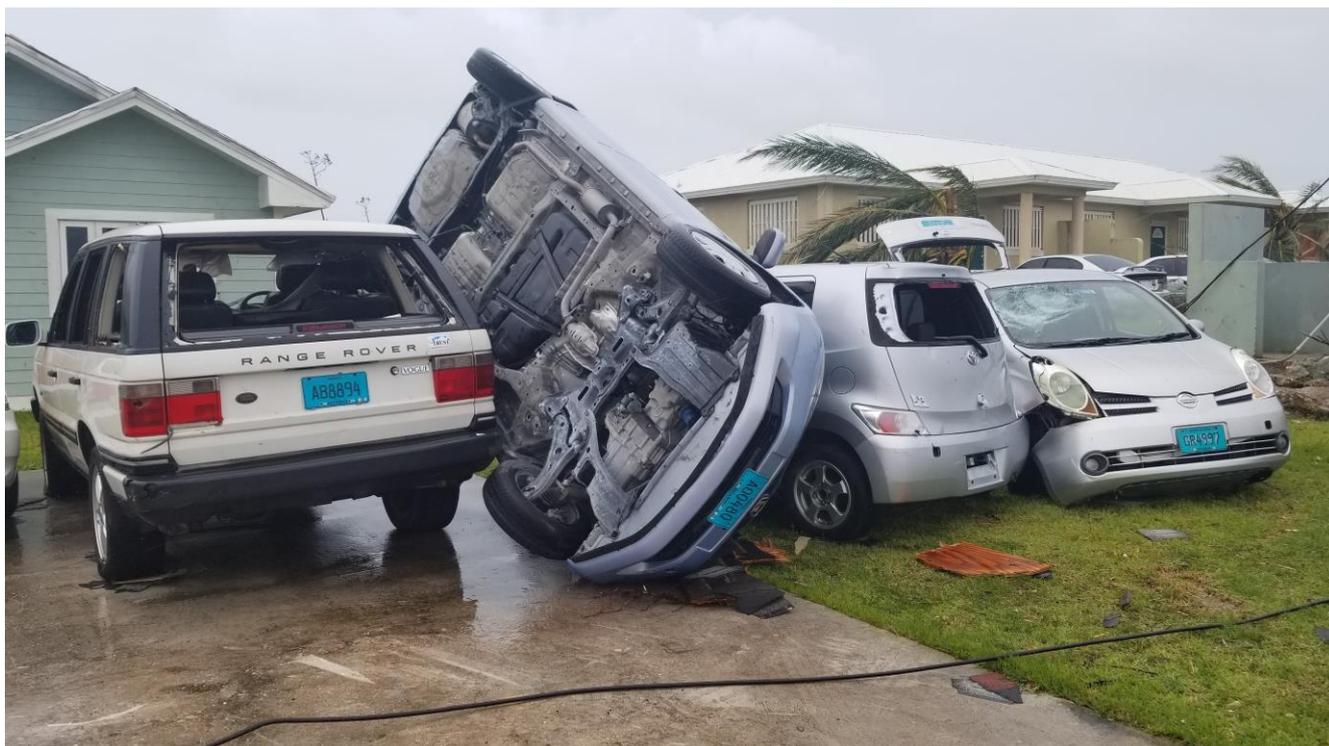
***Hurricane DORIAN's winds tossed cars in the Central Pines neighborhood like toys.***

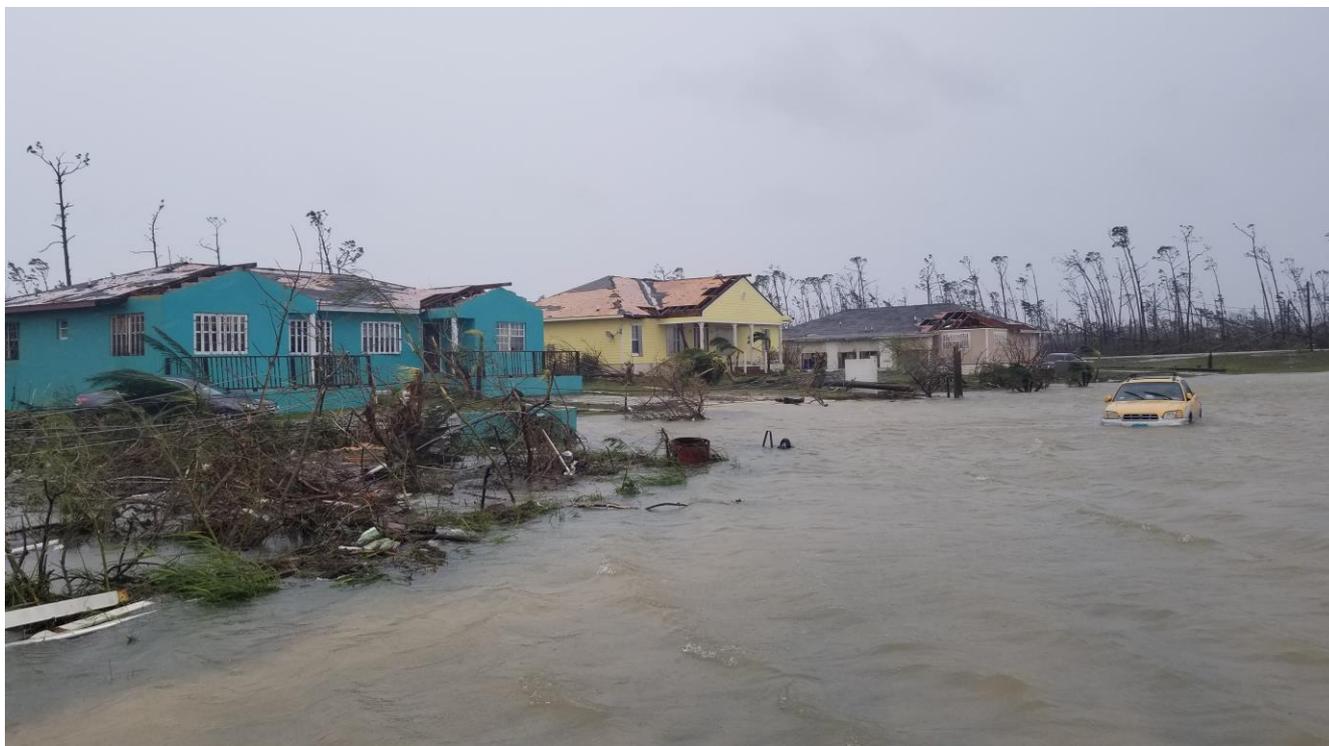
***These well-built homes in the Central Pines neighborhood mostly withstood the winds, although they took a beating.***

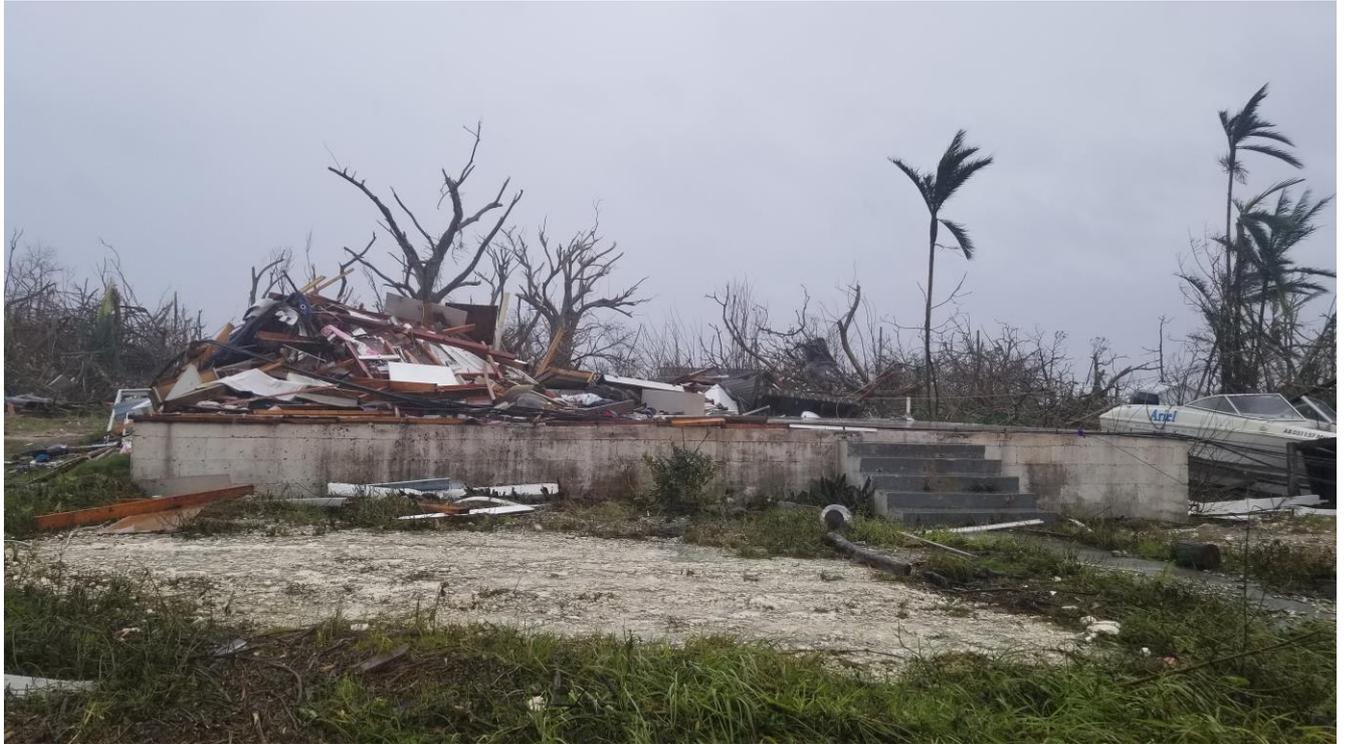
*A home completely destroyed by Hurricane DORIAN's winds.*

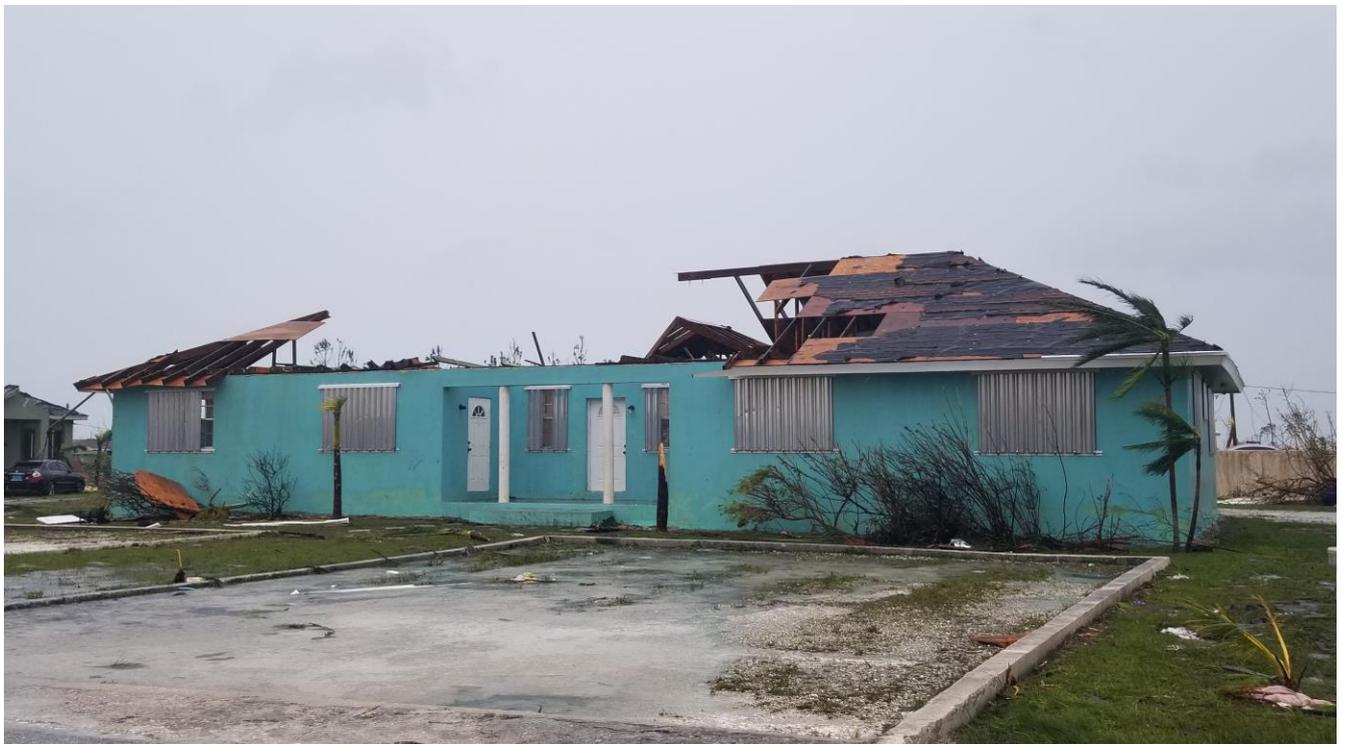
*Many houses in Marsh Harbour suffered extreme wind damage in DORIAN. Sights like this were common.*

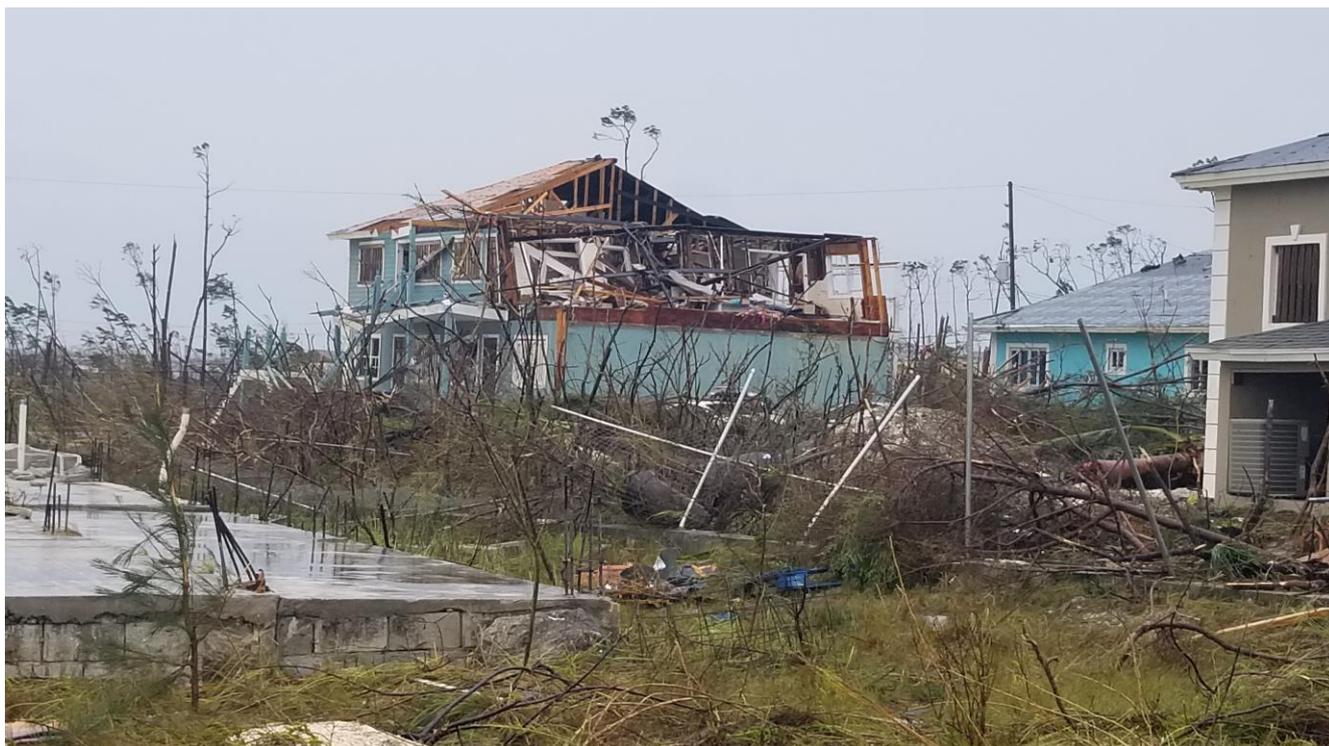
*Heavy wind damage to the second floor of a house.*

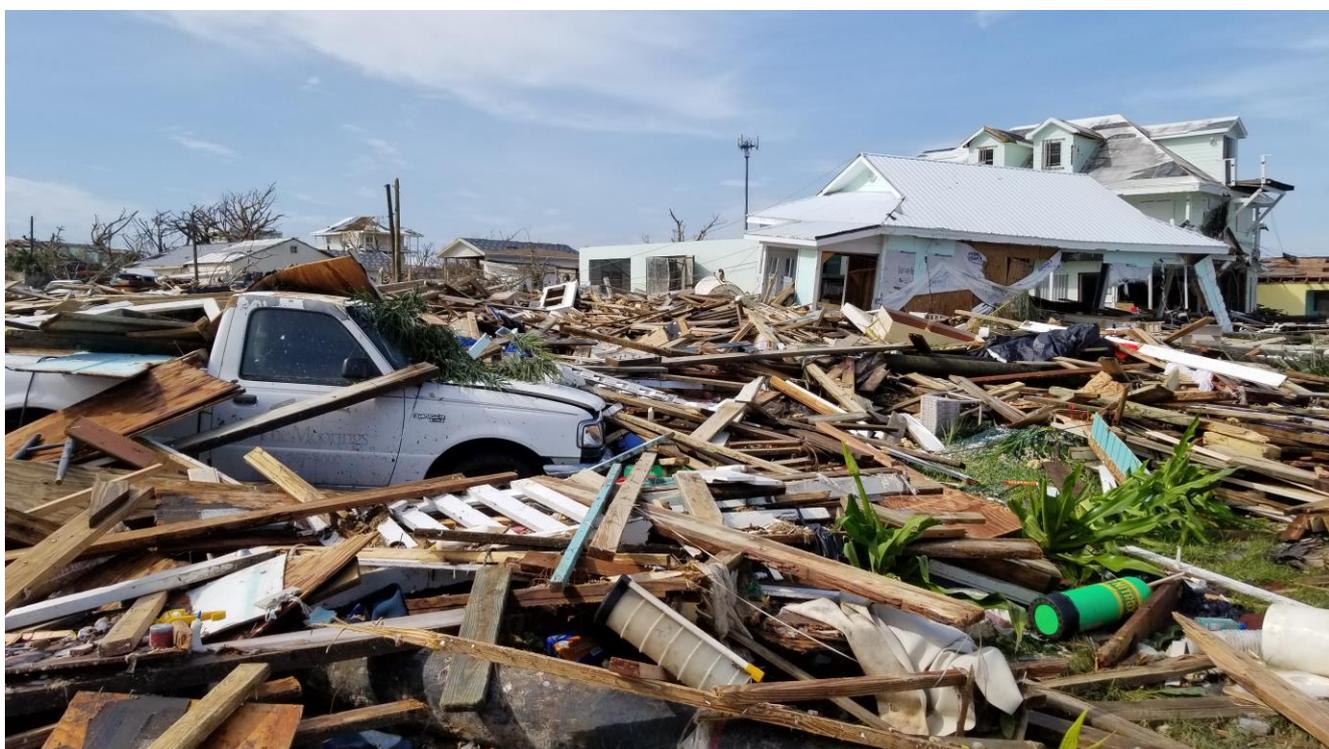
*The commercial heart of Marsh Harbour was flattened by storm surge and winds.*

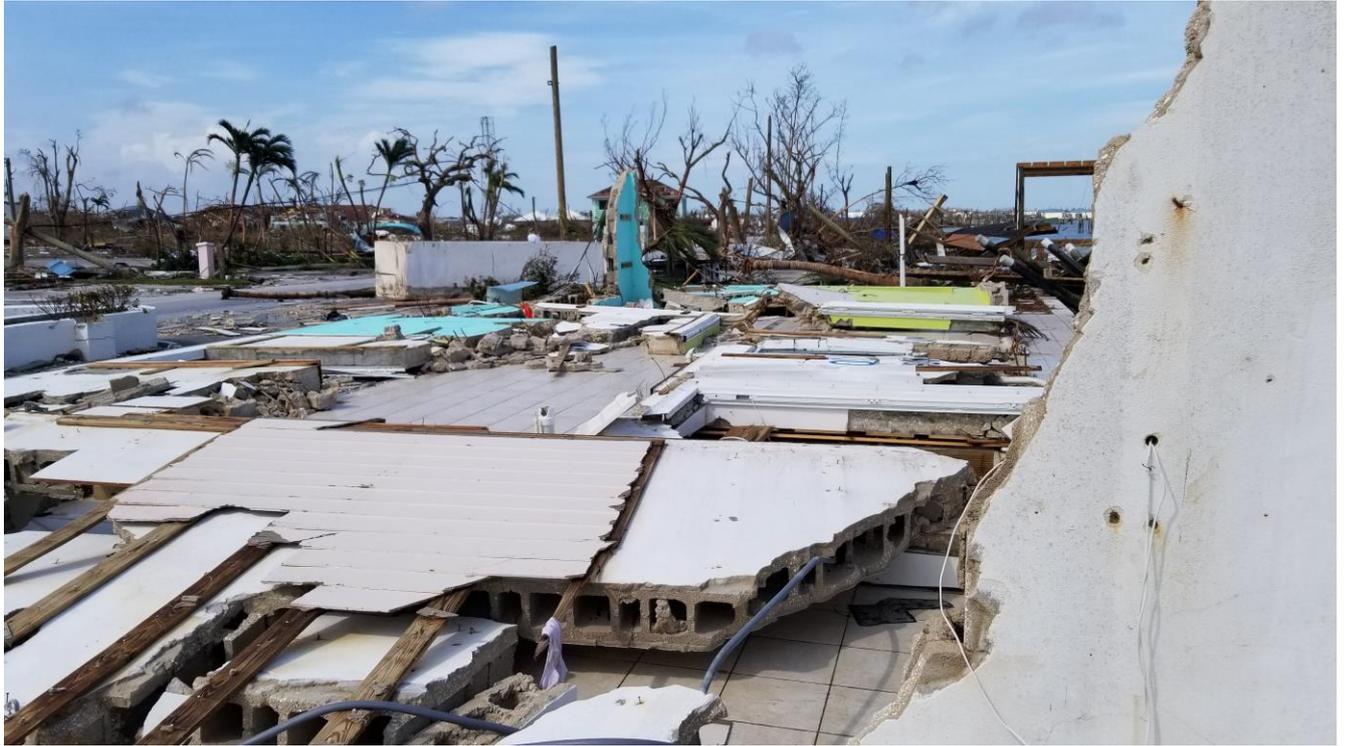
***Concrete-block buildings in Marsh Harbour's waterfront commercial district were flattened by Hurricane DORIAN's mighty storm surge.***

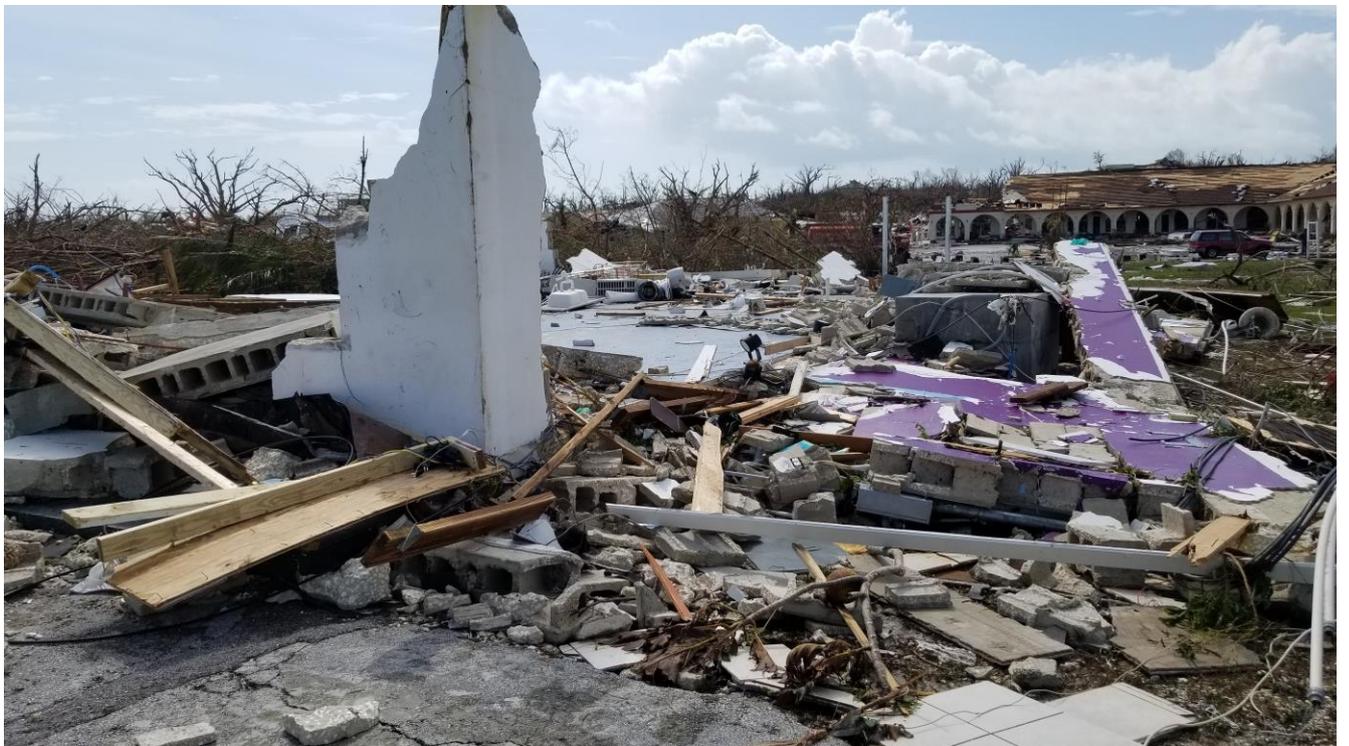
***In Marsh Harbour's waterfront commercial district, DORIAN's storm surge acted like a mighty bulldozer, mowing down buildings and leaving heaps of rubble.***
