# iCYCLONE CHASE REPORT

<b>storm</b>	<b>Hurricane DORIAN</b>		
<b>location</b>	Marsh Harbour, Great Abaco Island, Bahamas		
<b>date</b>	01 September 2019		
<b>chasers</b>	Josh Morgerman	<b>author</b>	Josh Morgerman

**Hurricane DORIAN** was an extremely intense, Category-5 hurricane that made a direct hit on Great Abaco Island in the Bahamas on 01 September 2019.

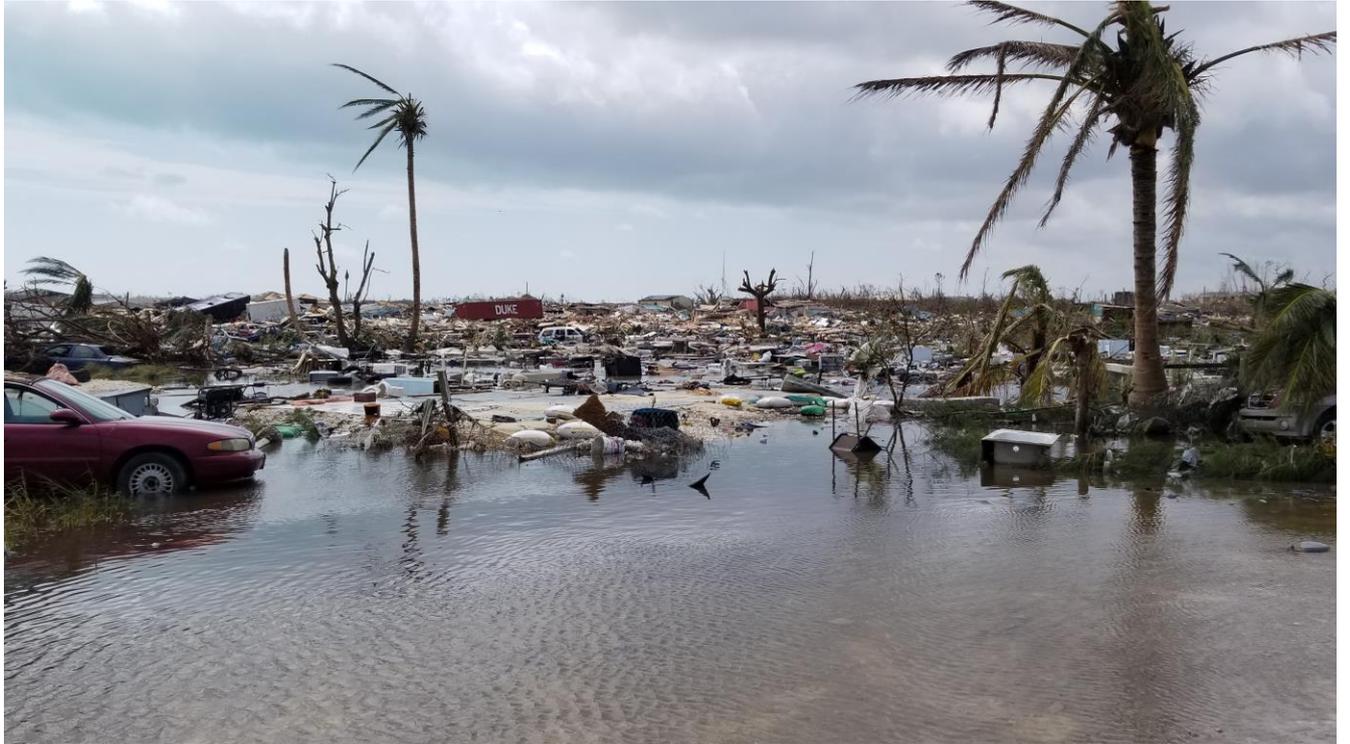
*The Mudd—a poorer, low-lying neighborhood of Marsh Harbour—was flattened by a tremendous, tsunami-like storm surge. All that was left in its wake was a vast field of rubble.*

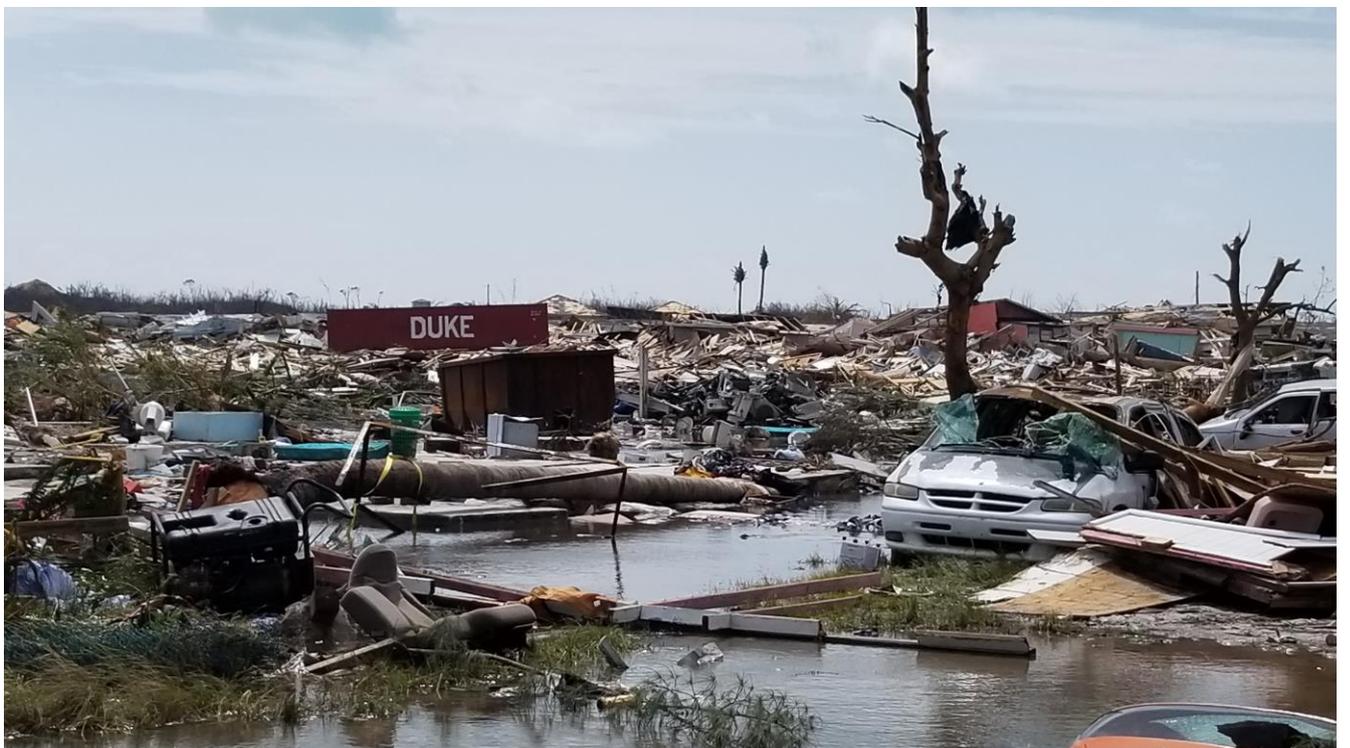
*Another view of the complete destruction in The Mudd neighborhood of Marsh Harbour.*

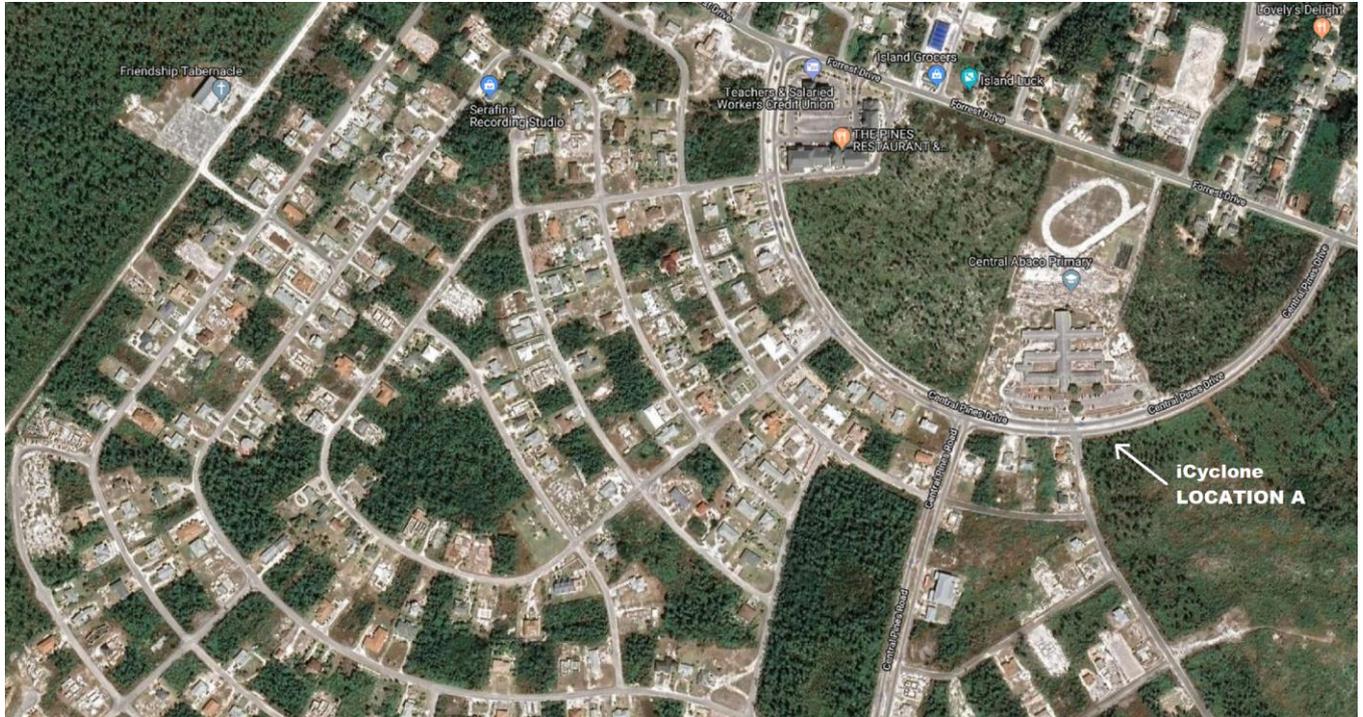
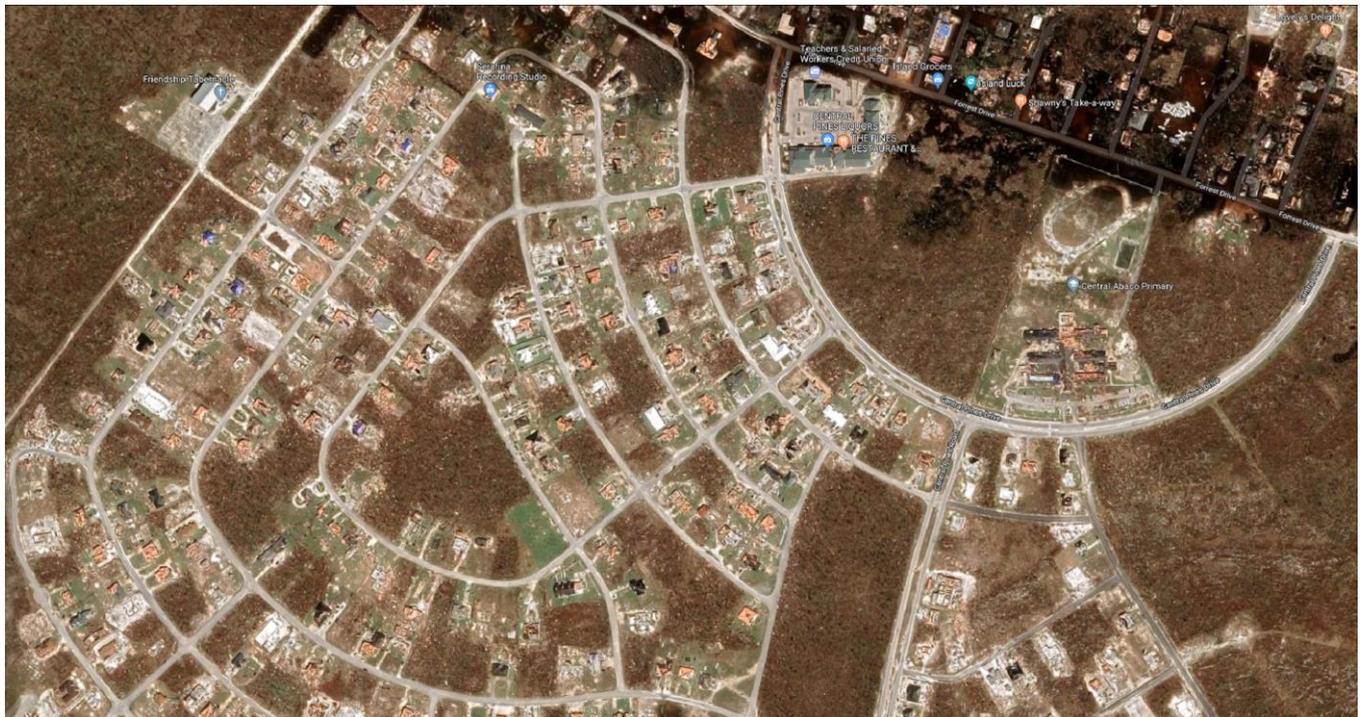
**Central Pines & Primary School: AFTER**

The Central Pines subdivision is on the left; the Great Abaco Primary School (**Location A**, where the author rode out the front side of the hurricane) is in the upper-right. This part of town is well above sea-level, so the destruction shown here is entirely wind damage.

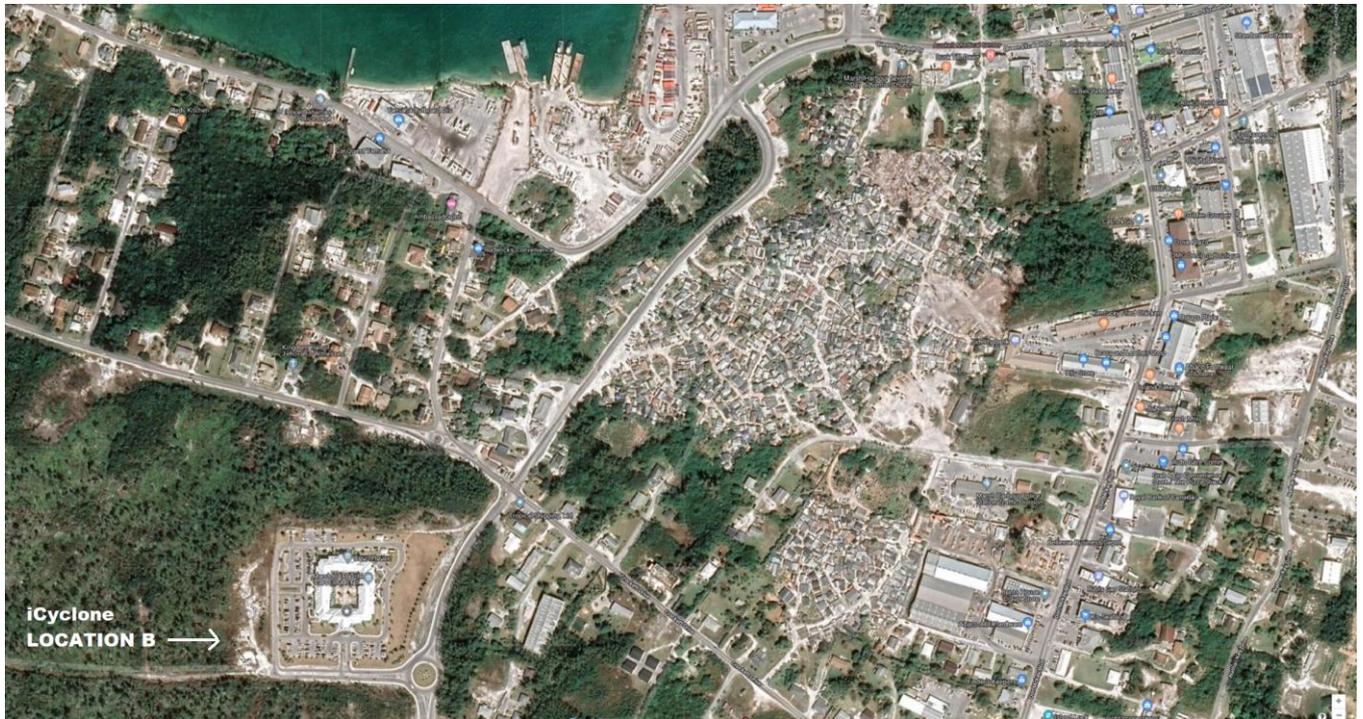
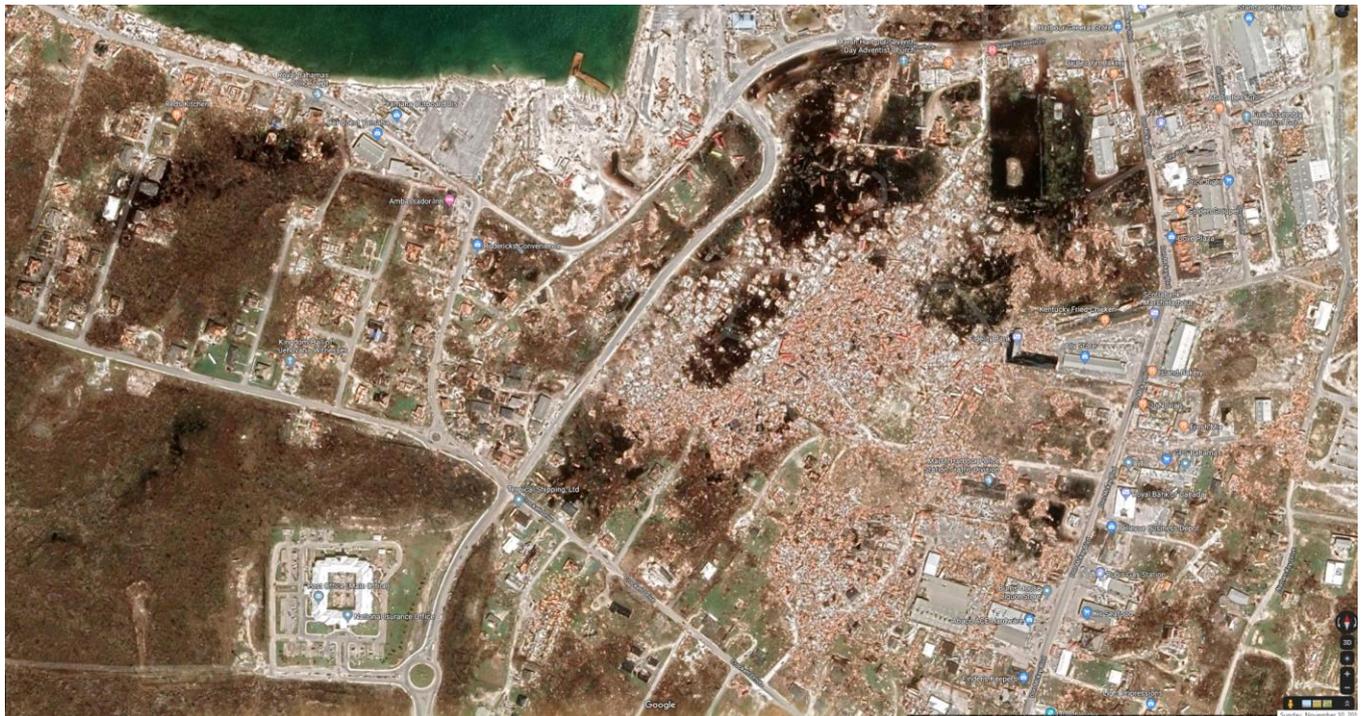
**Government Complex & Mudd: AFTER**

The Bahamas Government Complex (**Location B**, where the author moved to during the eye) is in the lower-left. A strong building on a hill high above sea-level, it survived the storm. The Mudd and Pigeon Peas are the densely-built areas just right of the image's center. These neighborhoods—low-lying and consisting of mostly substandard construction—were completely swept away by the storm surge.
