# iCYCLONE CHASE REPORT

storm	Hurricane LISA		
location	Belize City, Belize		
date	02 November 2022		
chasers	Josh Morgerman	author	Josh Morgerman

Hurricane LISA was a late-season Category-1 hurricane that struck the Caribbean nation of Belize on the afternoon of 02 November 2022.

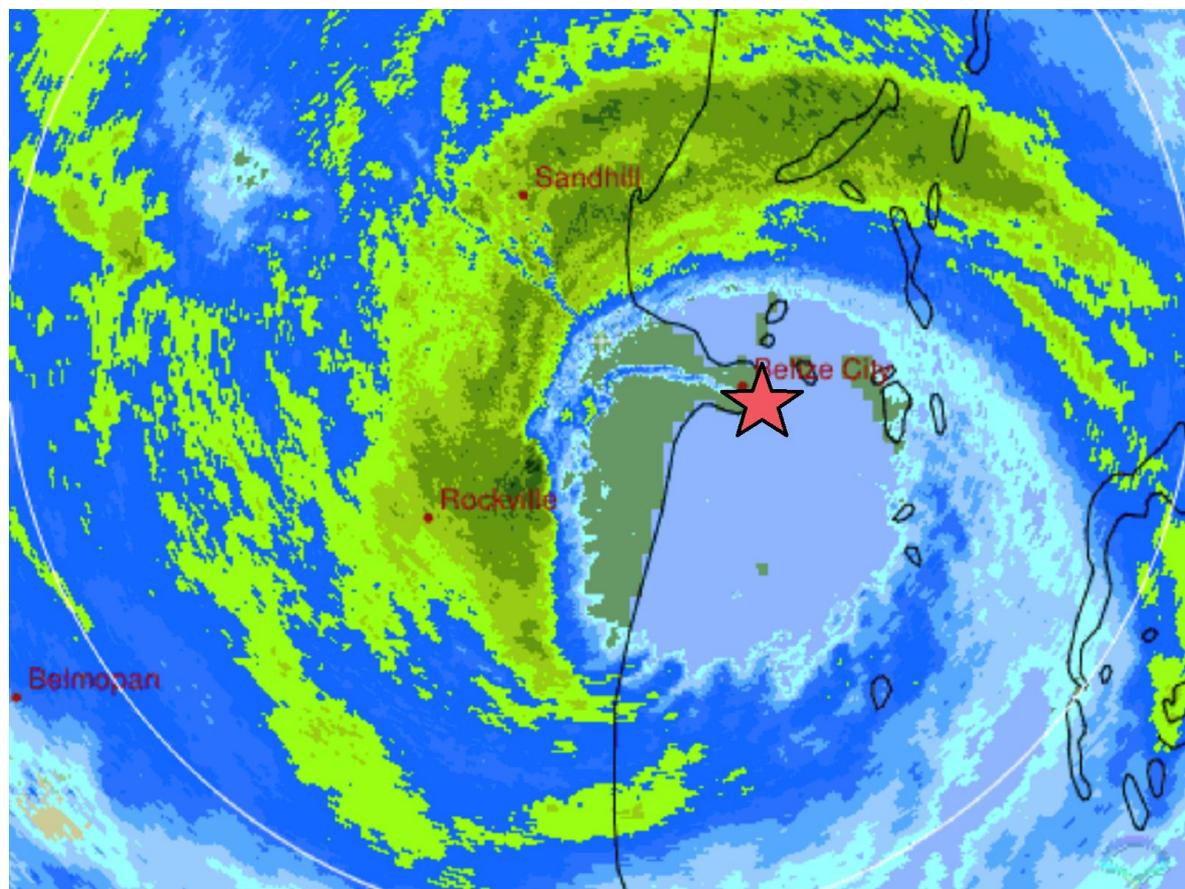
*Radar shot showing the eye of Hurricane LISA passing over Belize City, Belize. The red star indicates the author's location. (Image: Belize National Meteorological Service)*

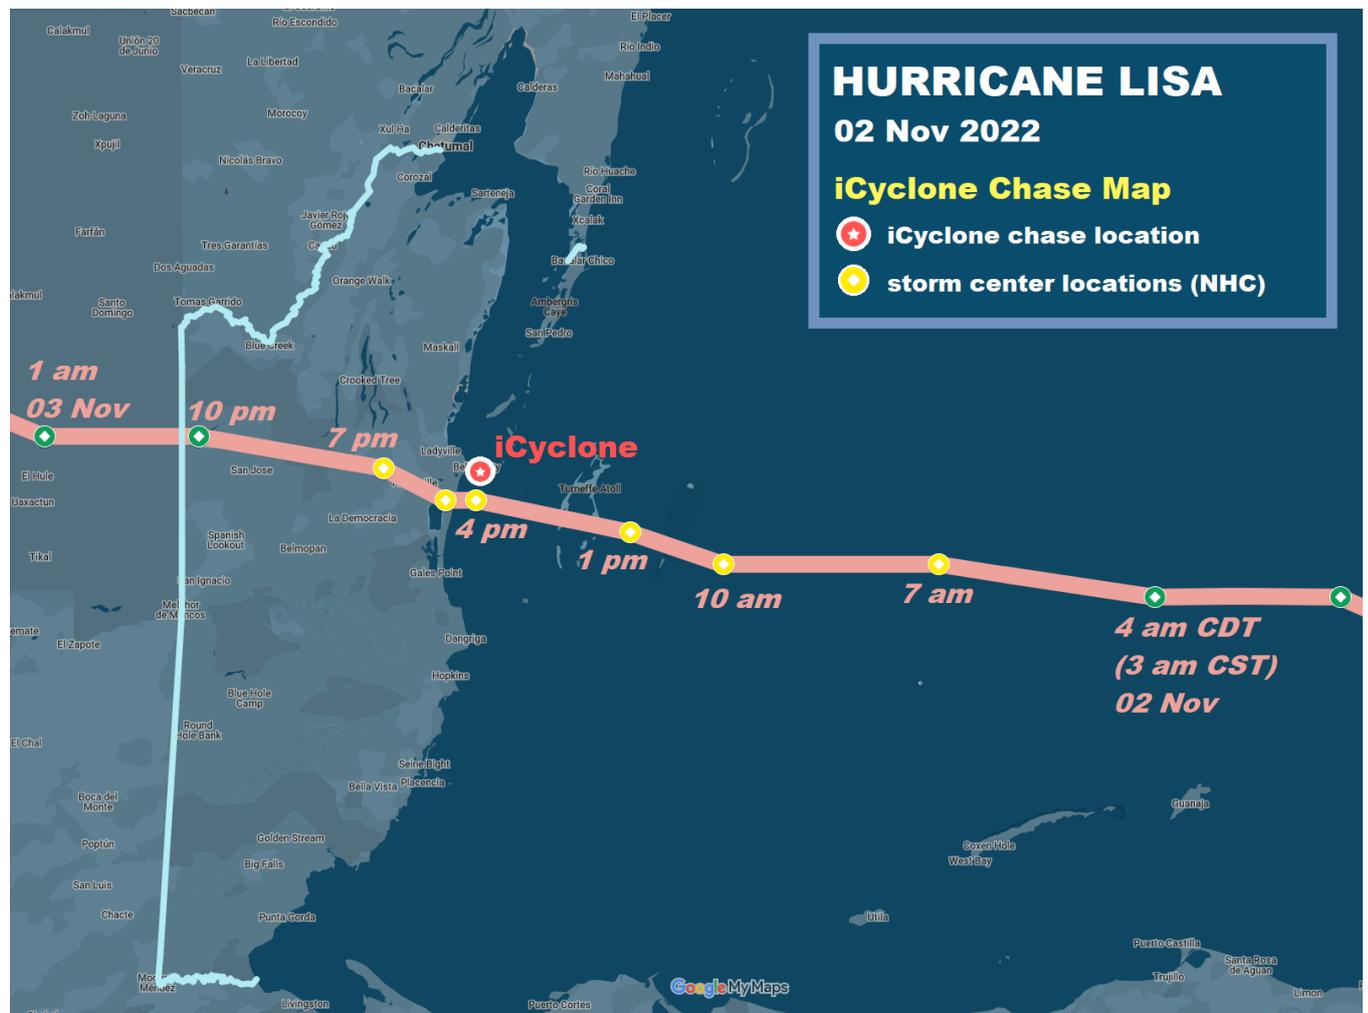
**Figure 1: Chase Map**

**Figure 1** shows the chase location (red star) in relation to **LISA's center** (yellow points), per NHC advisory positions. (**Figure 2** is a closer view.)

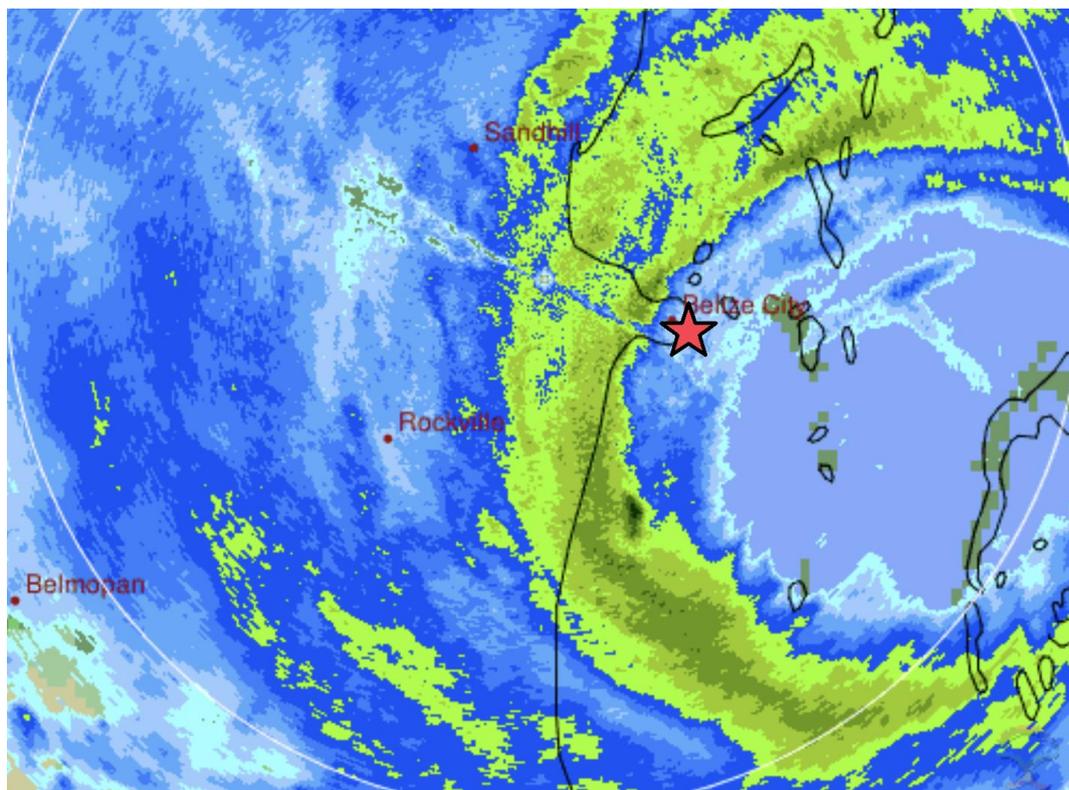
### **Figure 3: Hurricane’s Inner Eyewall Clearing Belize City**

Conditions gradually deteriorated from there, with the apparent peak winds and heaviest rain occurring from **~2:00 to 2:10 pm**. A radar image from around this time suggests these peak winds coincided with the inner edge of the hurricane’s eyewall. (See **Figure 3**.)

*This radar shot shows LISA’s inner eyewall just clearing Belize City (red star) at 2:08 pm CST 02 Nov 2022. The author noted the apparent peak winds occurred in the city at about this time. (Image: Belize National Meteorological Service)*

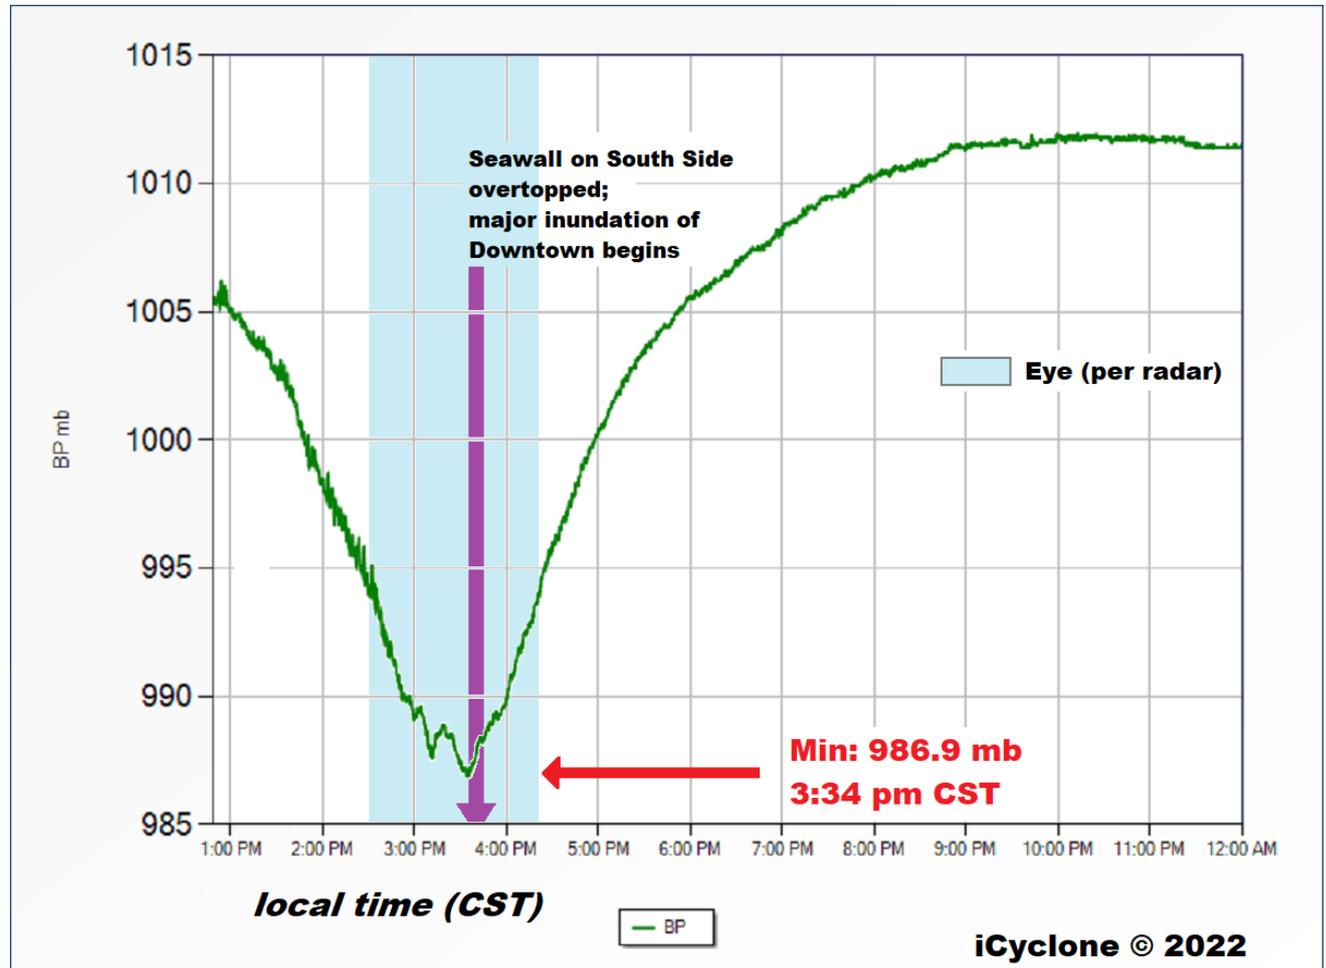
**Figure 4: Barogram—Device A**

The air-pressure trace for Device A. The minimum value of 986.9 mb occurred at 3:34 pm CST (2134Z), as Hurricane LISA's eye passed over Belize City. Also indicated is the approximate time the storm surge overtopped the seawall and inundated Downtown.

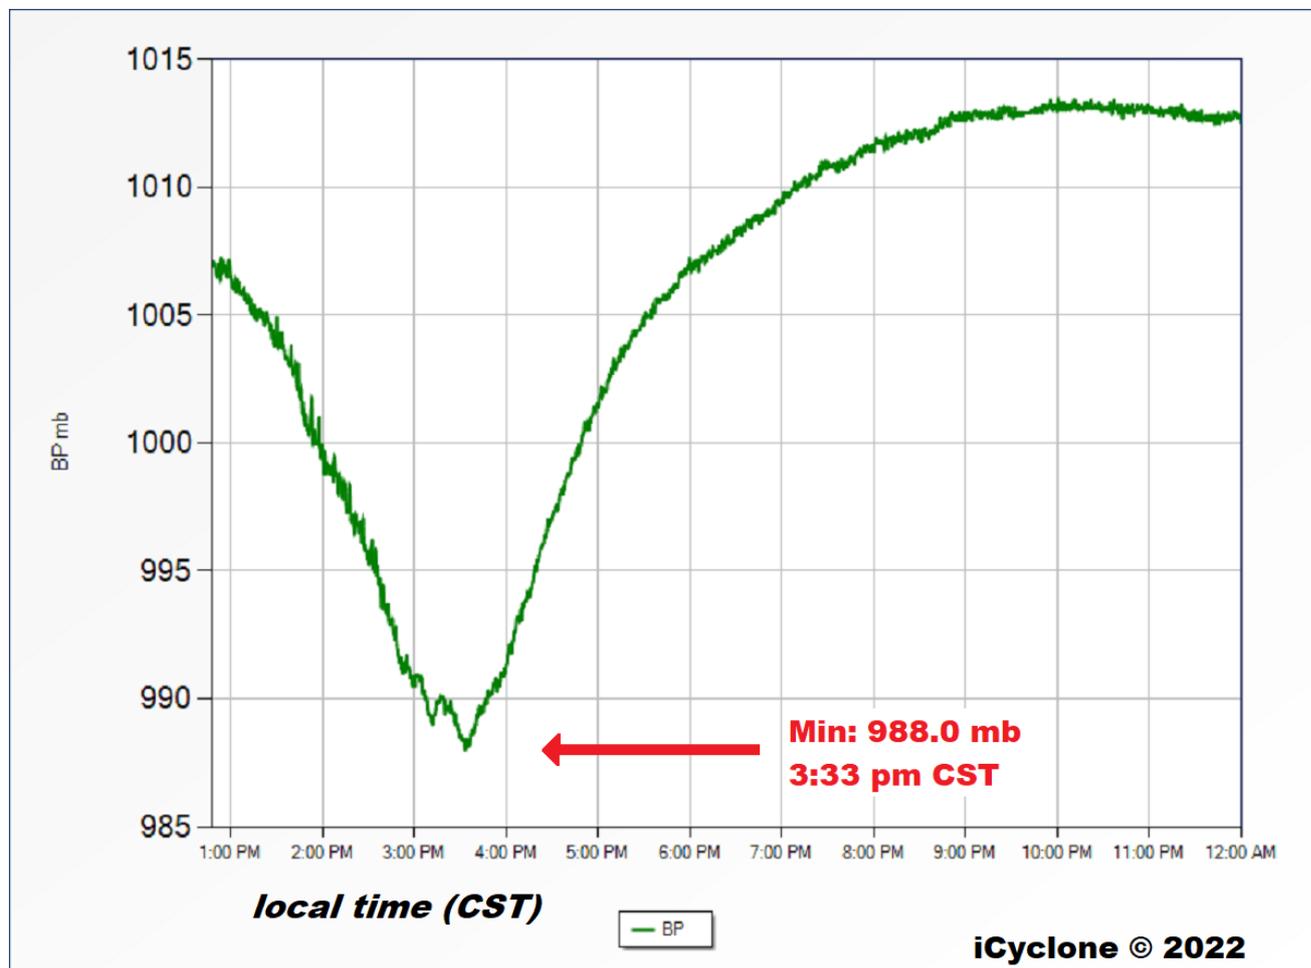
Figure 5: Barogram—Device B

The pressure trace for Device B. The minimum of 988.0 mb occurred at 3:33 pm CST (2133Z), in LISA's eye.

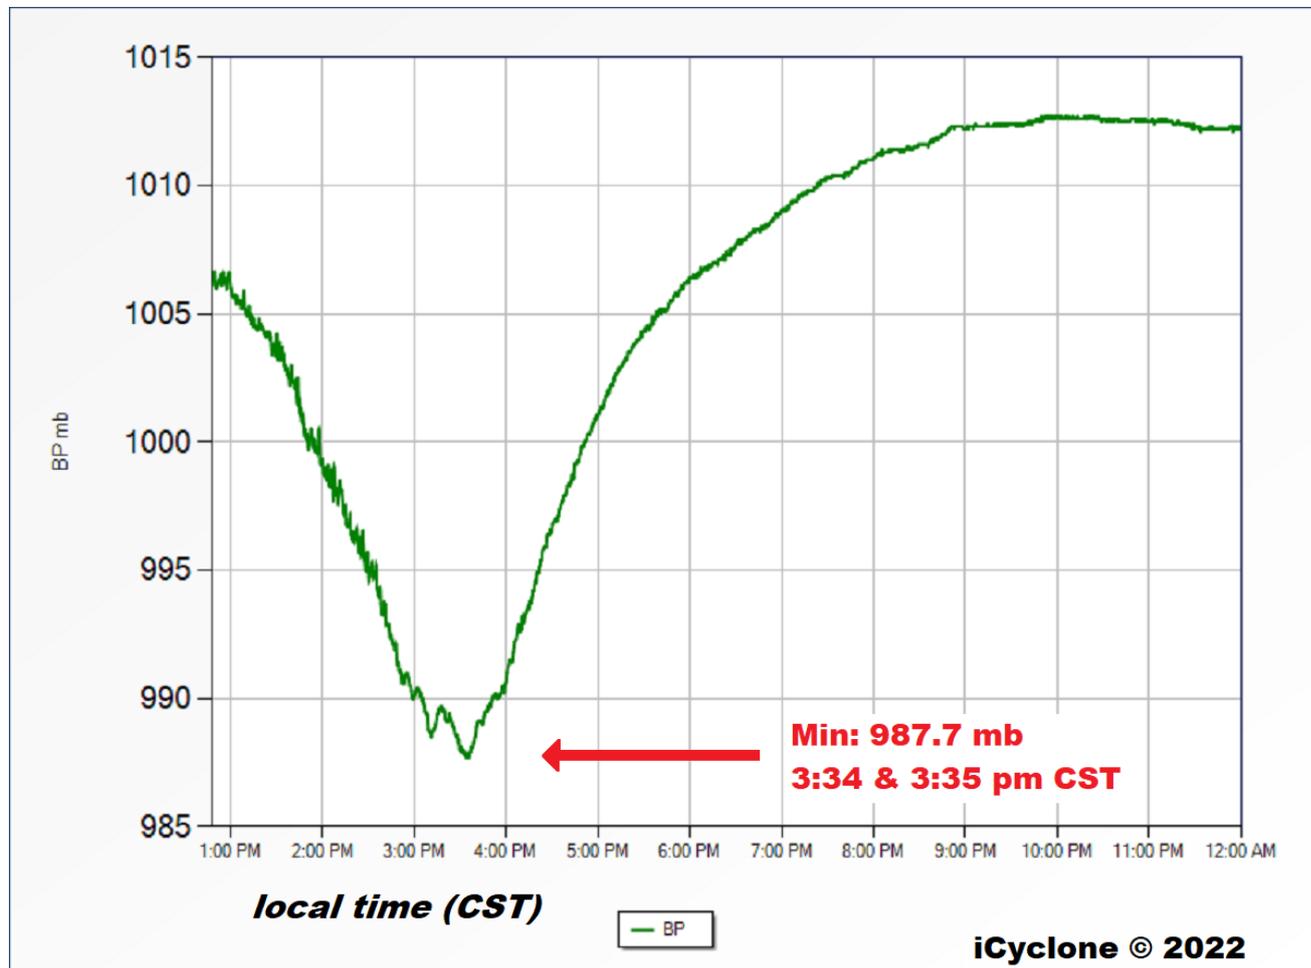
**Figure 6: Barogram—Device C**

The pressure trace for Device C. The minimum of 987.7 mb occurred at 3:34 and 3:35 pm CST (2134Z and 2135Z), in LISA's eye.

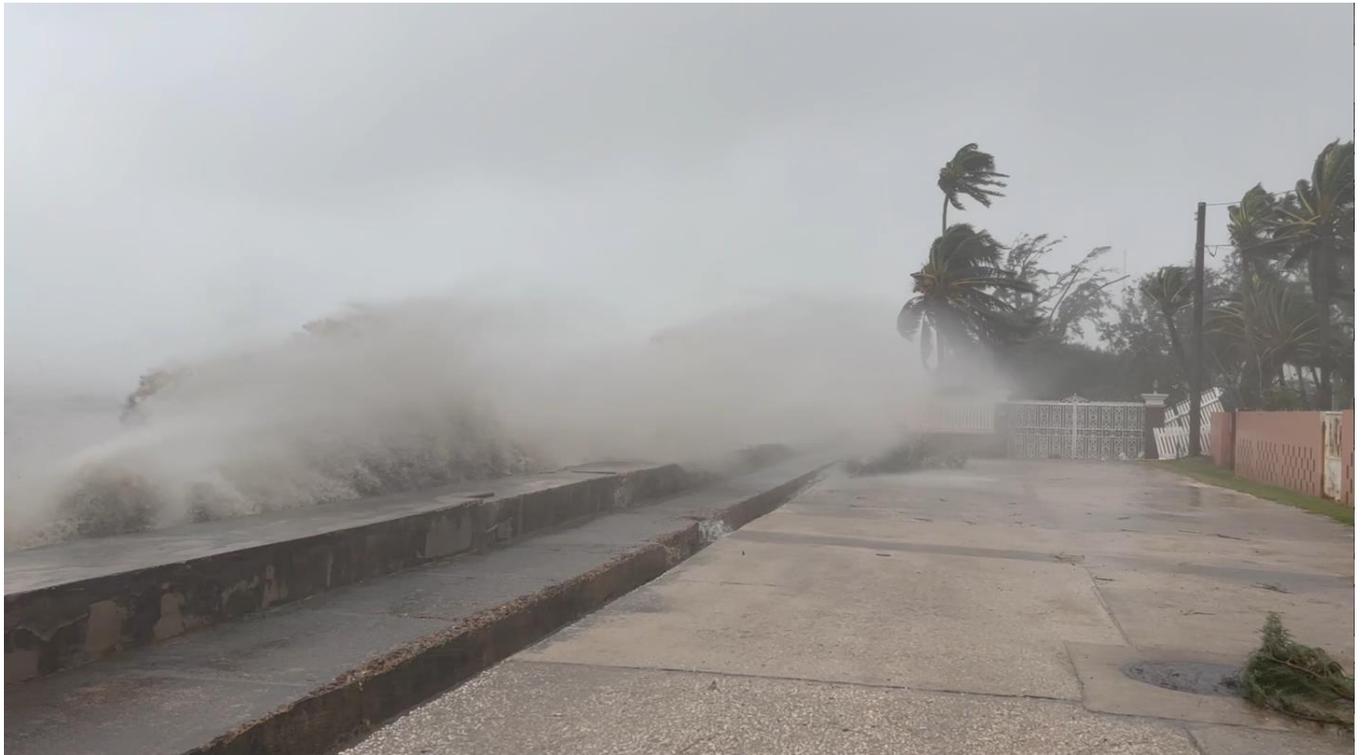
***Waves crashing against the seawall on the South Side of Belize City during Hurricane LISA. Shortly after this image was captured, the storm surge overtopped the seawall and rapidly inundated Downtown.***

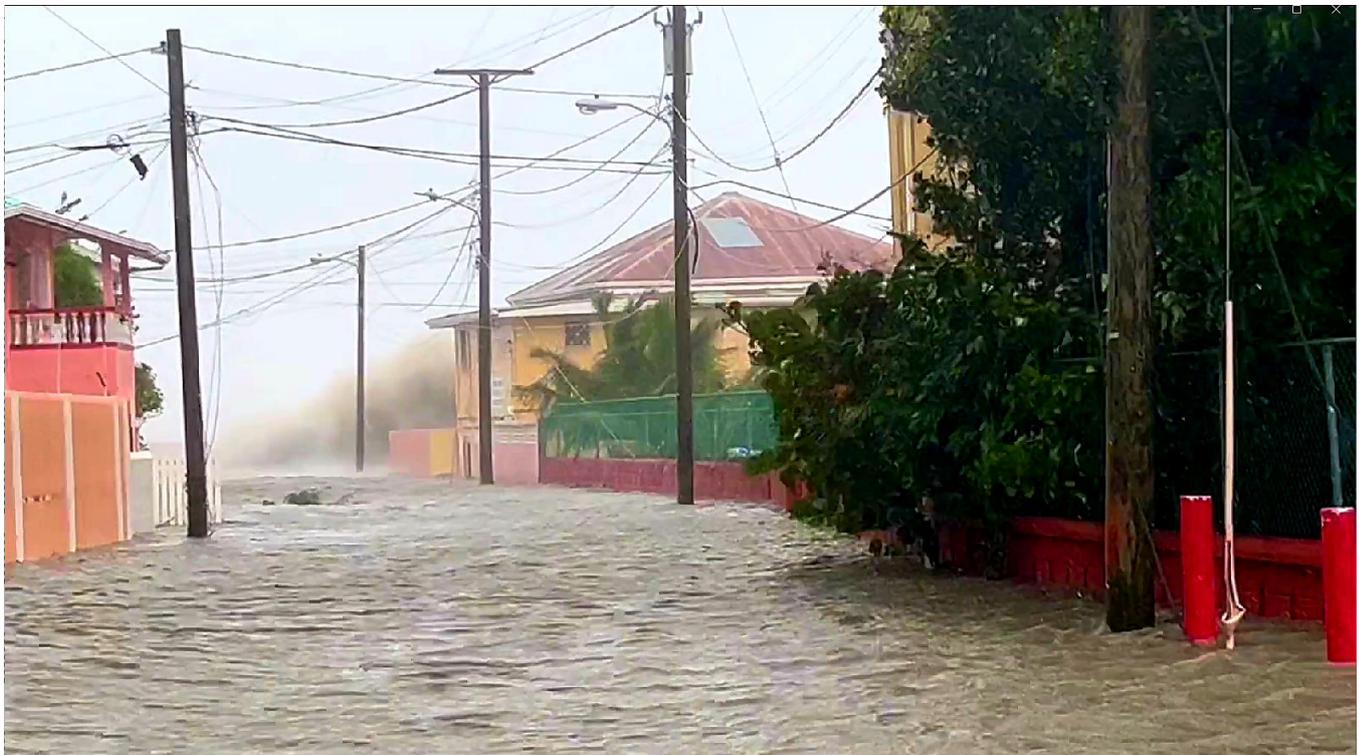
***3:47 pm CST. At the intersection of Regent Street and Rectory Lane, looking toward the waterfront. Waves can be seen crashing over the seawall as storm surge rushes into the neighborhood.***

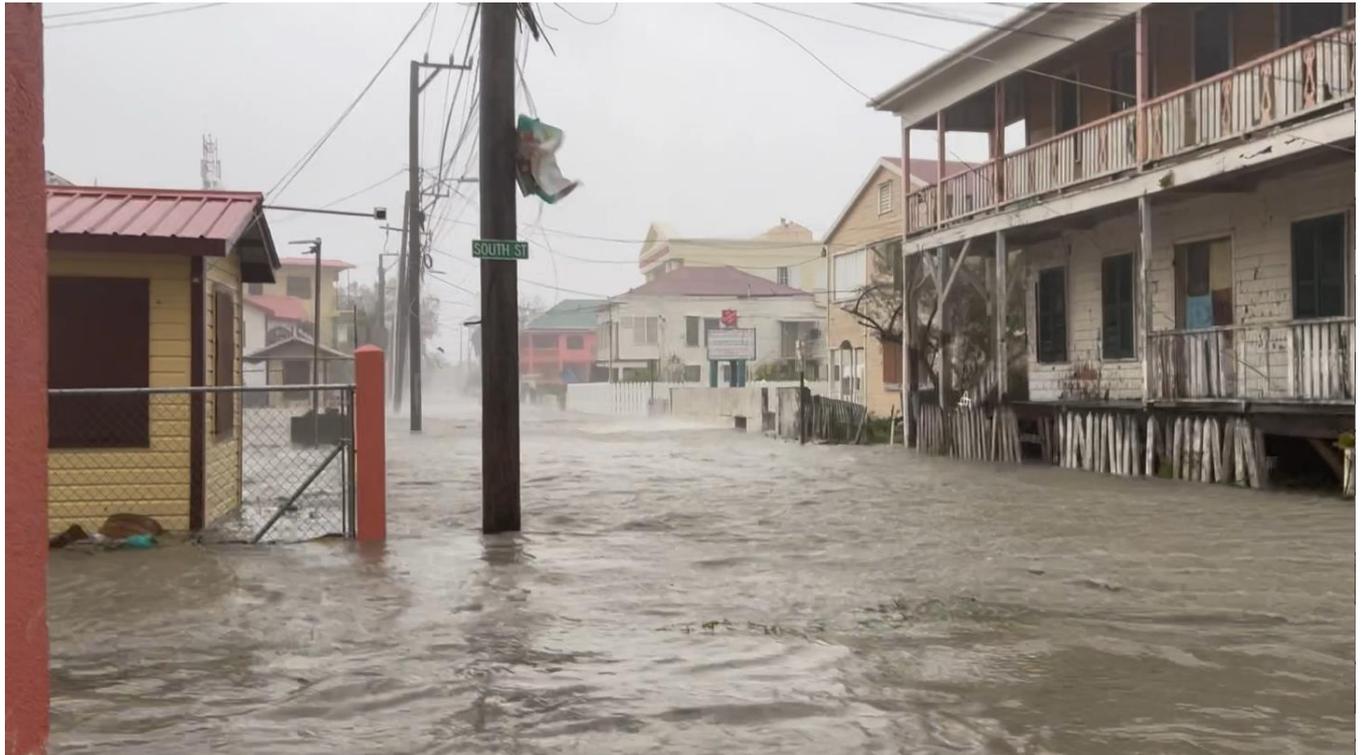
***Storm surge flooding in Belize City during Hurricane LISA. The view is looking S, down Regent Street. The street was completely inundated at the height of the storm.***

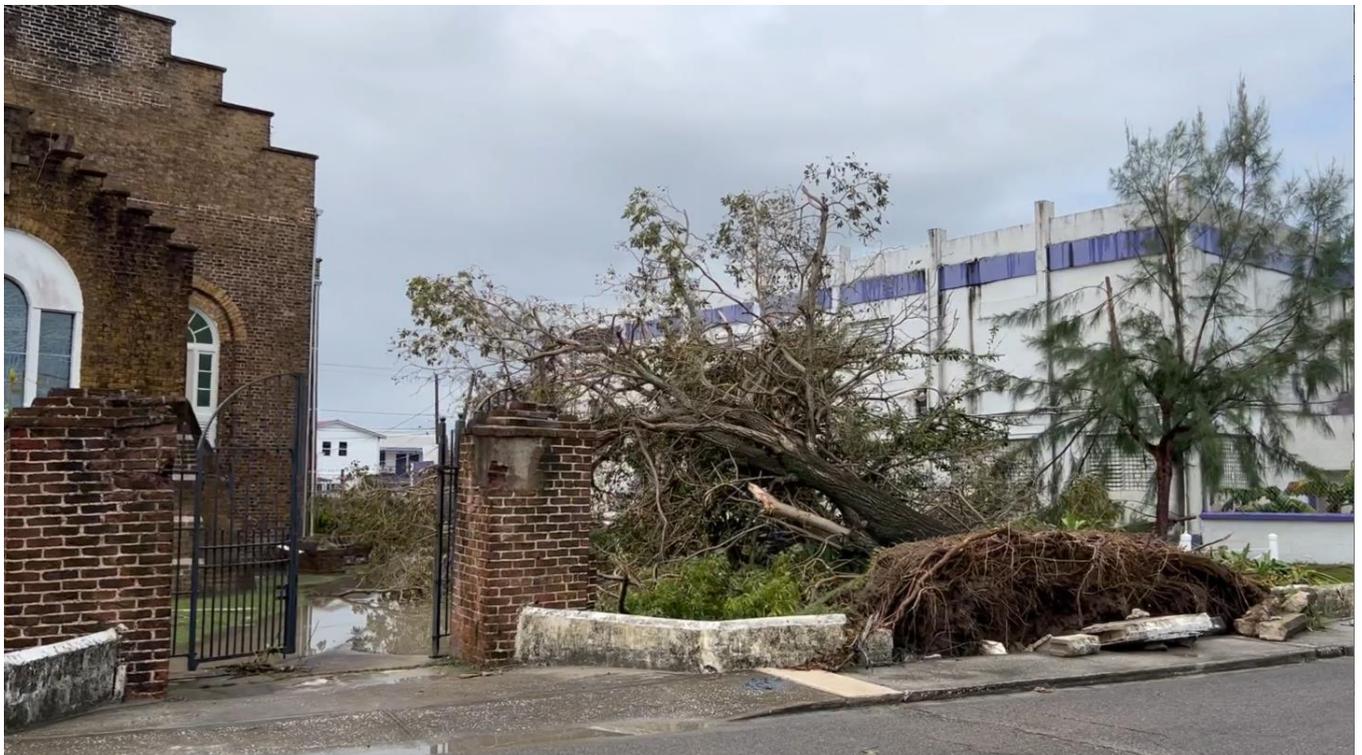
***Large felled tree in front of a church in Downtown Belize City, the day after Hurricane LISA. Wind damage across the city was streaky.***

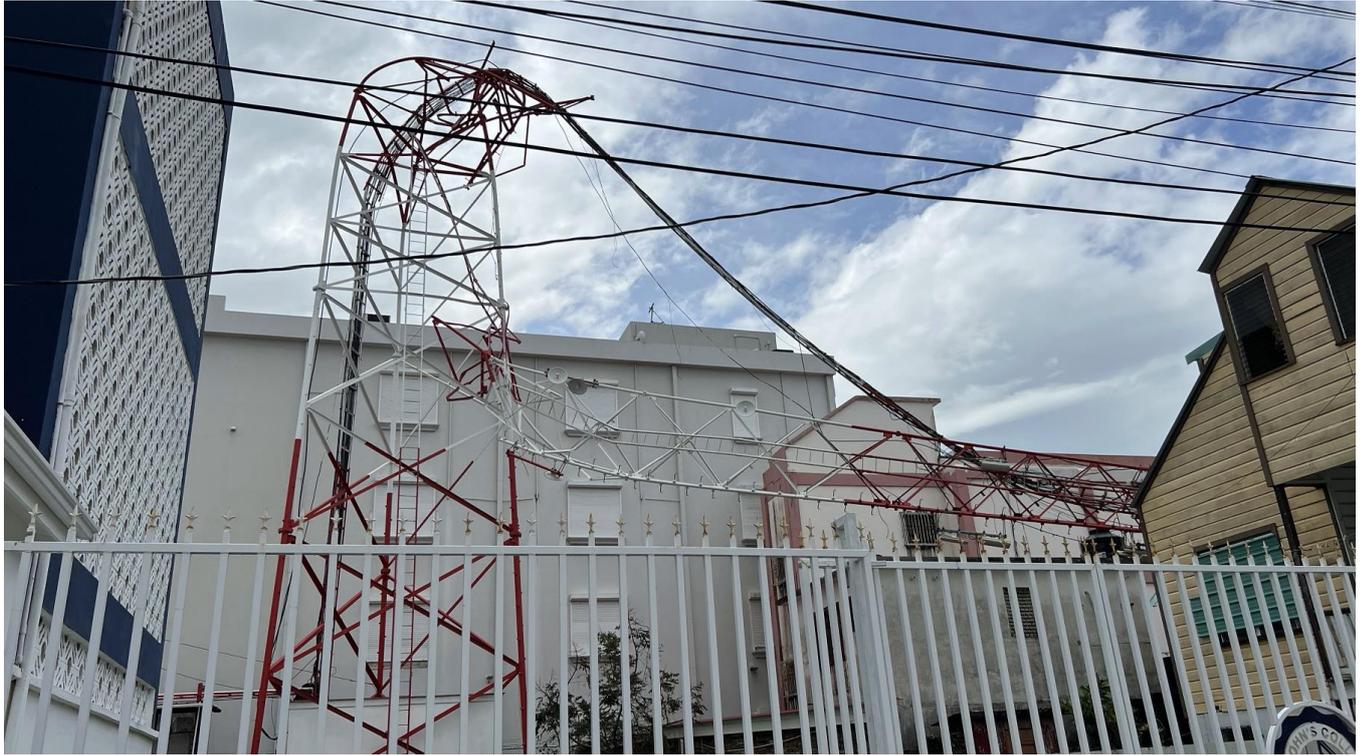
Wind damage was extensive in the city's poorer neighborhoods, with less resistant structures—especially wood-frame ones—losing their roofs. Large trees and signs were felled. Sturdier homes and businesses in the Downtown area fared better, but there was still some roof damage, and a large communications tower near the author's hotel was destroyed—bent in half by the winds.

***A destroyed communications tower off Regent Street in Downtown Belize City. Hurricane LISA's winds bent the structure in half.***

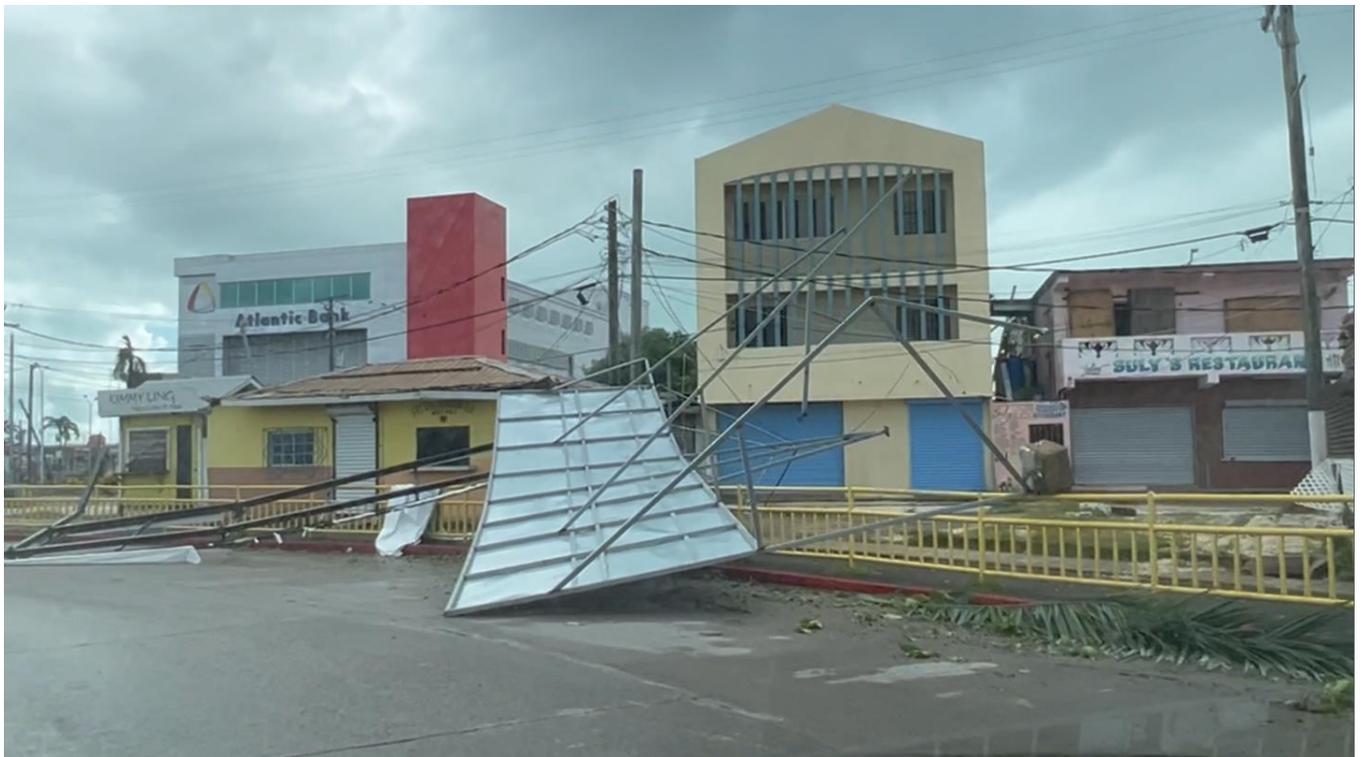
***Destroyed sign at a major traffic roundabout in Downtown Belize City, the day after Hurricane LISA.***

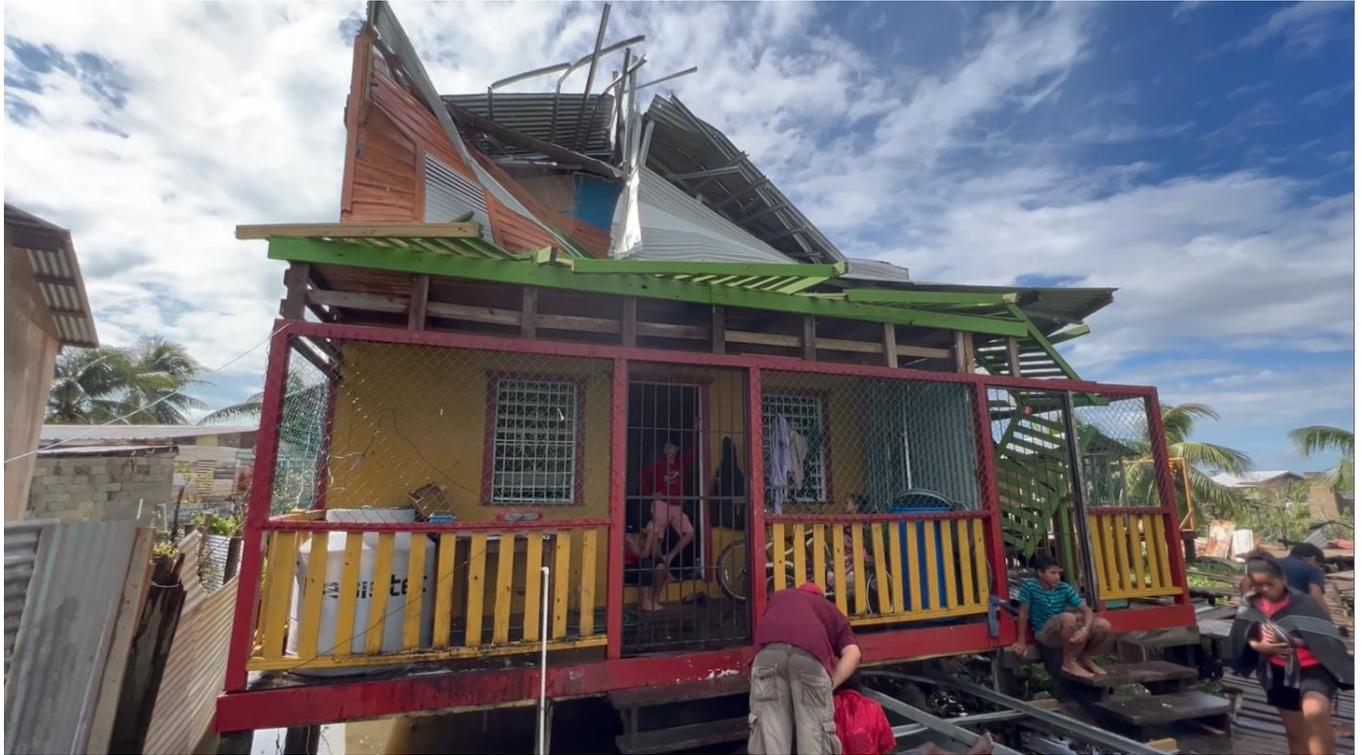
***A home with a destroyed second story in a poorer neighborhood in Belize City. Wood-frame structures with tin roofs were no match for Hurricane LISA's winds. Many such structures across the city were damaged.***

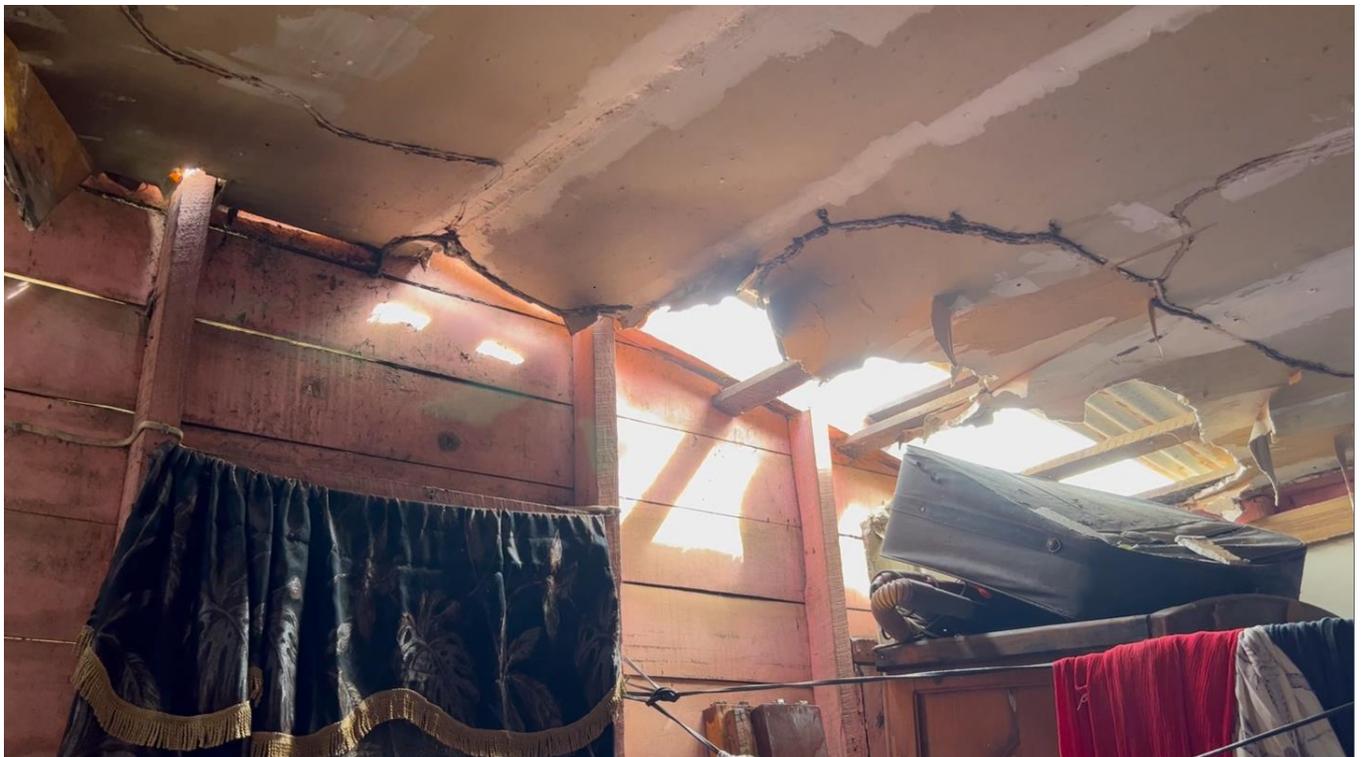
***Roof damage from inside a home in a poorer neighborhood in Belize City. Hurricane LISA's winds destroyed many such roofs (with tin surfacing) across the city.***

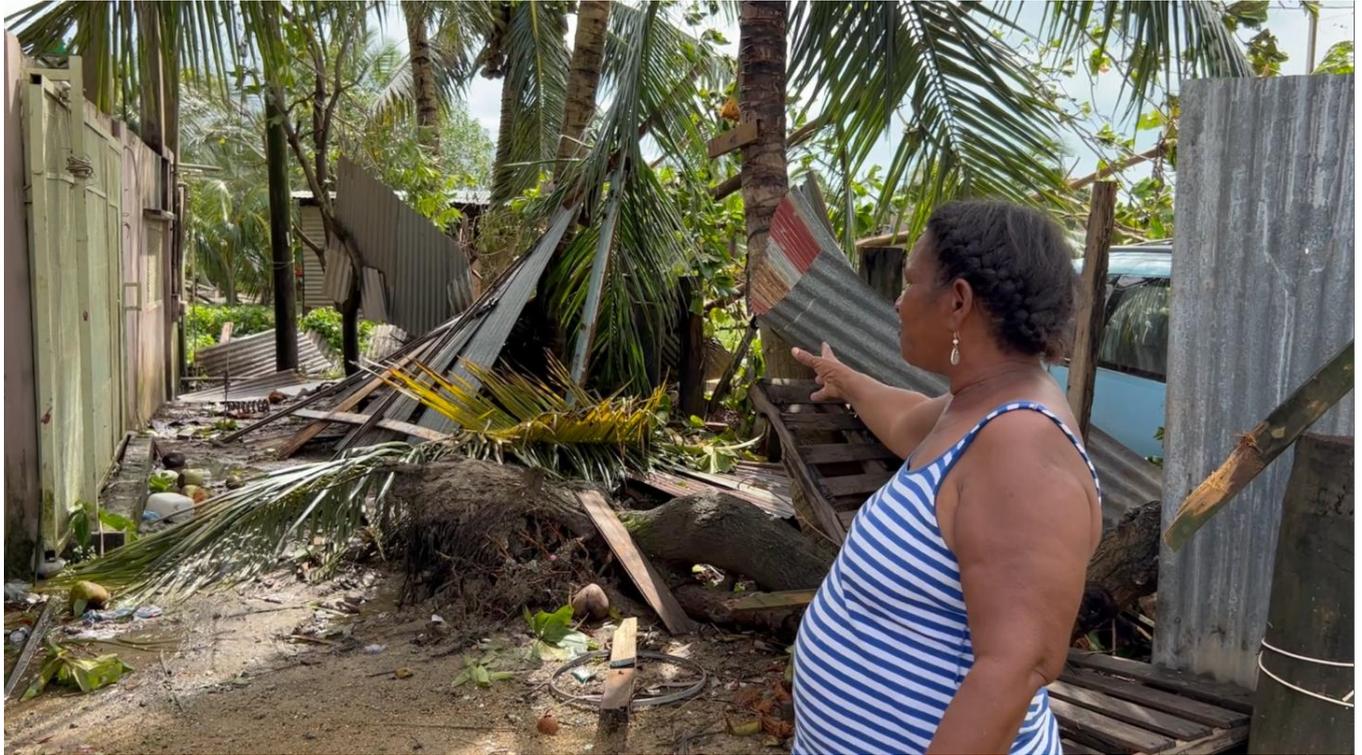
***A resident of Belize City shows the damage to her home. Hurricane LISA's winds tore off the roof and scattered the debris in the trees.***

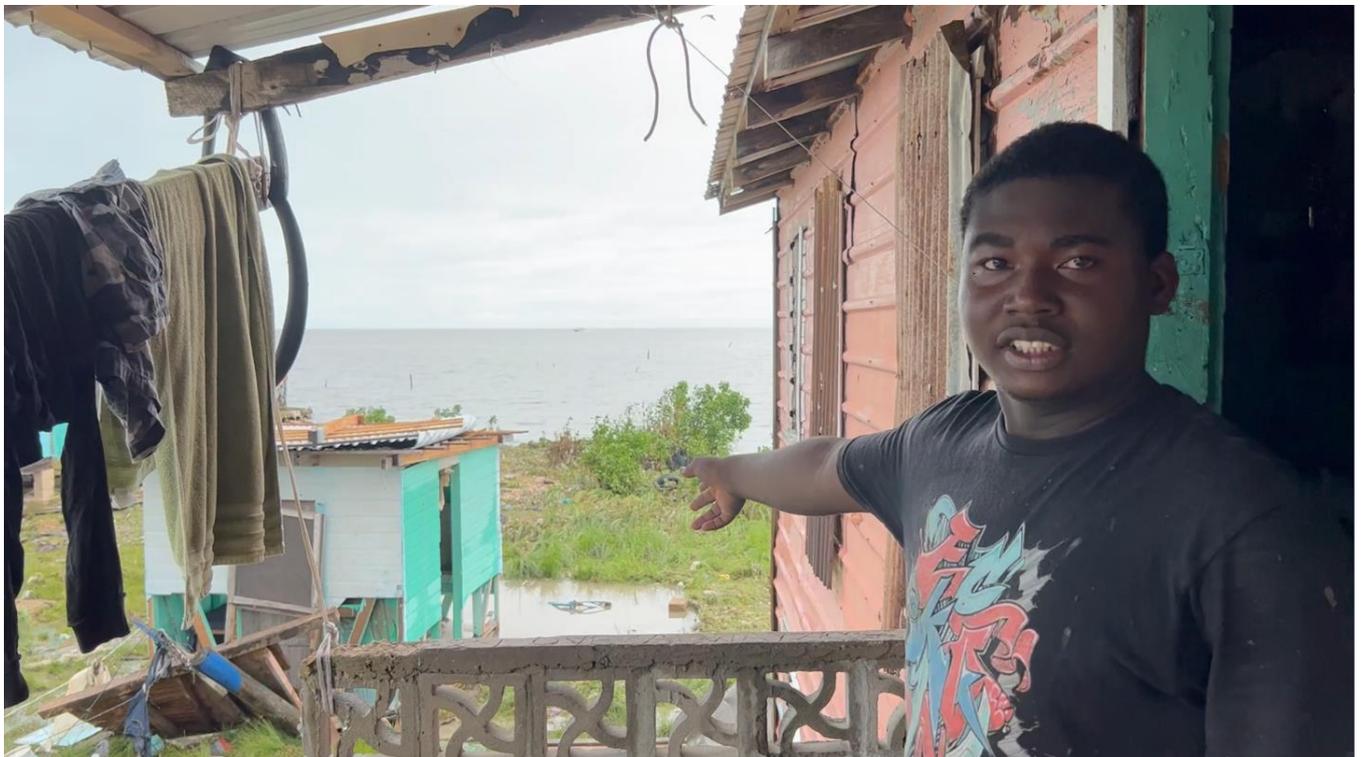
***A resident of a waterfront family compound in Belize City describes how Hurricane LISA's storm surge swept ashore fast and struck the house below with "full impact." He added, "It was like a tsunami."***

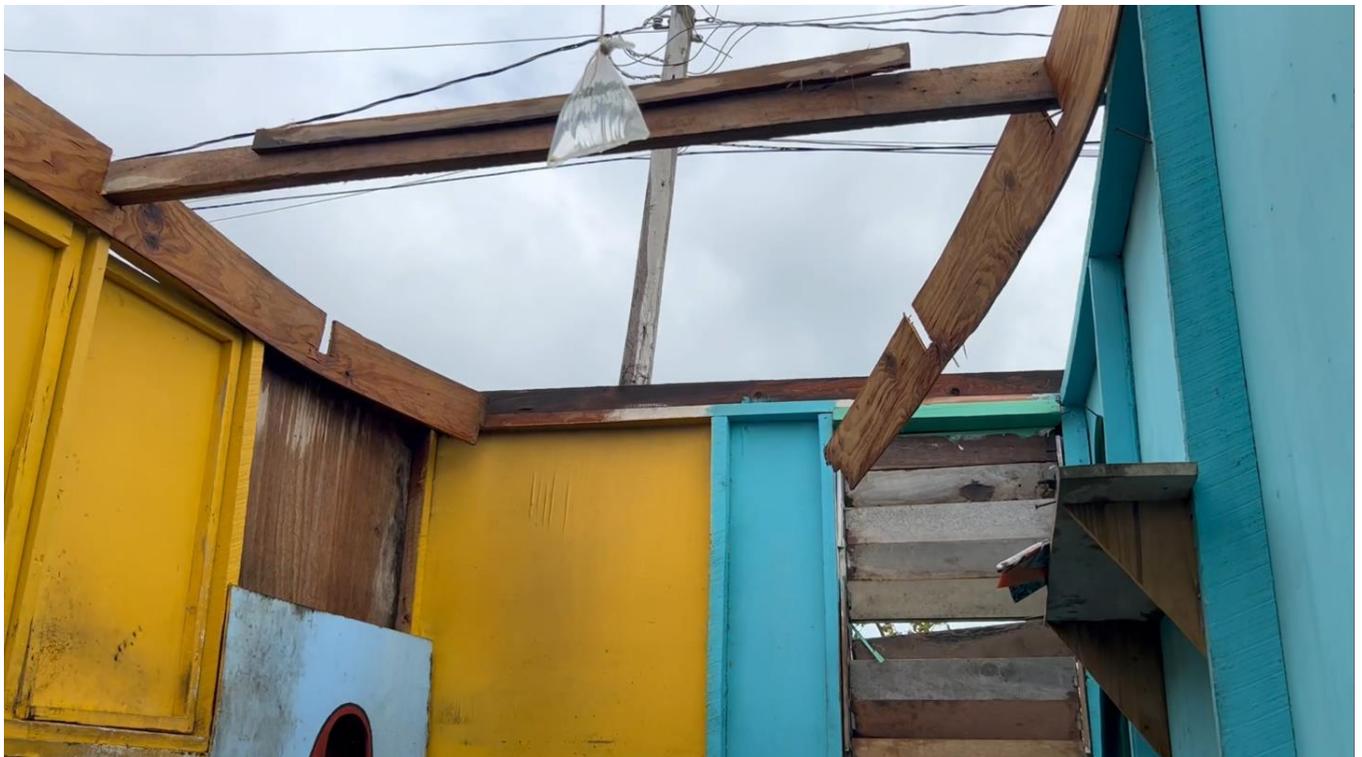
***Hurricane LISA's winds tore the roof off this small restaurant/food stand in Belize City. Damage such as this was especially unfortunate, as it also impacted people's livelihoods.***

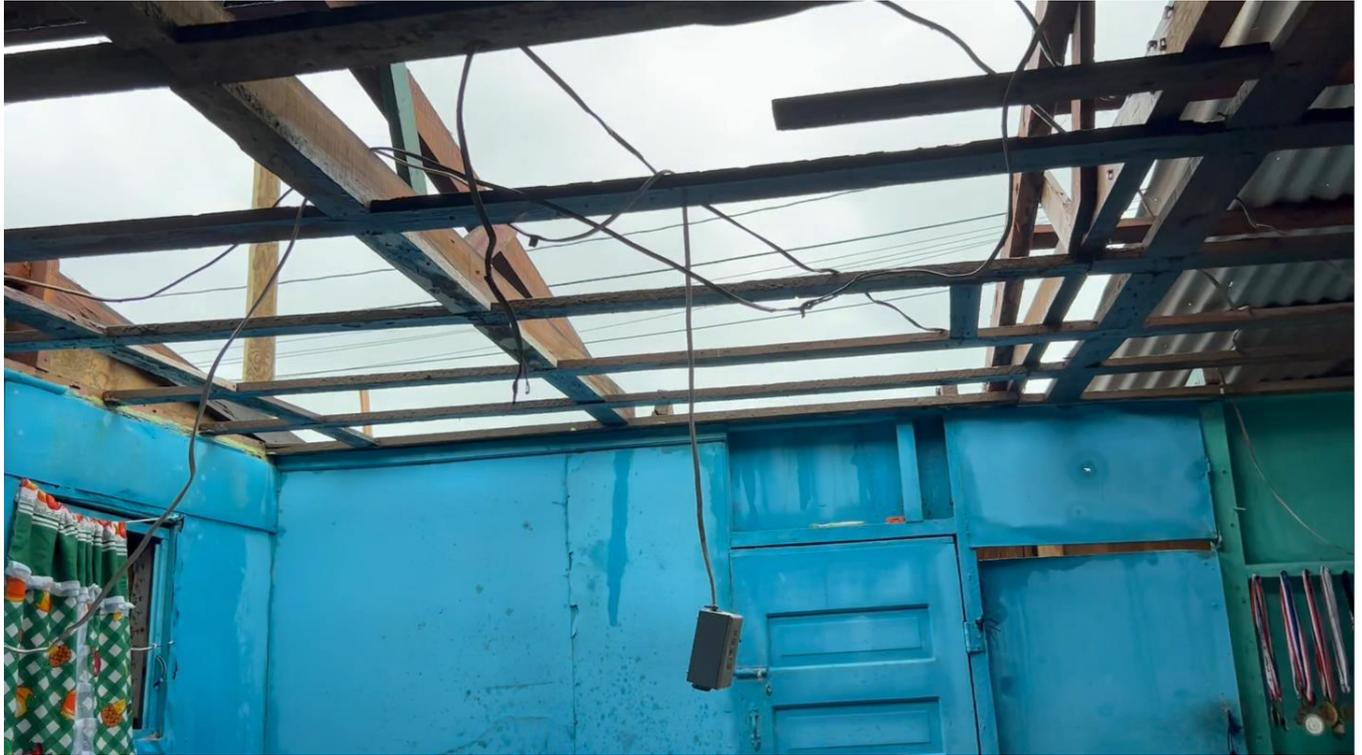
*View from inside a damaged home in Belize City. Hurricane LISA's winds tore off most of the roof, exposing the inside to the elements.*

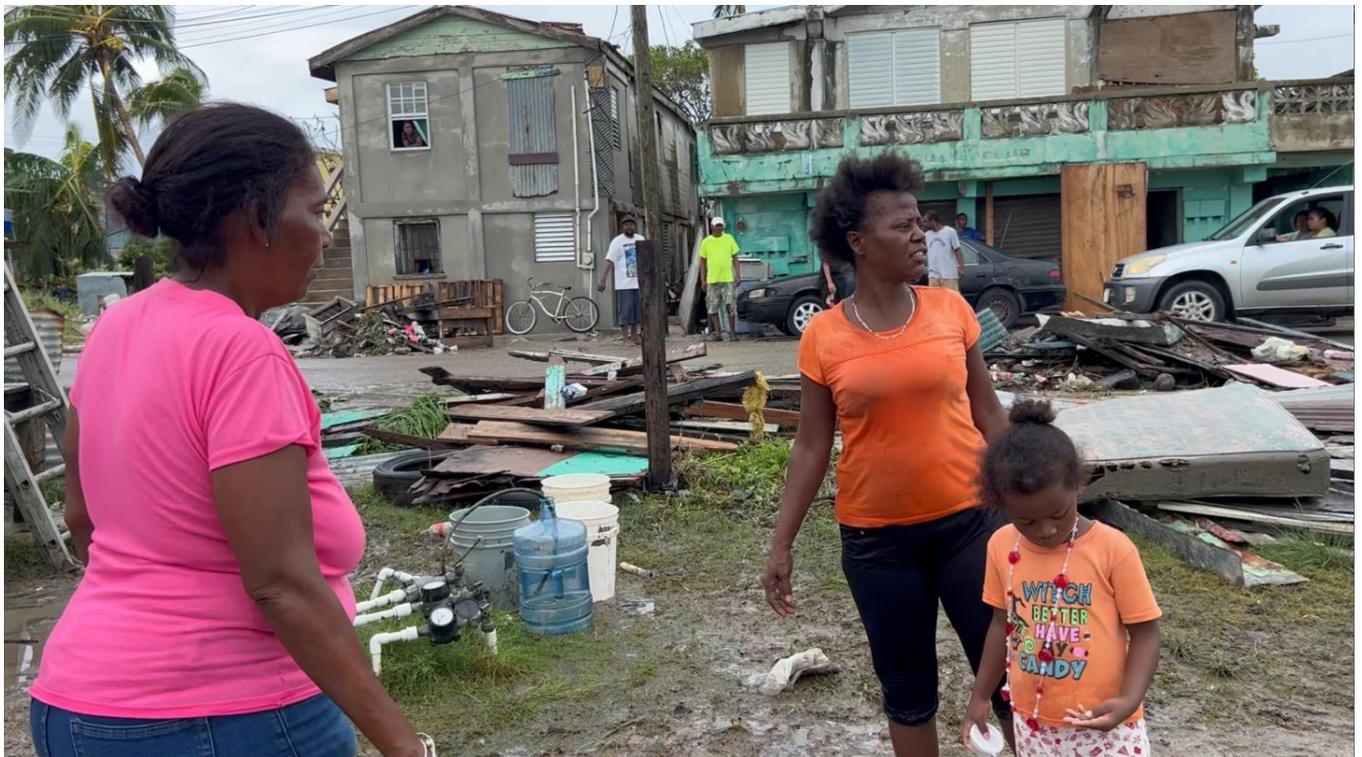
*Members of an extended family survey the damage to their family compound in Belize City. Hurricane LISA's storm surge scattered wreckage across their property and into the street.*

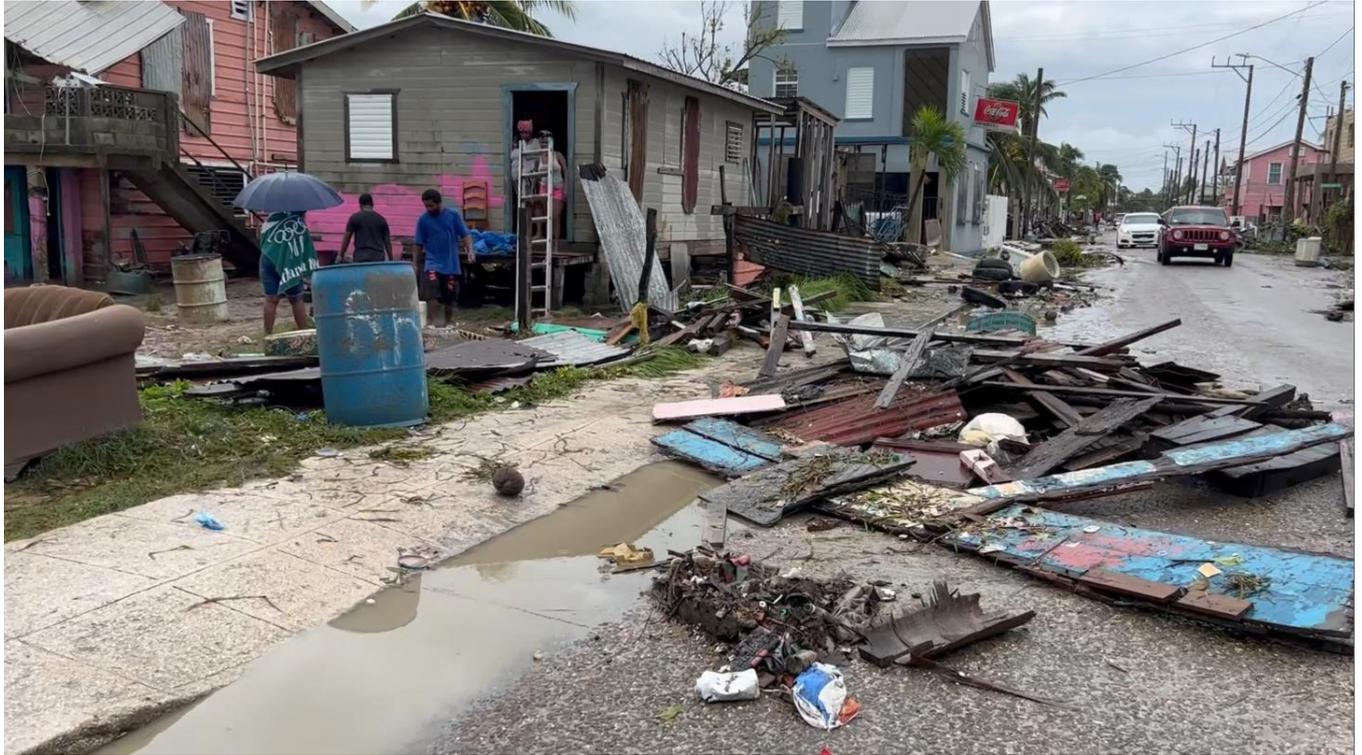
***Debris and wreckage litter a street in Belize City the day after Hurricane LISA. The storm surge left a tremendous mess across the city.***
