# iCYCLONE CHASE REPORT

storm	Hurricane LISA		
location	Belize City, Belize		
date	02 November 2022		
chasers	Josh Morgerman	author	Josh Morgerman

Hurricane LISA was a late-season Category-1 hurricane that struck the Caribbean nation of Belize on the afternoon of 02 November 2022.

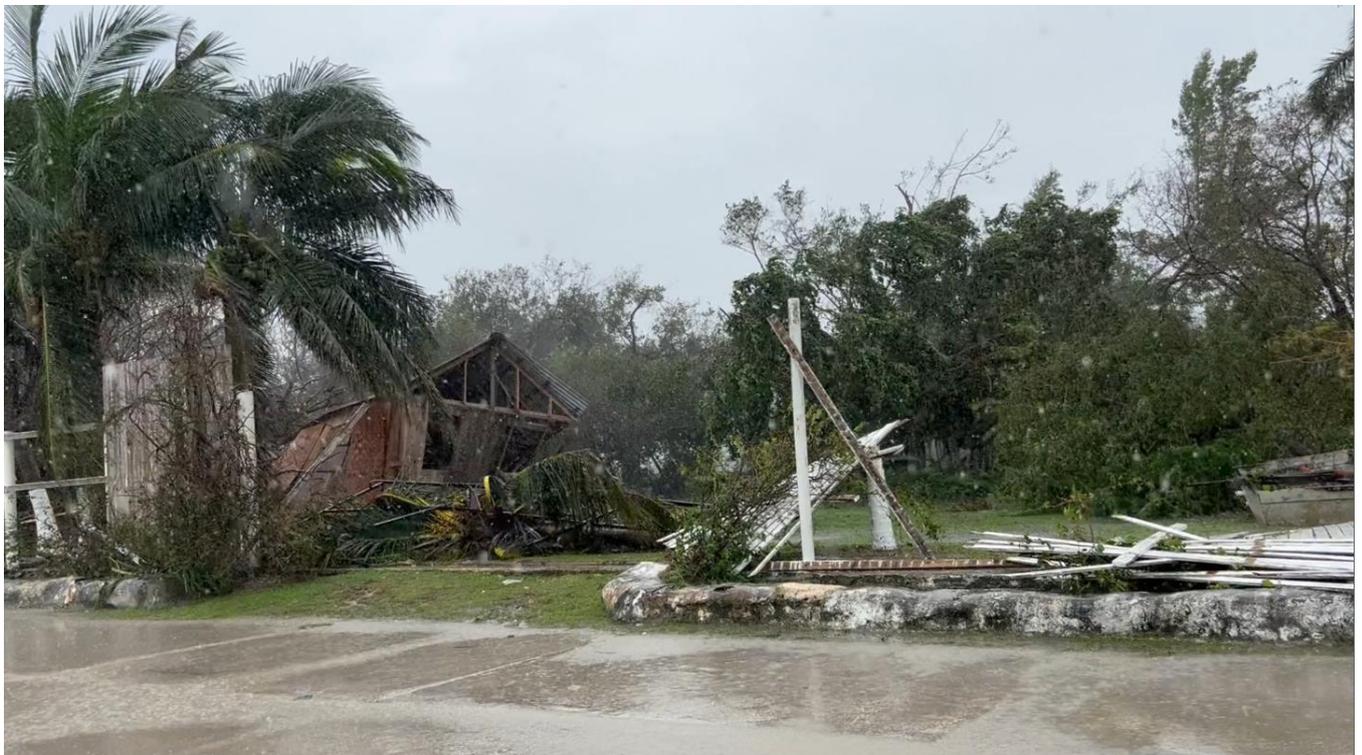
***The flimsy structure in the background was no match for LISA. The hurricane's winds knocked it askew and scattered the debris.***
