iCYCLONE CHASE REPORT

storm	Hurricane PAMELA		
location	Sinaloa, Mexico		
date	13 October 2021		
chasers	Josh Morgerman, Erik Sereno	author	Josh Morgerman

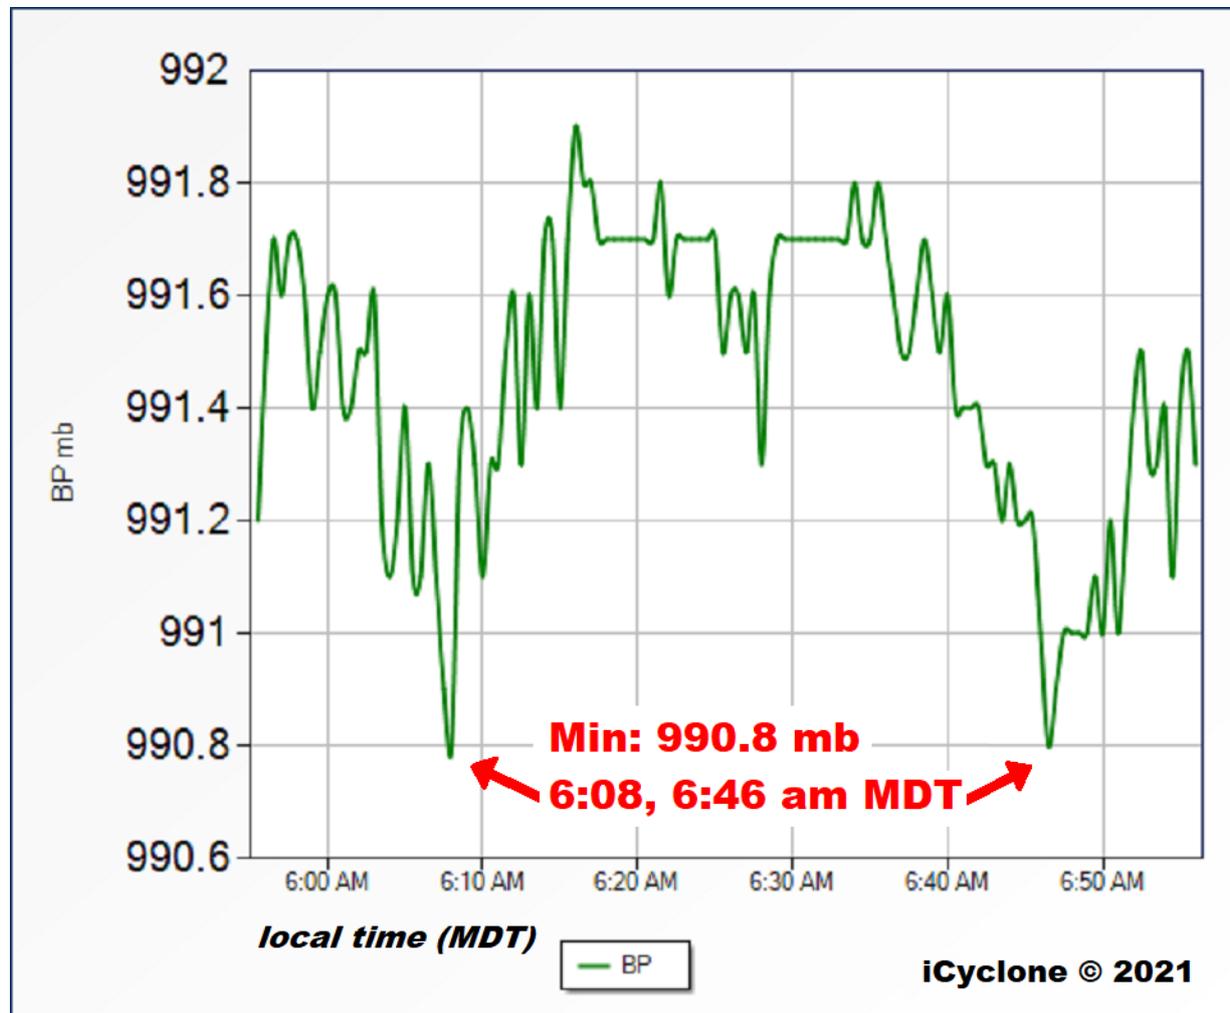
Figure 3: Barogram—Location A

The minimum pressure of 990.8 mb occurred at 6:08 and 6:46 am MDT, as the eye passed over Marmol de Salcido.

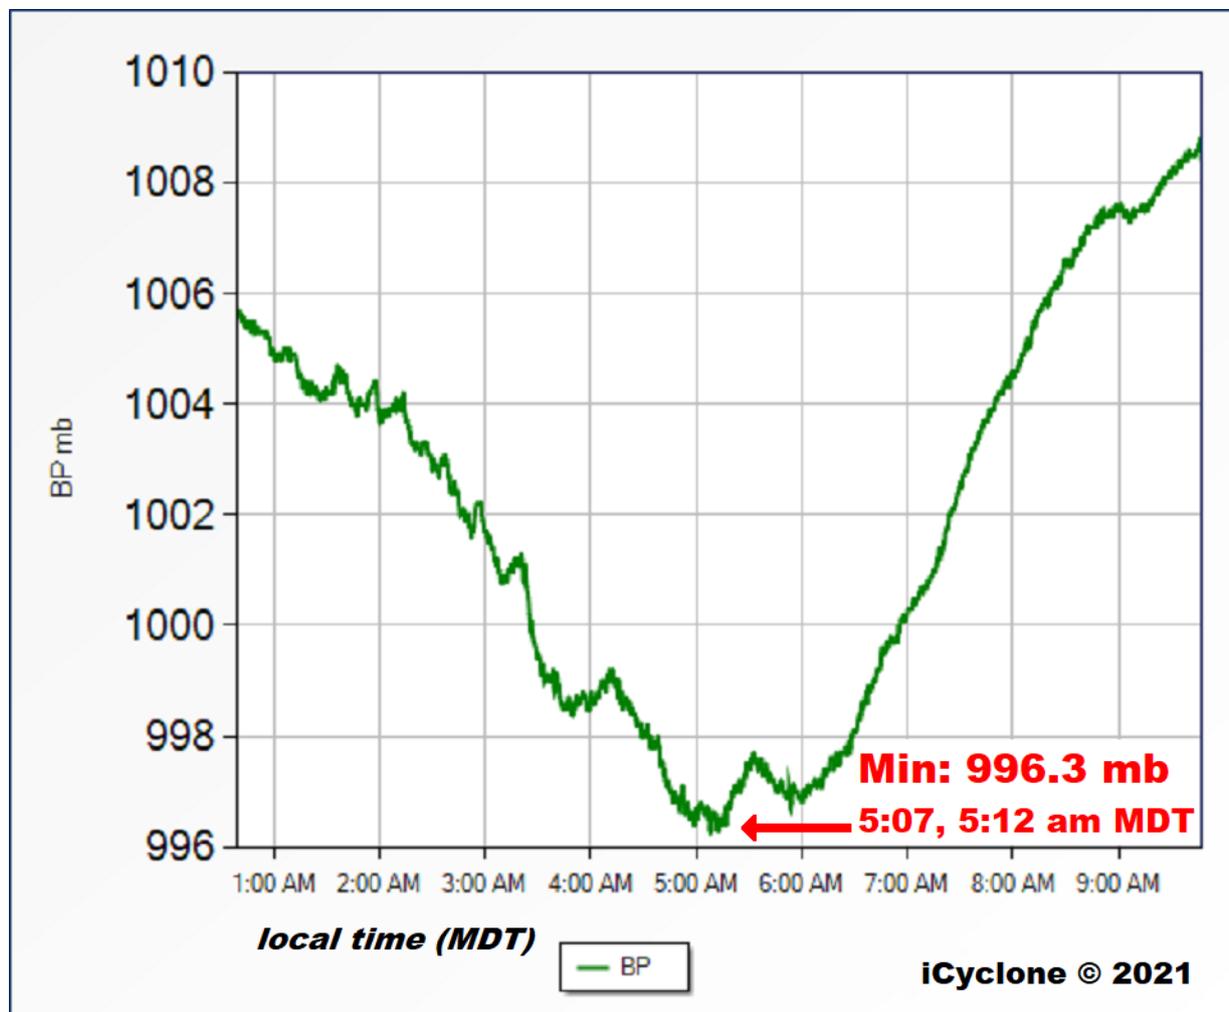
Figure 4: Barogram—Location B

The minimum pressure in Mazatlan was 996.3 mb at 5:07 and 5:12 am MDT. This minimum occurred as the eye passed NW of the city.
