# ICYCLONE CHASE REPORT

storm	Hurricane ROSLYN		
location	Santa Cruz, Nayarit, Mexico		
date	23 October 2022		
chasers	Josh Morgerman, Erik Sereno	author	Josh Morgerman

Hurricane ROSLYN was a small, violent Category-3 hurricane that struck the Pacific coast of Mexico, in the state of Nayarit, just before dawn on 23 October 2022.

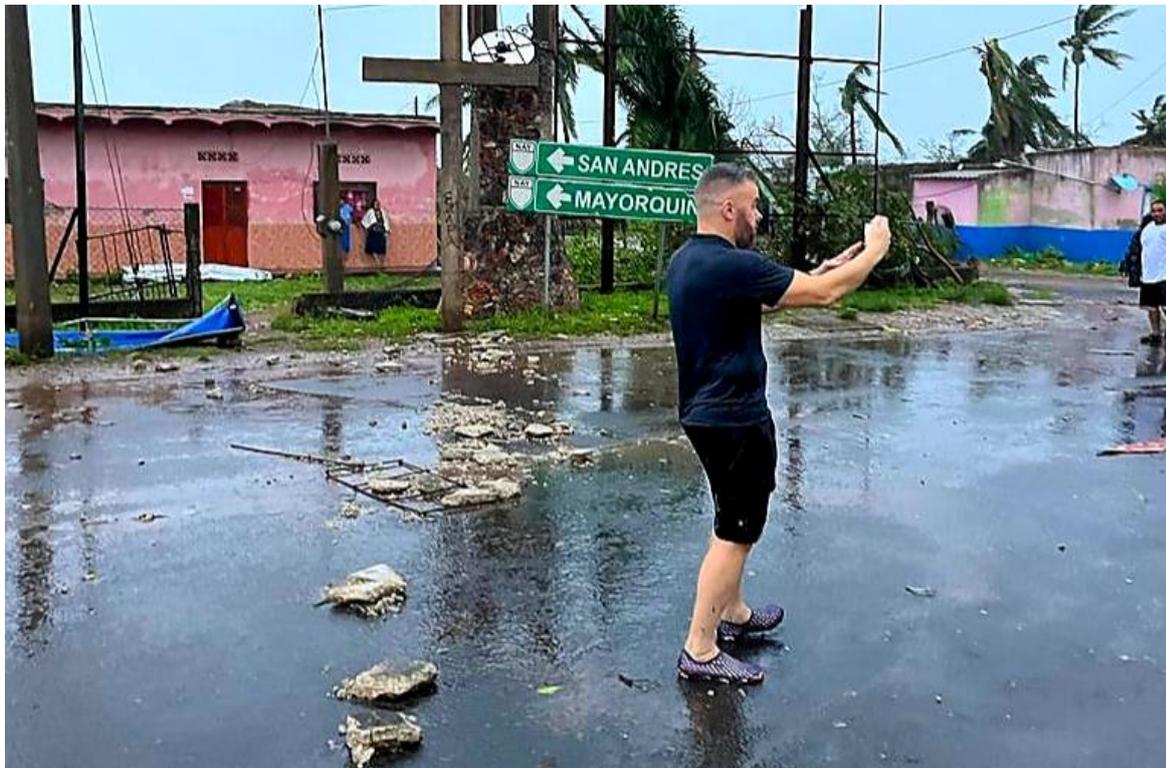
Wind damage across the small town was extensive. Scores of homes and businesses suffered major damage, many with roofs torn off. Many trees and power poles were felled, some falling onto houses and walls to inflict serious secondary damage. A tangle of fallen trees and branches, broken power poles, twisted metal, and smashed concrete littered the town and blocked all major roads. The roof of a large open-air athletic facility was mostly torn off, the metal sheets scattered across the neighborhood and caught in tree branches and wires. Power was out across Santa Cruz and the surrounding region.

*The author documenting ROSLYN's aftermath in Santa Cruz. (Photo: Erik Sereno)*

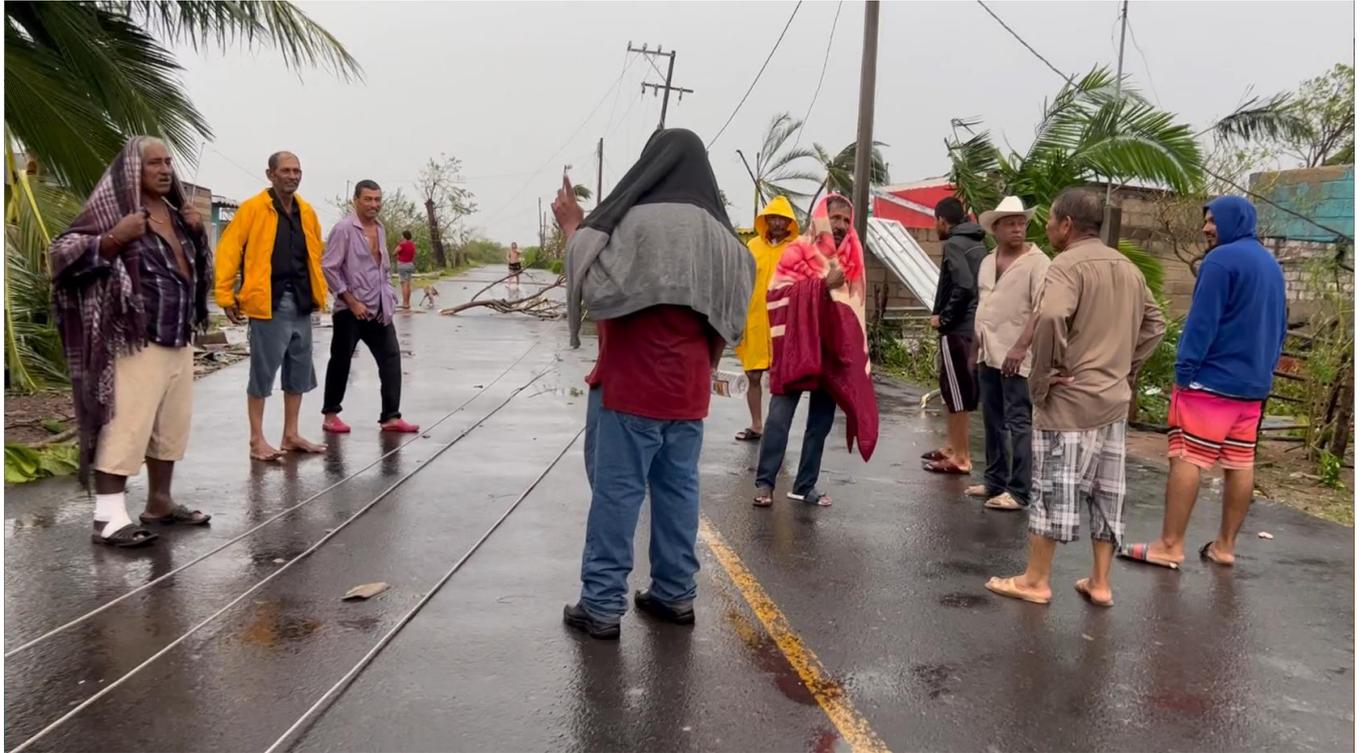
**Santa Cruz. Stunned residents congregate in the street hours after ROSLYN's devastating impact.**

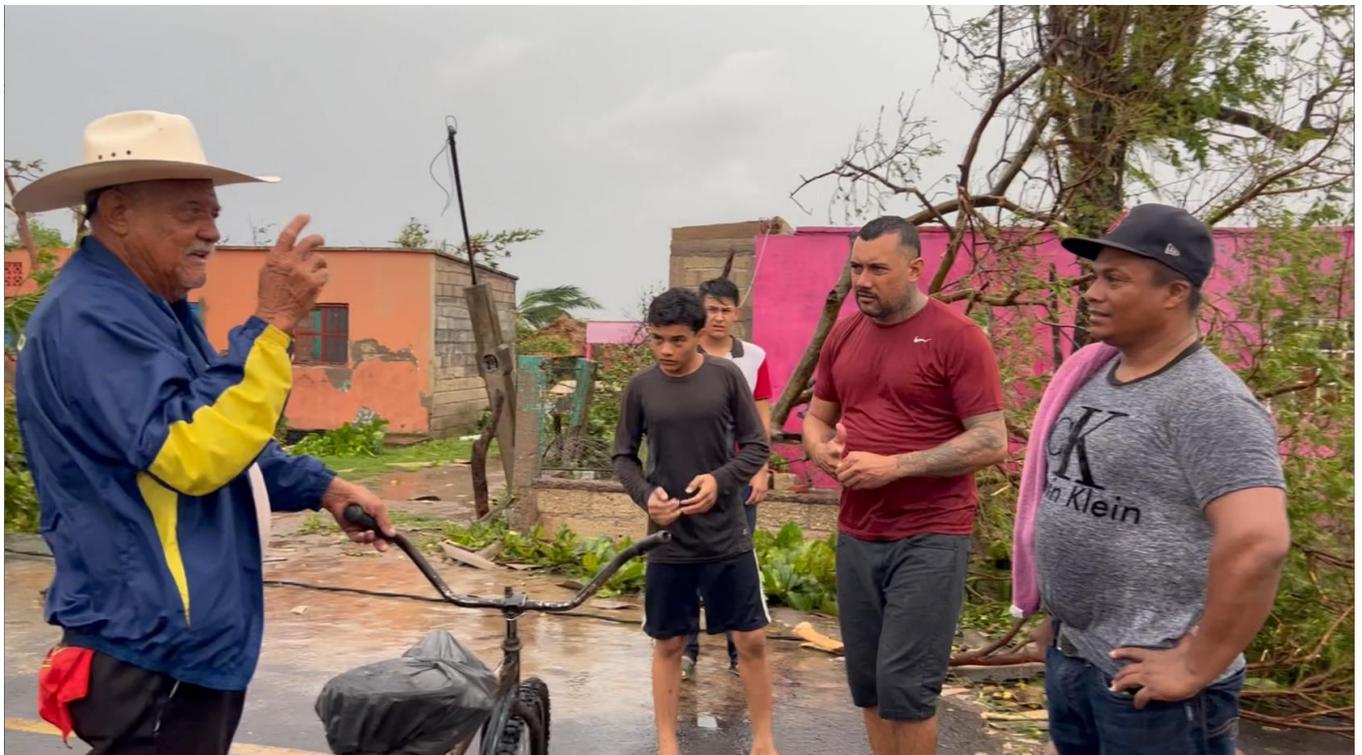
**Santa Cruz. Residents share their experiences riding our Hurricane ROSLYN. Many were surprised by the storm's violence.**

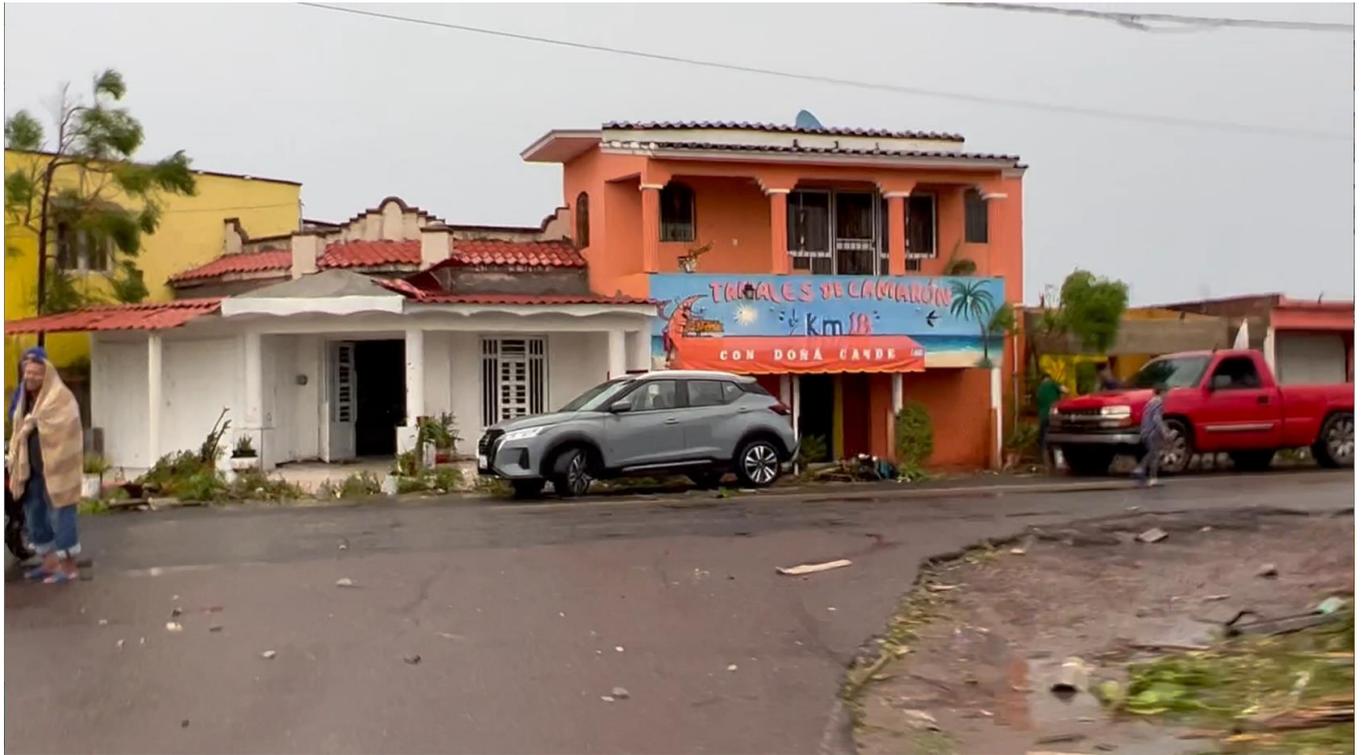
**Santa Cruz. The author and his partner rode out Hurricane ROSLYN pressed against the front entrances of these buildings near the center of town.**
